*Ford Motor Company of Canada,  
Limited*

TO: ALL FORD OF CANADA DEALERS

Subject: Campaign #654  
Accelerator Linkage Interference Inspection  
Certain 1969 Model Mustangs and Cougars with 302 or 351, 2V Engines

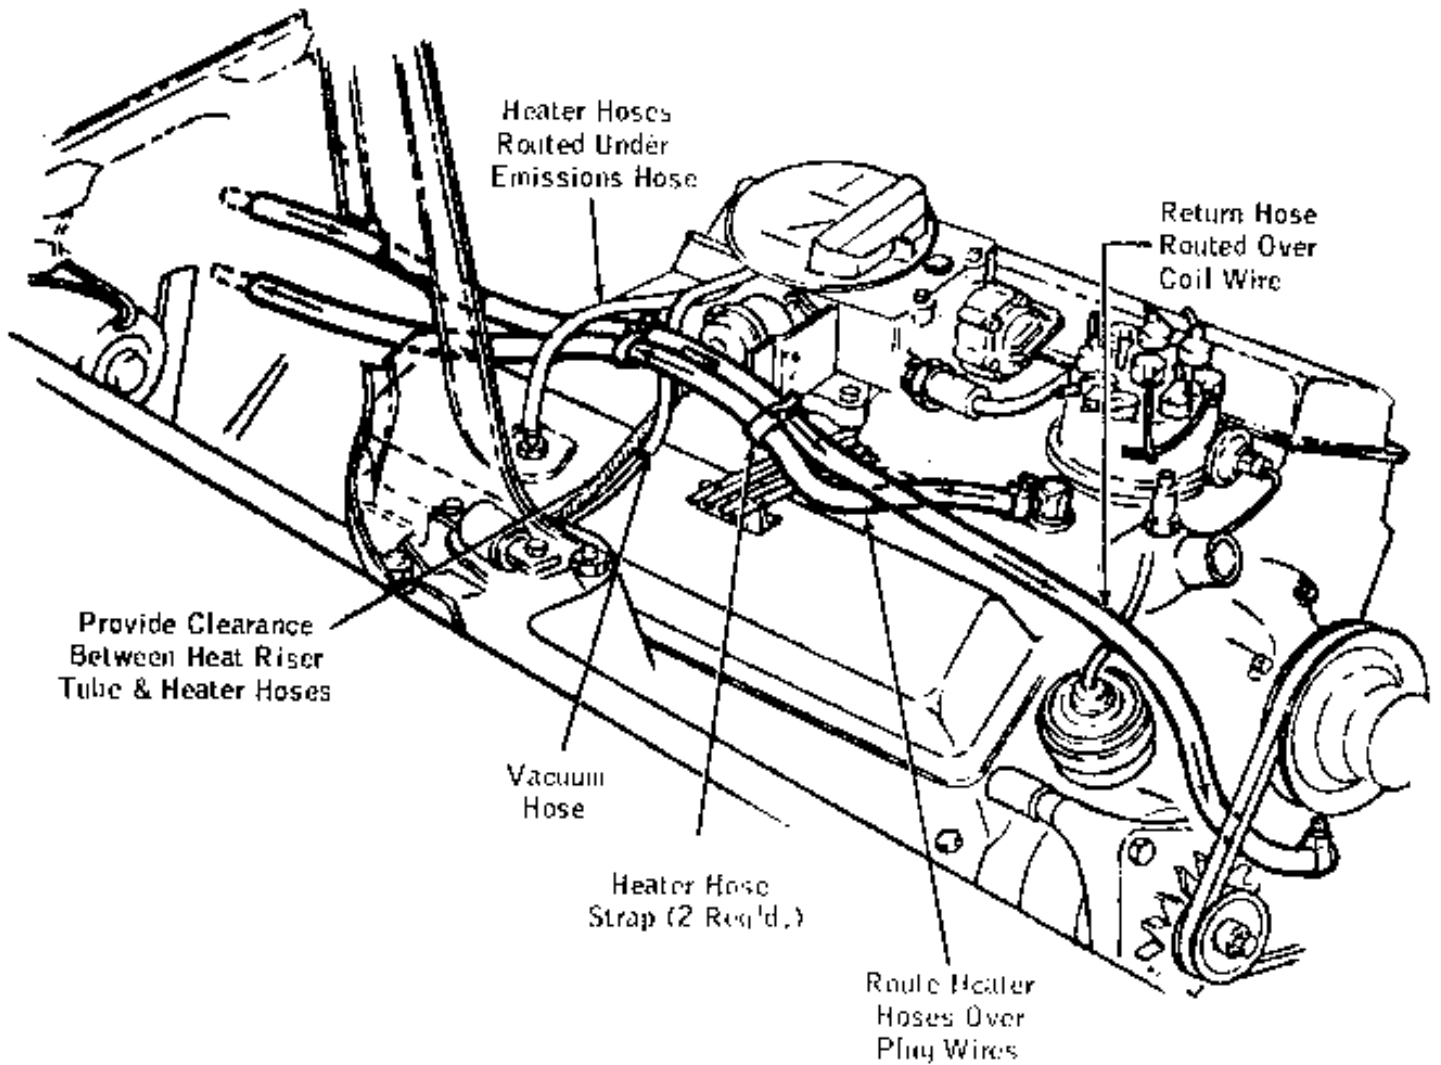
1969 MUSTANG AND COUGAR  
HEATER HOSE ROUTING

We have recently learned that it is possible, under certain circumstances, for a misrouted heater hose to interfere with the throttle linkage, causing it to stick in the open position during heavy acceleration. This could result in the car continuing to accelerate even though the driver's foot is removed from the accelerator pedal.

2. Referring to attached sketch, inspect for proper hose routing and installation of straps as shown.
  3. If hoses and straps are not installed as shown, proceed with Step 4 and 5.
  4. If hose is routed between the choke heat tube and carburetor base, disconnect the heat tube from the choke assembly and relocate heater hose to the outboard side of tube. See attached sketch. Reconnect heat tube.
  5. Assure that straps are installed as shown.
- Note: Should straps be unavailable, friction tape may be substituted.
6. Install air cleaner and close hood.
