Ford Motor Company of Canada, Limited

SUBJECT: CAMPAIGN #668
CERTAIN 1969 MODEL MUSTANG AND COUGAR WITH DISC BRAKES
INSPECTION OF FRONT SPINDLE AND/OR HUB AND ROTOR ASSEMBLIES

1969 DISC BRAKE ROTOR CAMPAIGN # 668

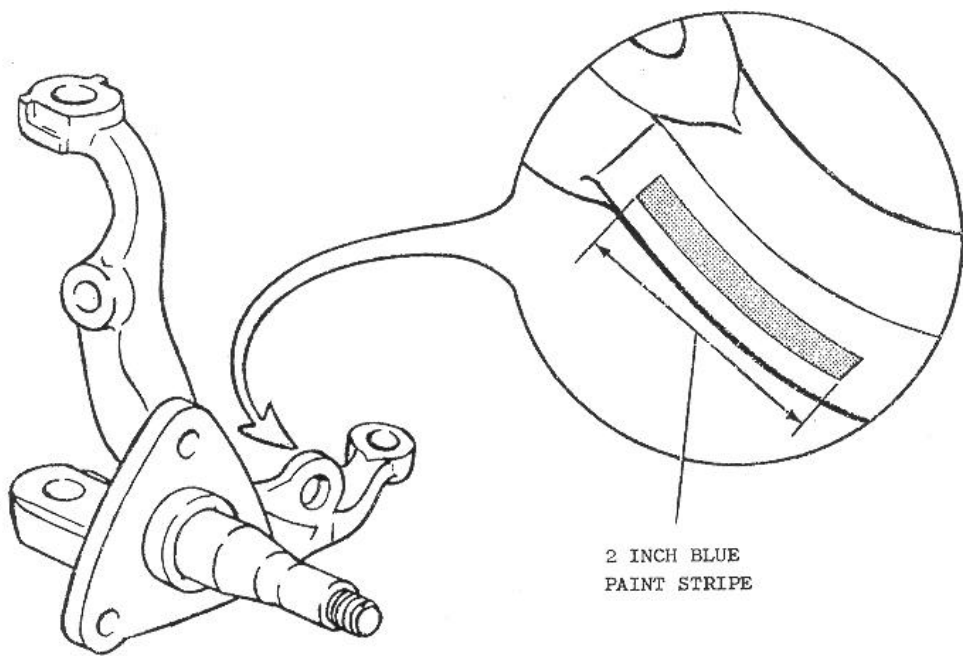
SPINDLE IDENTIFICATION

1. Raise vehicle and inspect both front spindles for the presence of a 2" BLUE stripe colour code on the spindle arm. (See attached sketch)
2. If both spindles have the blue stripe, no further action is required. If one or both spindles cannot be identified as having a blue stripe, proceed with the steps listed below.
3. Should either spindle not have the blue stripe, replace the spindle, hub and rotor and wheel bearings using the following parts:

1. Raise vehicle and inspect both front spindles for the presence of a 2" BLUE stripe colour code on the spindle arm. (See attached sketch)
2. If either spindle has a blue stripe, replace the spindle, hub and rotor and wheel bearings, using the following parts.
