SPECIAL SERVICE LETTER

NUMBER SSI #77

DATE March 10, 1969

Subject: Windnoise and Water Leak Corrections - 1969 Ford & Mustang

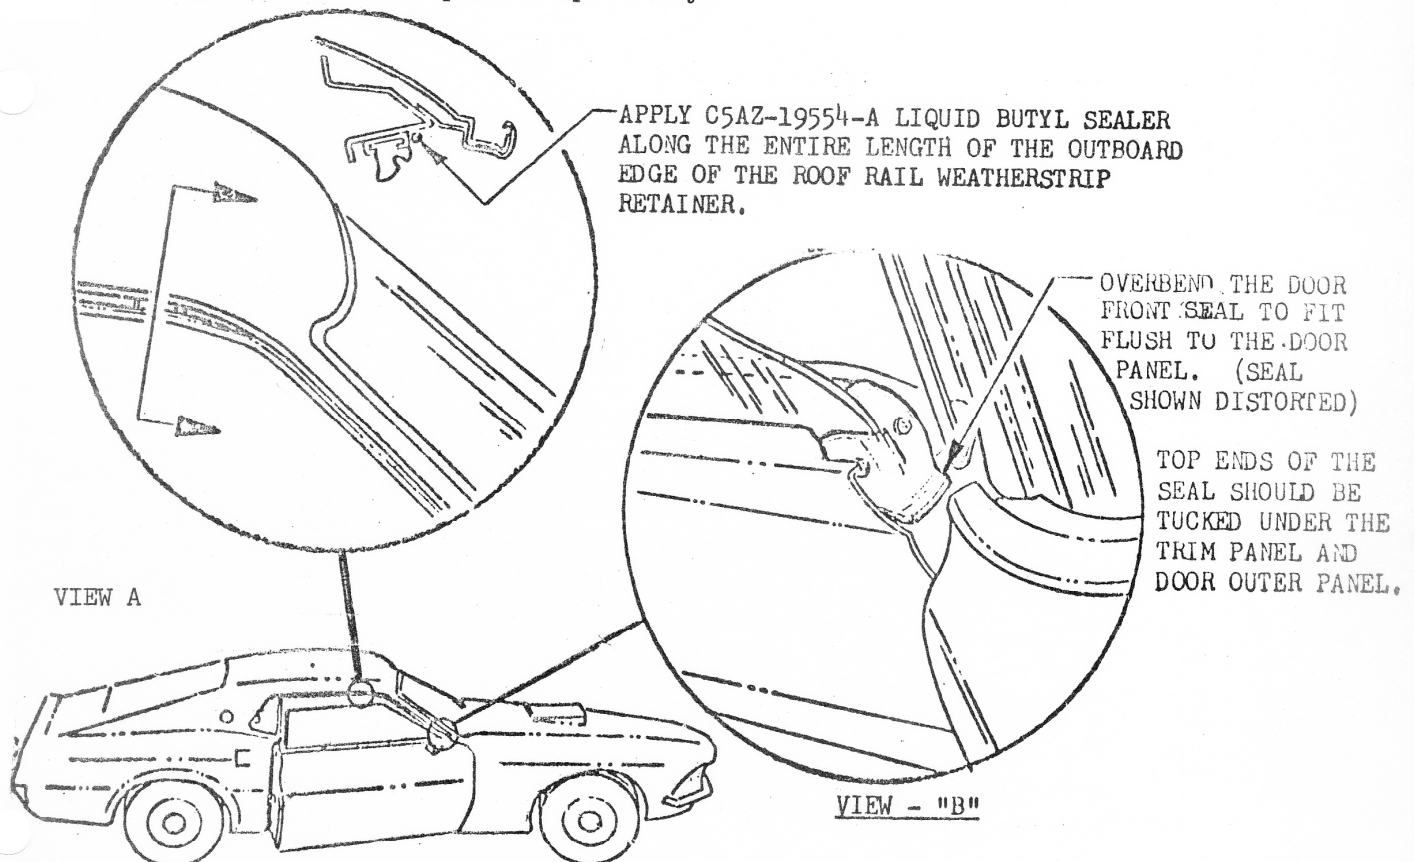
Problem and Cause: 1969 Mustang - All Models

A windnoise occurs at the door glass to "A" post at the belt line. This problem is due to an inadequate seal between the weatherstrip retainer and the "A" post and/or poor fit and coordination of the front door seal assembly to the door inner panel.

Apply C5AZ-19554-A sealer along the outboard edges of the weatherstrip retainer for the entire length of the "A" pillar. This is illustrated in View "A". Also, visually inspect the fit of the front door seal to the door inner panel. Assure that the seal is installed as shown below (View "B"), is free from damage and that the retaining screws are tightened securely.

Note: The top ends of the subject seal should be tucked under the trim panel and door panel respectively.

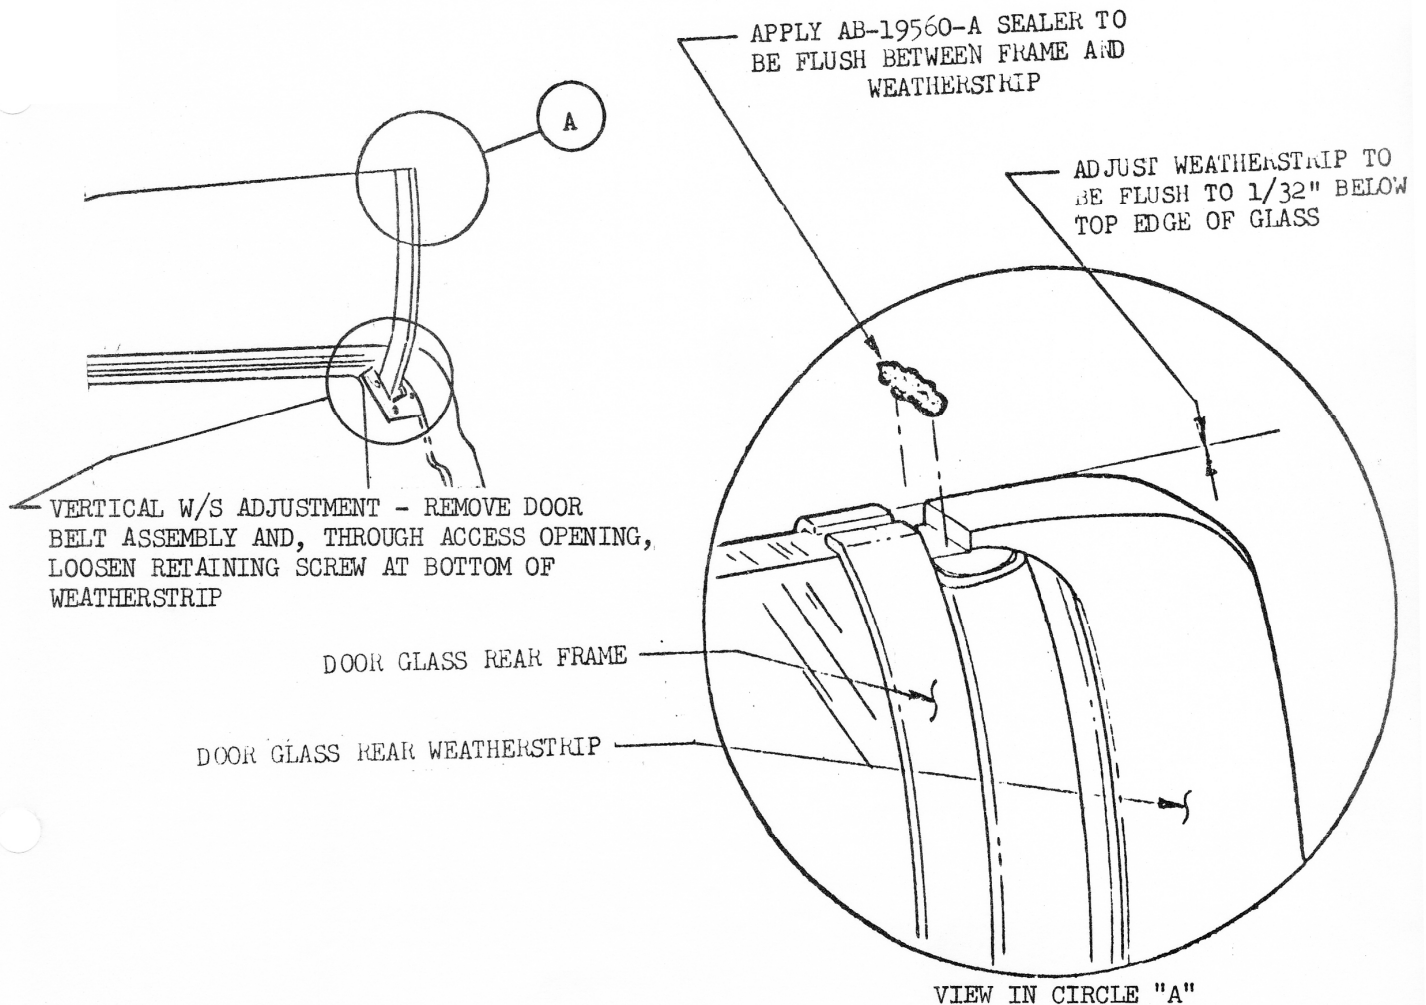
Problem and Cause: 1969 Mustang - All Models

A windnoise occurs at the top of the door vertical weatherstrip, when the weatherstrip is adjusted too high causing interference with the roof rail weatherstrip, or when the slot between the vertical weatherstrip and the retainer is not adequately sealed.

The adjustment of the vertical weatherstrip should be checked to ensure that it is flush to 1/32" below the top of the glass. If adjustment is required it is made at the bottom of the weatherstrip retainer after removing the front door belt assembly. The windnoise can result from a small unsealed gap between the door glass rear frame and the top of the door glass rear weatherstrip. To correct this it may be required to add a daub of AB-19560-A sealer flush between the top surfaces of the frame and weatherstrip.

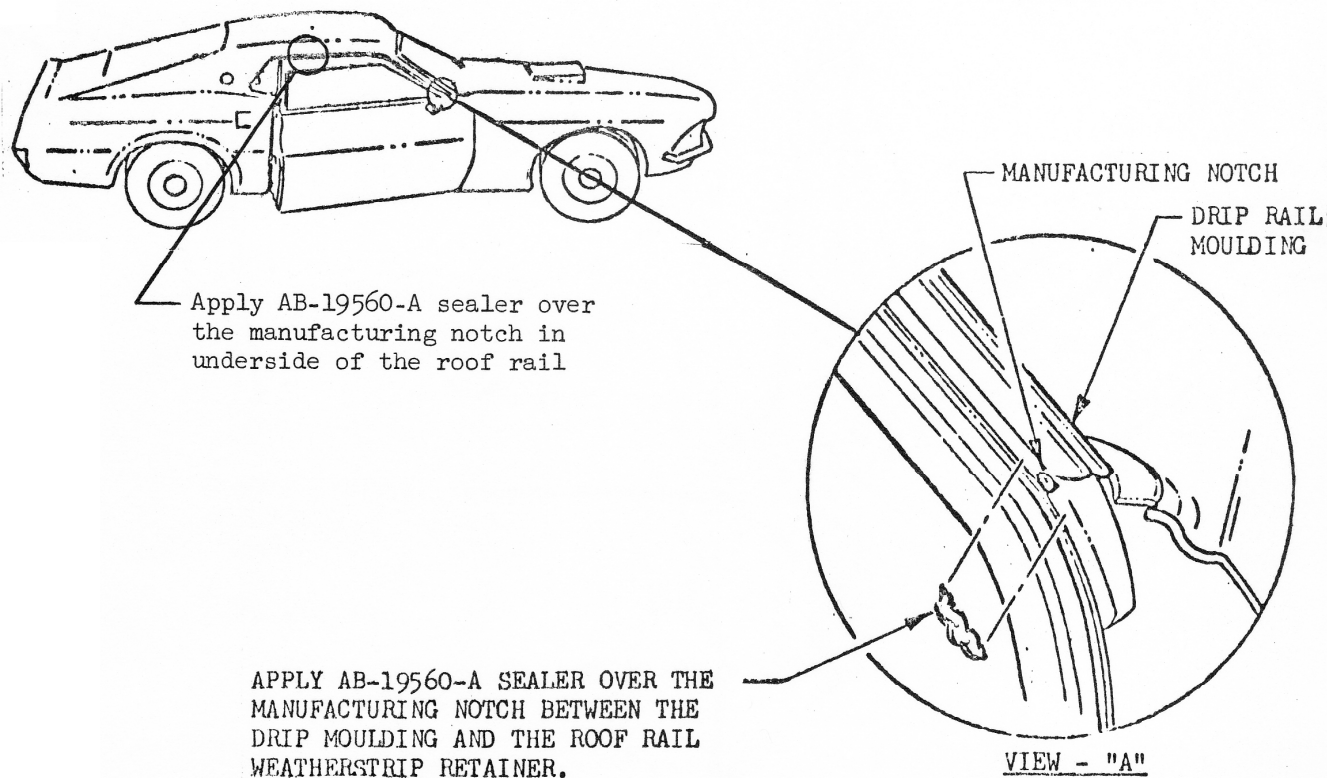
Problem and Cause: 1969 Mustang - Models 63 and 65

A windnoise is heard above the door opening through the headliner in the area of the drivers or passengers ear. There are two sources for this noise which are some distance from where the noise is heard. The first source is at the "A" post belt area where a manufacturing notch is not adequately sealed. This allows the air to enter the hollow roof rail section and transmit the noise through an opening behind the headliner. The second, is in the underside of the roof rail approximately 8" forward of the 1/4 glass area and outboard of the roof rail weatherstrips. This is also due to a manufacturing notch which may not have been adequately sealed.

The manufacturing notch in the "A" post belt area can be sealed with AB-19560-A sealer as illustrated in the sketch below, view A. The notch is located outboard of the weatherstrip but the hollow roof rail transmits the sound into the vehicle above the corresponding door opening. The manufacturing notch located in the underside of the roof rail can also be sealed with the AB-19560-A sealer to eliminate noise into the vehicle through the hollow roof rail.

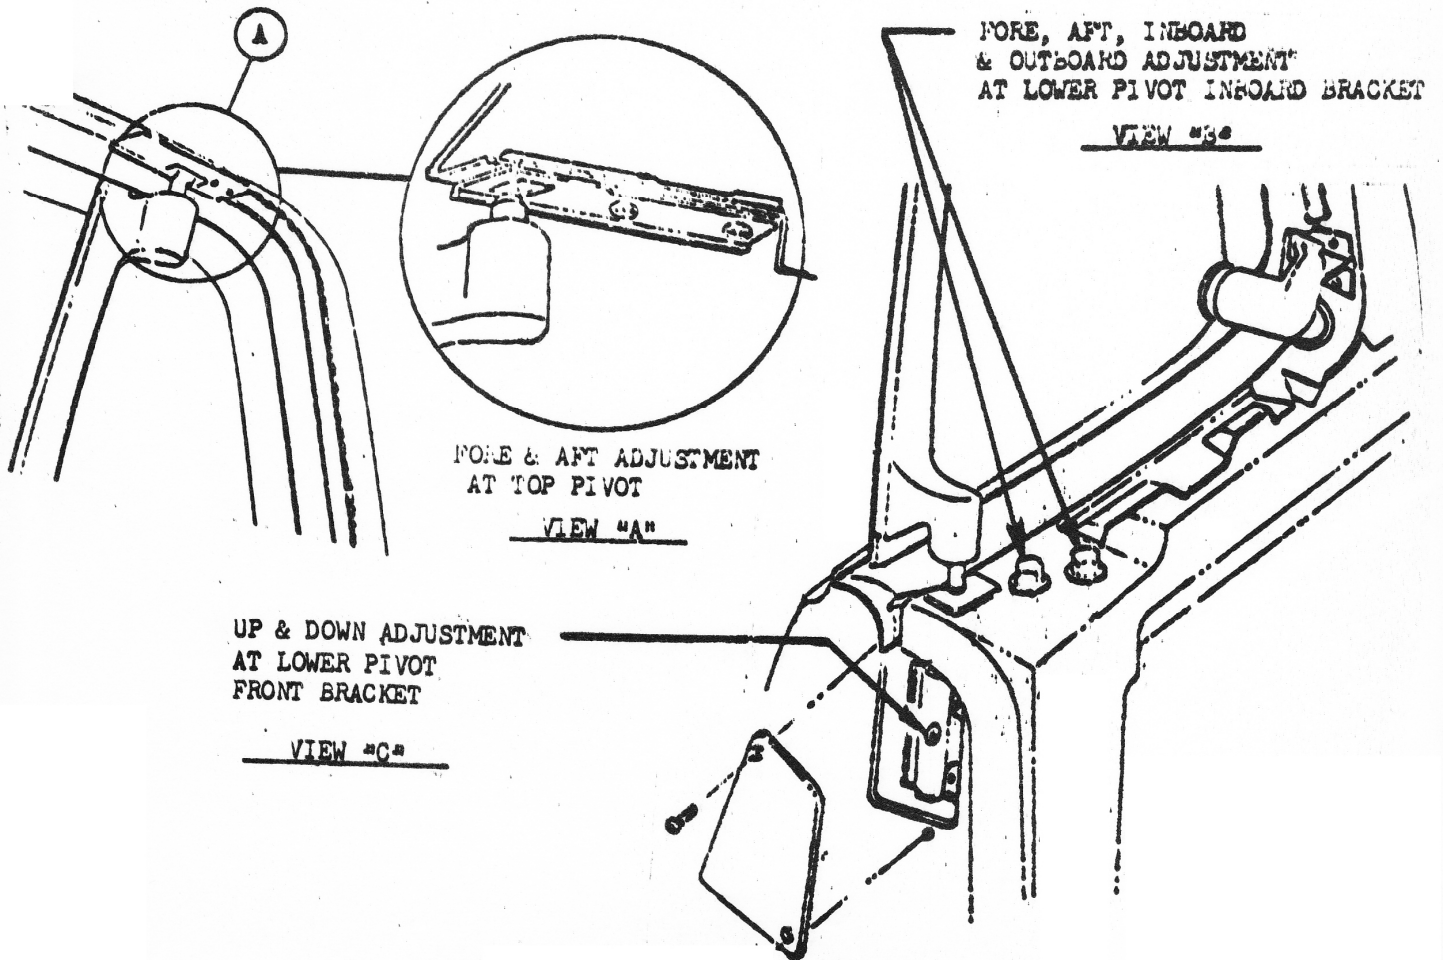
Problem and Cause: 1969 Mustang - Model 63

Water leaks and wind noise occur in the quarter vent area due to a poor seal between the quarter vent window glass and the roof rail weatherstrip.

Properly adjust the quarter vent window to achieve an effective seal by utilizing the following adjustments:

1. Fore and aft at the top pivot (2 screws). Refer to view "A" of the attached sketch.
2. Fore, aft, inboard and outboard at the lower pivot inboard bracket (2 screws). Refer to view "B" of the attached sketch.
3. Up and down at the lower pivot front bracket (1 screw). (See View "C")

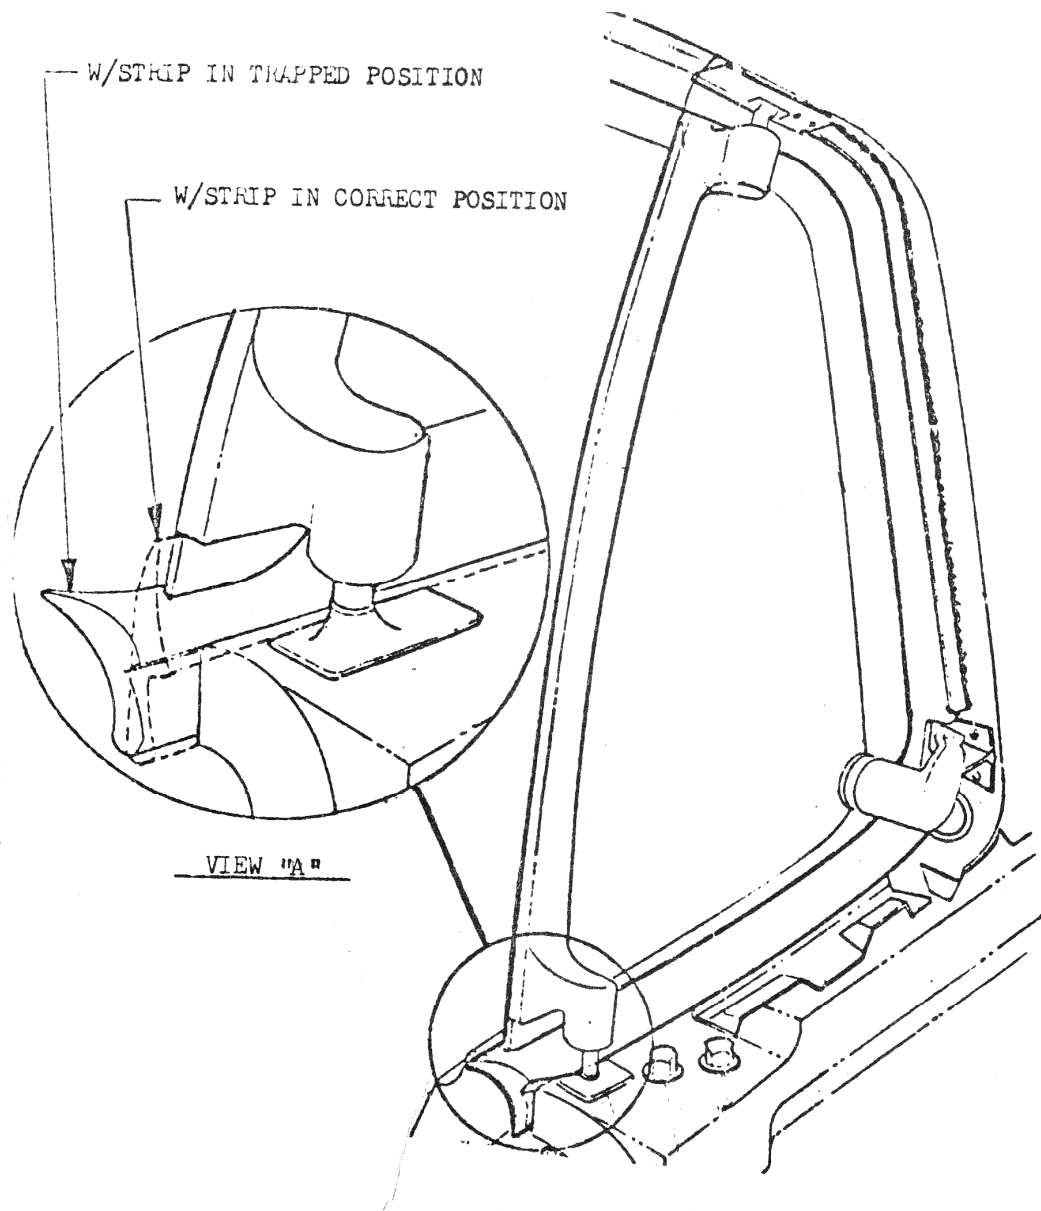
Problem and Cause: 1969 Mustang - Model 63

Water leaks and wind noise occur at the quarter belt area due to the upper lip of the roof rail weatherstrip, at the top of the lock pillar, being trapped under the vent window vertical frame.

Pull the subject lip from under the frame and locate it in the side notch on the inboard side of the vertical frame as shown on the attached sketch, view "A".

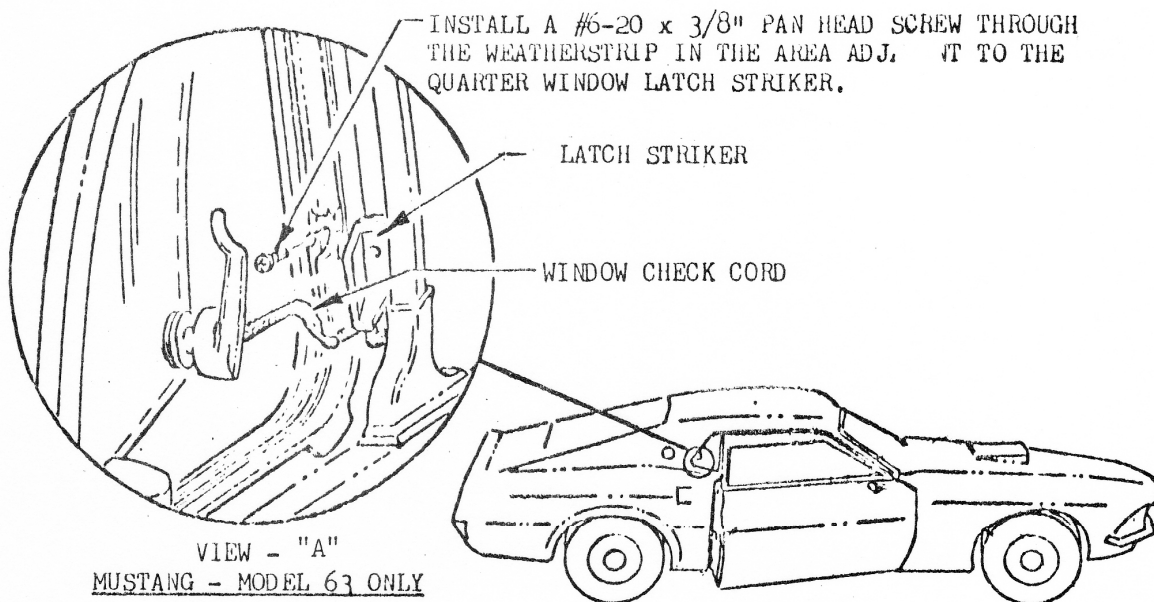
Problem and Cause: 1969 Mustang - Model 63

A wind noise and water leak may occur at the quarter window to roof rail weatherstrip in the area of the "C" pillar, when the curved portion of weatherstrip is puckered.

Drill a 1/8" diameter hole through the weatherstrip, the retainer and into the roof rail in the area adjacent to the quarter window latch striker. Secure the weatherstrip with a #6-20 x 3/8" pan head self tapping screw (part #382566-S100) or equivalent. Refer to the attached sketch, view "A".

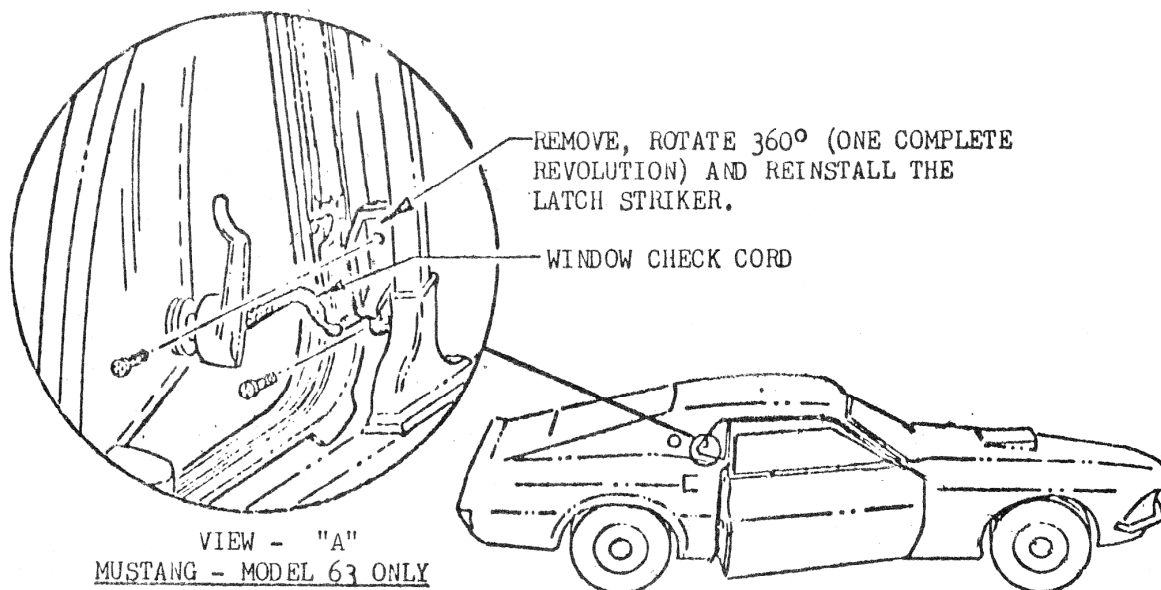
Problem and Cause: 1969 Mustang - Model 63

A windnoise and/or water leak occurs at the quarter belt area, when the quarter window check cord becomes trapped between the window assembly and the inner sealing lip of the roof rail weatherstrip.

1. Unlatch and push open the quarter vent window.
2. Remove the two latch striker retaining screws.
3. Rotate the striker 360° (one complete revolution) in either direction and reinstall with the screws. Refer to the attached sketch, view "A".

Note: Rotating the striker will put a bind on the cord forcing it to kink upwards and away from the weatherstrip.

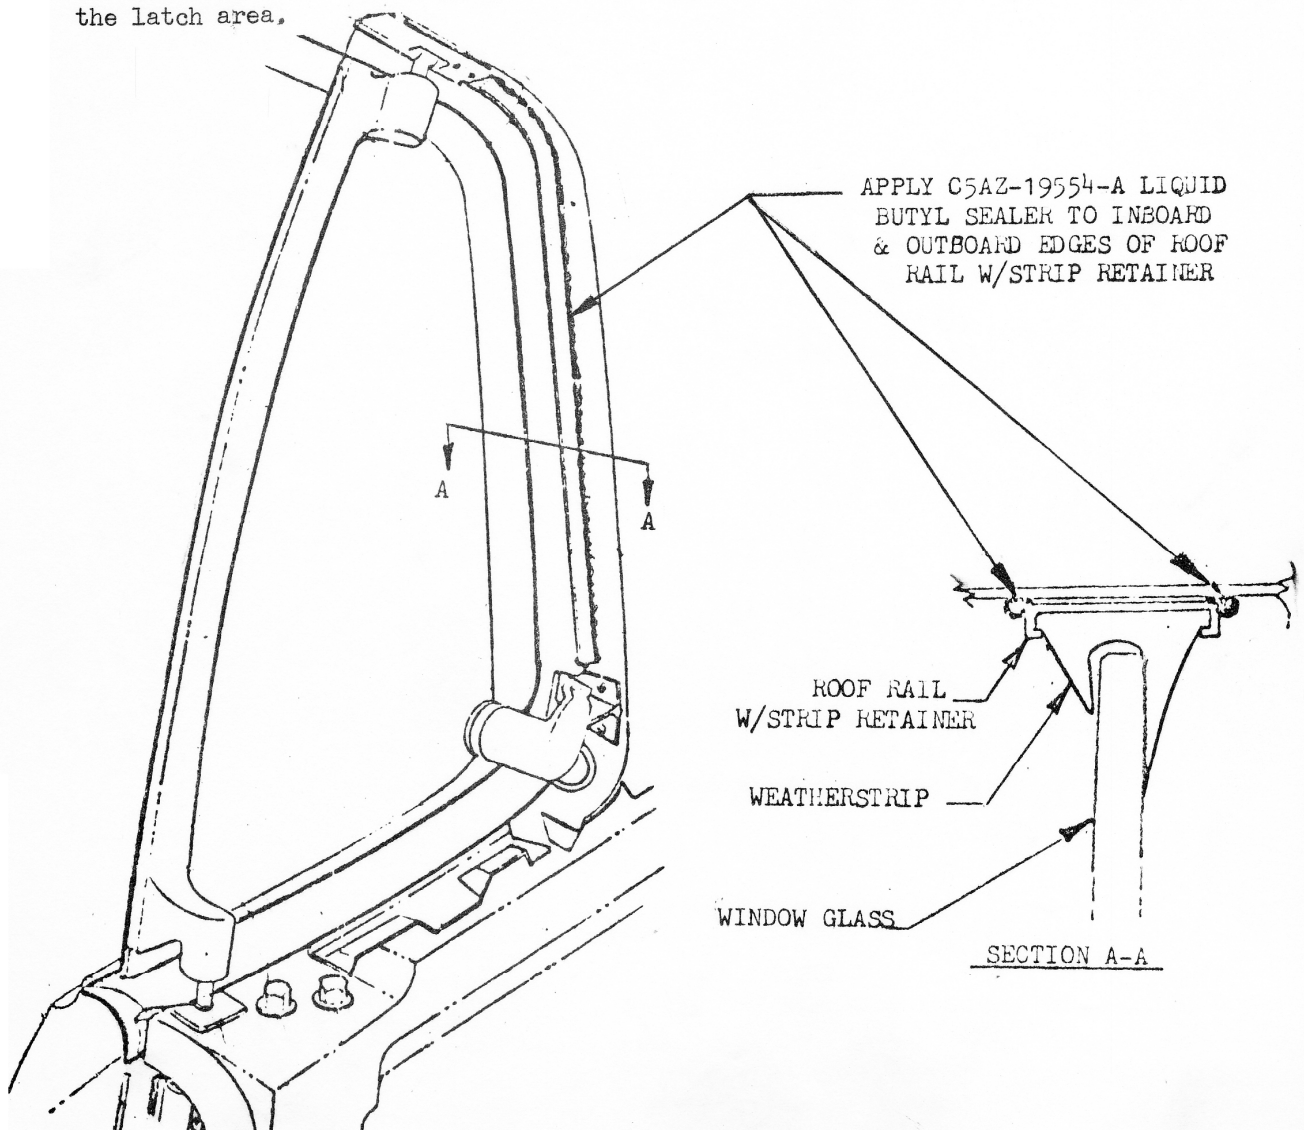
Problem and Cause: 1969 Mustang - Model 63

Water leaks and windnoise in the "C" pillar area can be caused by a poor seal between the roof rail weatherstrip retainer and the roof rail.

Apply liquid butyl (Part No. C5AZ-19554-A) to the inboard and outboard edges of the retainer in the area of the quarter vent window. Refer to the attached sketch, Section A-A. Sealer along the outboard edge of the weatherstrip retainer is important to eliminate water entering behind the retainer and running down into the vehicle at the latch area.
