## Paint Marks - Four Speed Toploaders - The Basics

## Identifying Your Ford Toploader

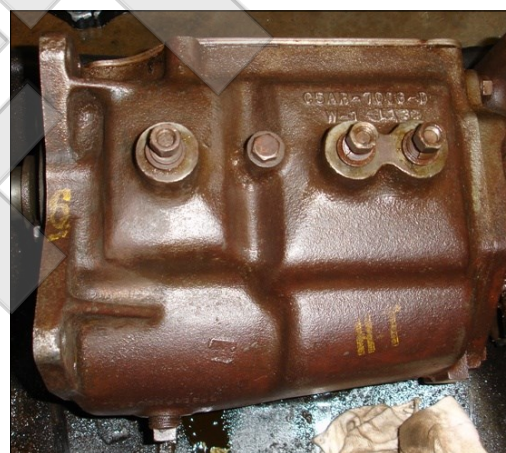
Each transmission was assembled at a remote plant before it was shipped to one of the car assembly plants. During assembly identification, quality control and accountability steps and checks were often accompanied by the placement of a paint mark or stamp on the exterior of the transmission. In some examples we have seen a dozen or more of these markings on a single transmission. Fifty years later we still don't know the reason or purpose for every marking but through collection and study we can identify common patterns and practices of some of these repetitive markings. The purpose of this article is to share what has been collected in the hope of helping others locate markings on their transmissions and promote a better understanding of what has been found.

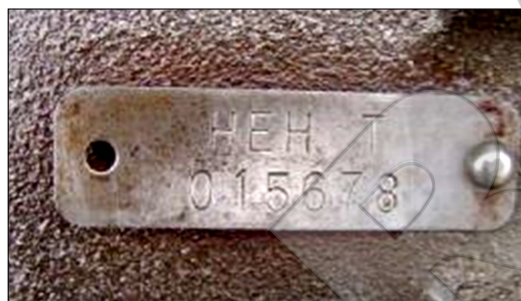
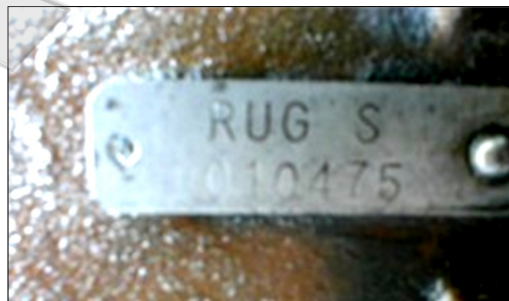
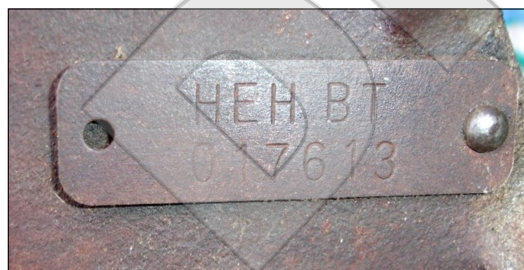
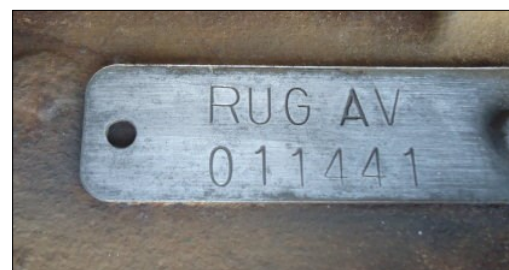
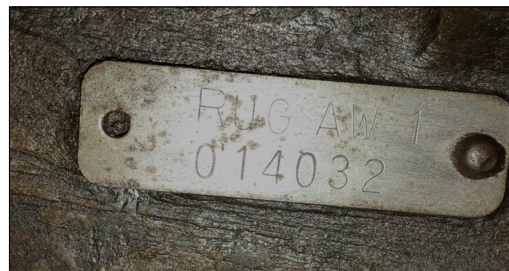
On the passenger side of the transmission about midway between the forward mating flange mounting holes, you should find a small rectangle piece of metal. The identification tag is held to the main case with a single rivet in the forward most hole.

On the top row of printing is the identification code that typically starts with three letters following with a suffix to complete the code. On the lower line tags will have a individual serial number identifying the specific transmission of identification and quality control needs. Some examples are shown at the bottom of the page.

This surface on the drivers side of the main case typically has the identification code that matches the identification code found on the passenger side metal tag we saw earlier in this article. For this location workers used a premade stamp with a shortened version of the code.

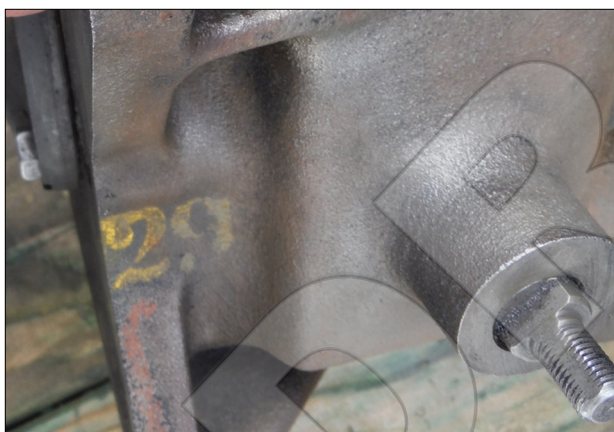
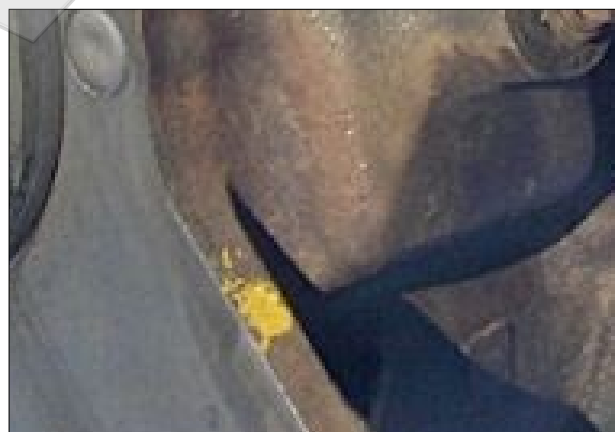
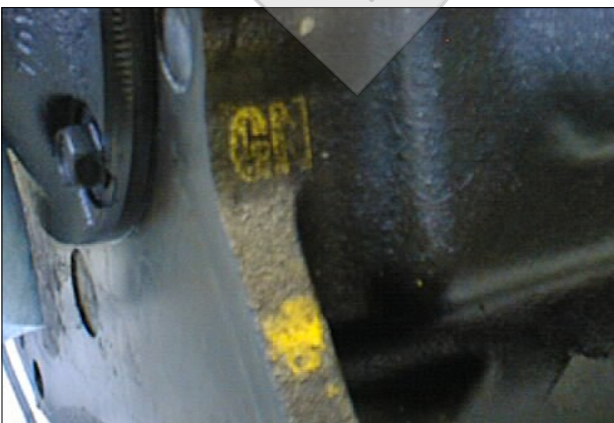
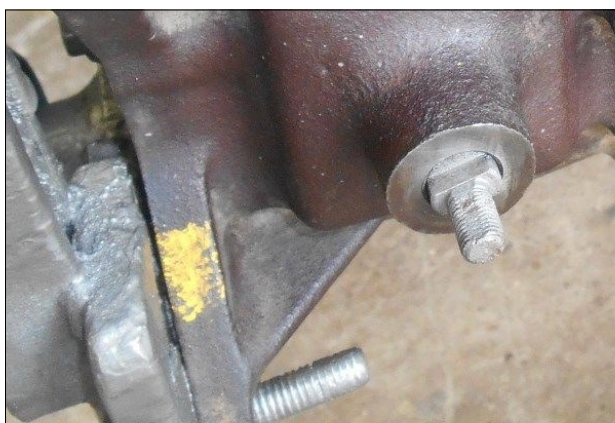
## Driver's Side - Forward Mounting Flange - Stamps & Daubs

The usage of this area of the main transmission body changed over time. In early years the area above the rear shifter shafts was used to show the casting information, this forward flange side was used as a location to indicate the assembler or inspector, a number later moved to the area

above the rear shifter studs, identification letters or later for either a simple some what square or stripe, yellow mark as shown below . These markings appear to use a school buss or strong yellow paint color.

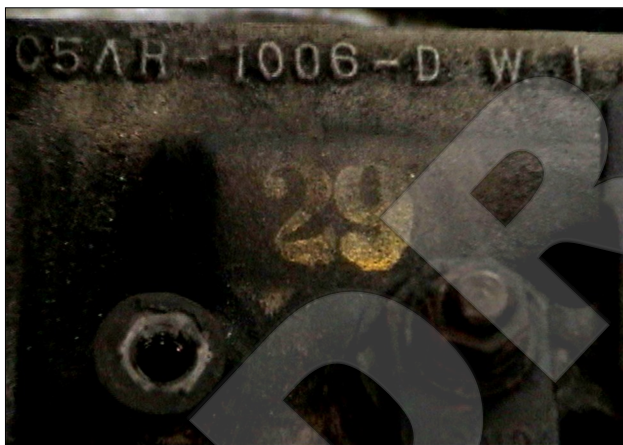
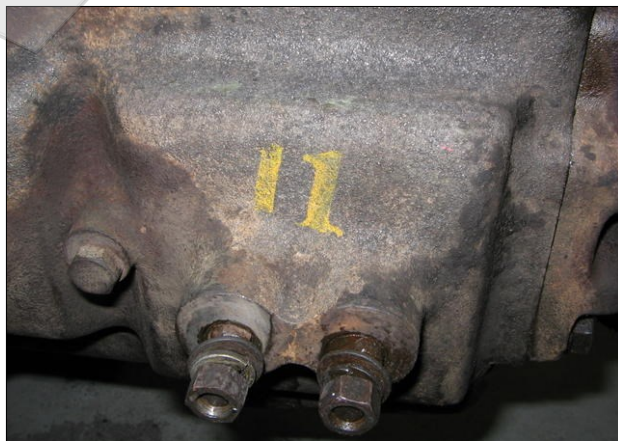
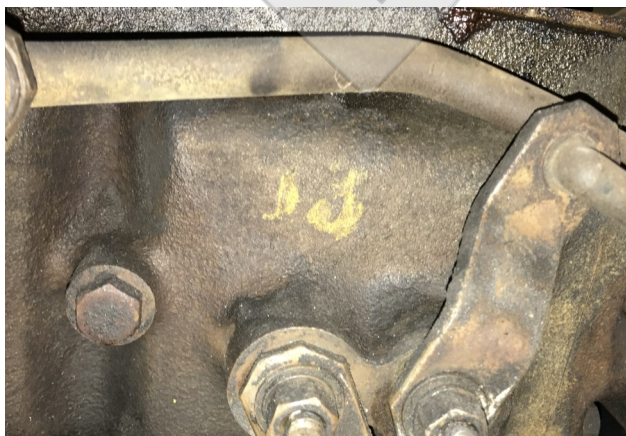
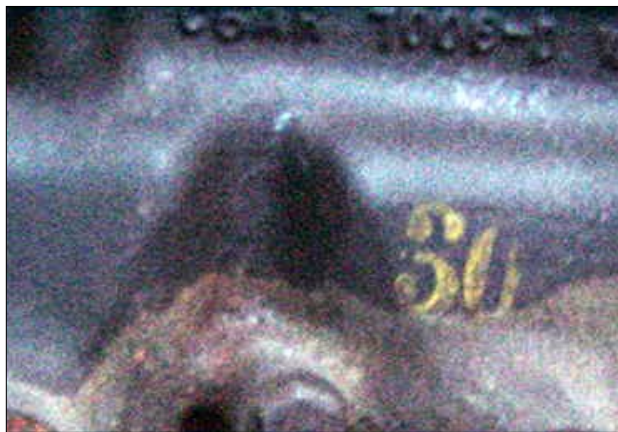
## Driver's Side - Above Rear Shifter Arms - Paint Stamp

On earlier main cases this area has the casting information while later this information was moved up around the top edge of the main case just under the top cover flange.

On later Ford toploaders we find a number indicating either assembler or inspector applied in a school bus yellow. In the following charts I refer to this number as the Assembler Number.

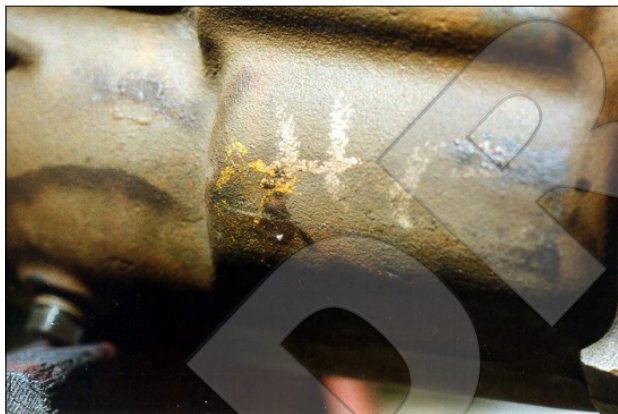
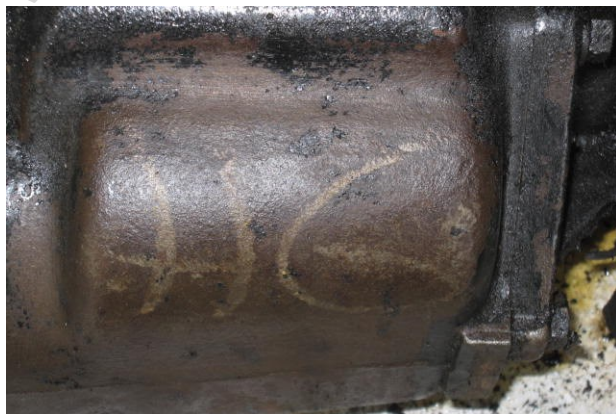
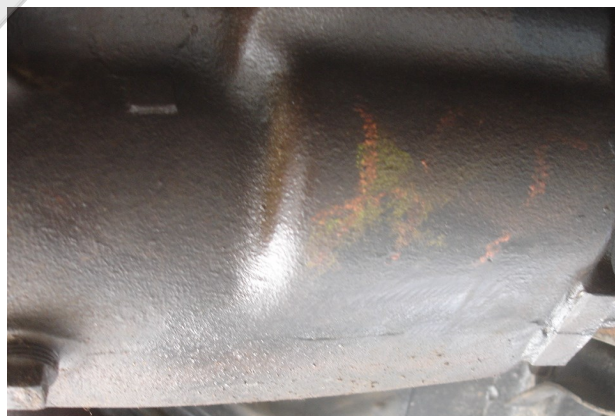
## Driver's Side - Identification Code - Hand Written

On the earlier transmissions the identification marking was applied with a medium tipped applicator. White or a possible orange color have been documented as shown in the pictures below .

Some of the smaller sub-patterns identified during research for this article were found. On some early models we can find some where the identification stamp was replaced by a hand written identification - possibly the stamp was lost for a period of to. In another period the "G" in some of the identification stamps was damaged or made differently in cross bar area of the stamp.

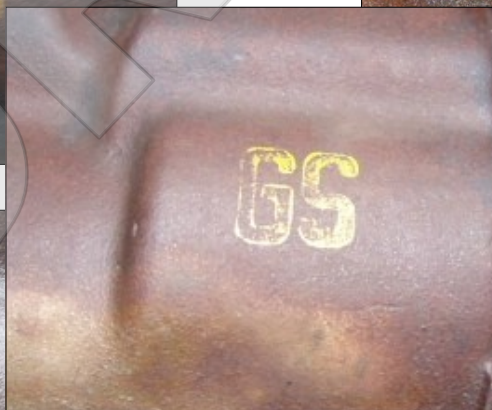
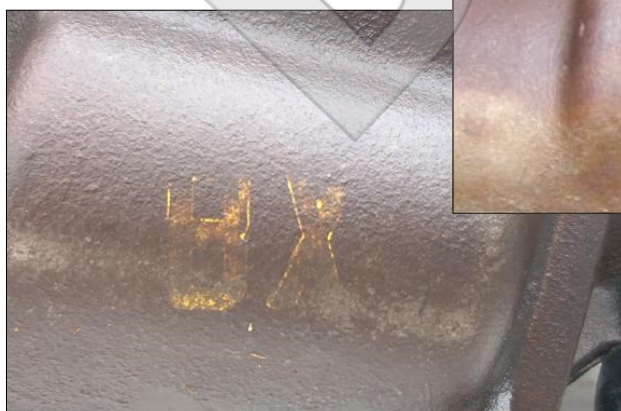
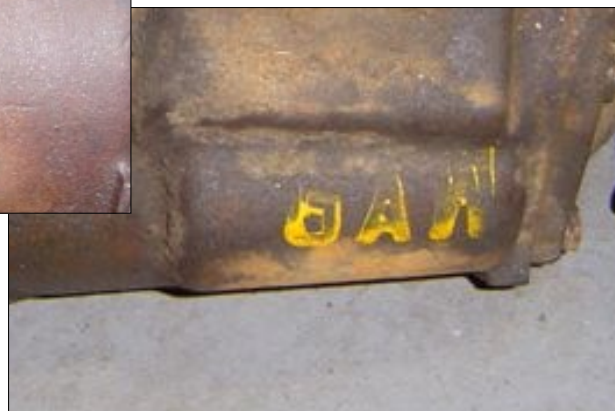
## Driver's Side - Identification Code - Paint Stamp

For the stamp numerical versions (RUG-AE1, RUG-AE2 for example) of the same transmission were shortened to just G-AE for all of these variations. Color used was a school bus yellow typically. Workers usually applied the stamp to one these two semi-flat surfaces but they are much more often found at the lower of the two locations.

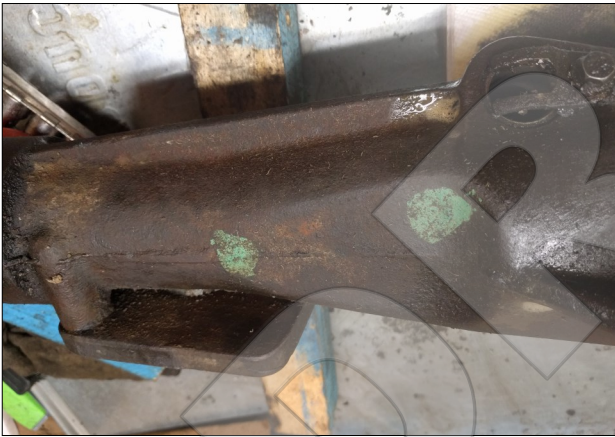
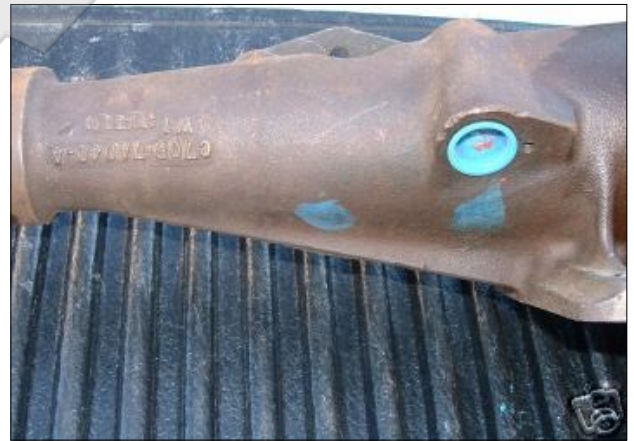
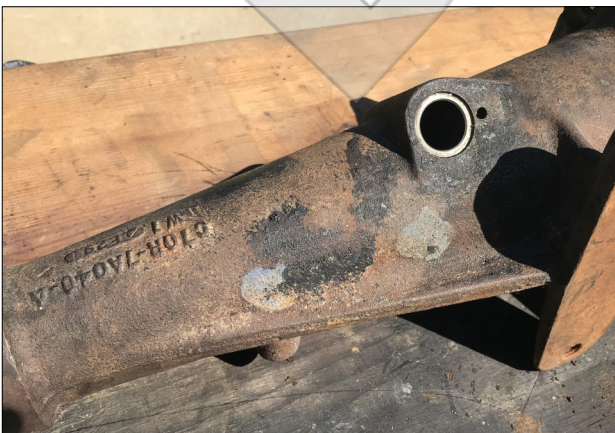
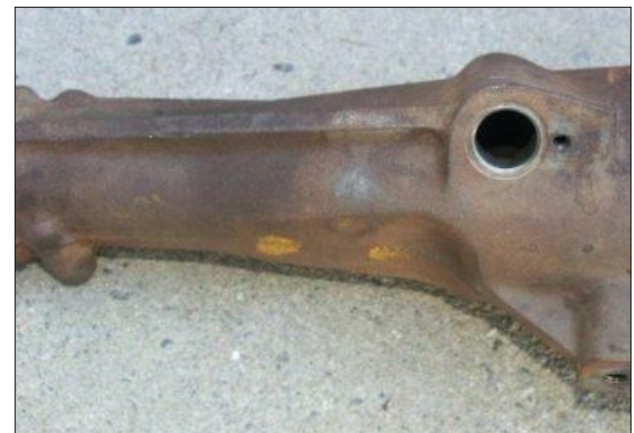
## Tail Shaft Housing - Paint Doubts

On the tail shaft housing we often find two markings. One is at or near the top surface where the speedometer opening. May have been placed to help the installers of the speedo cable locate the hole quicker.

On the bottom of the housing to the rear of the transmission mount we find a mark or marks that may have identified different housings during the assembly of the transmission as we see in other sub assembly processes.

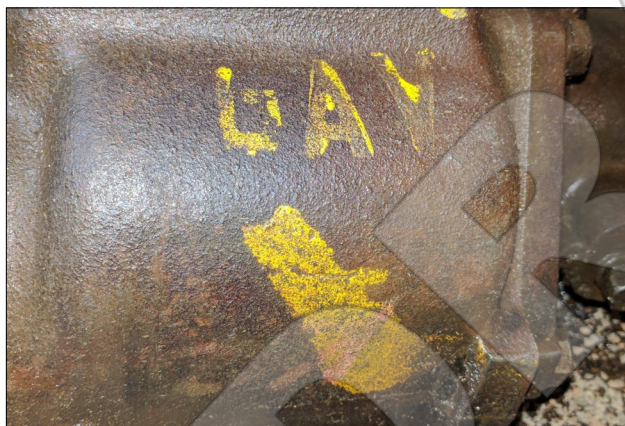
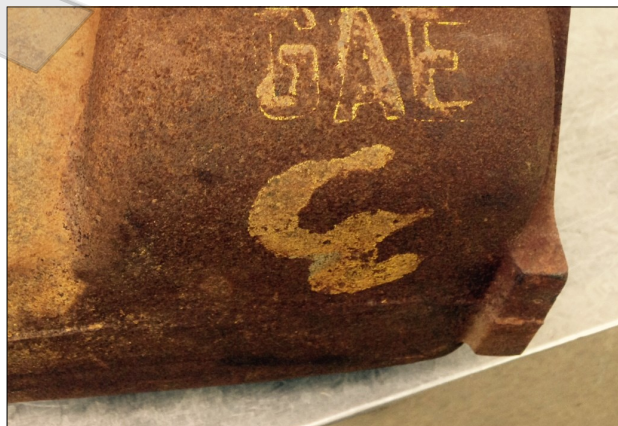
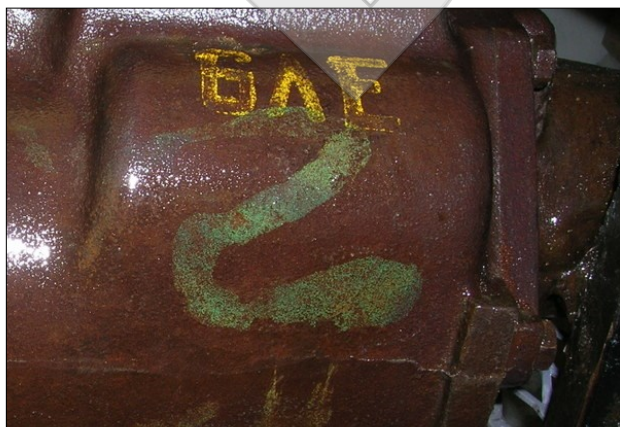
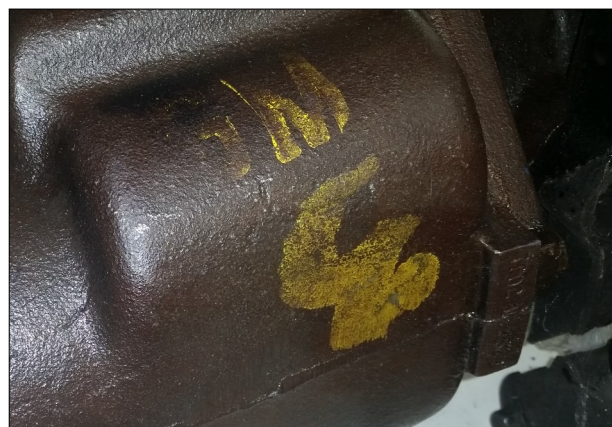
## Lower Main Body Rear - Paint - Hand Written

The main body, bottom and passenger side, are often covered by many marks, lines, letters and numbers. These have been so plentiful and varied there has been no apparent pattern or understanding.. There is one location, lower rear,

that has shown up on just about all of the examples with regularity. I choose to share so that others can look for and compare. This is typically a single digit number (one through three) shown below.

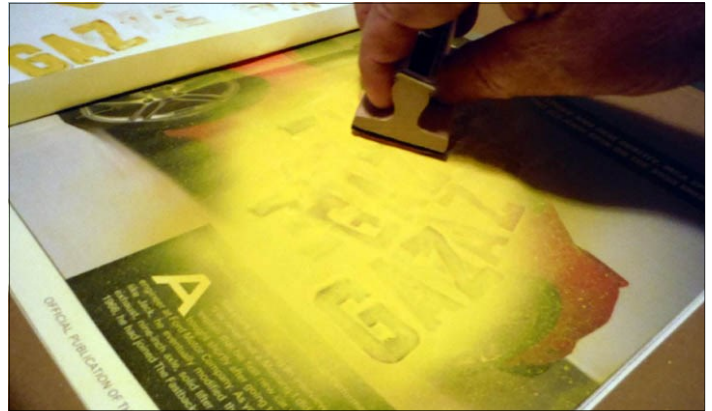
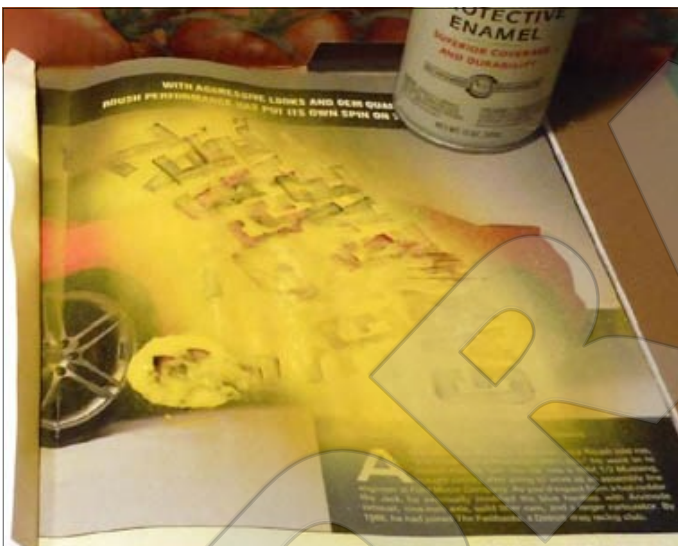
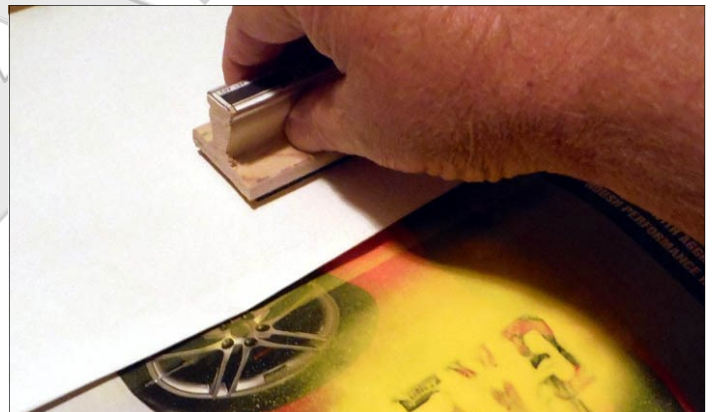
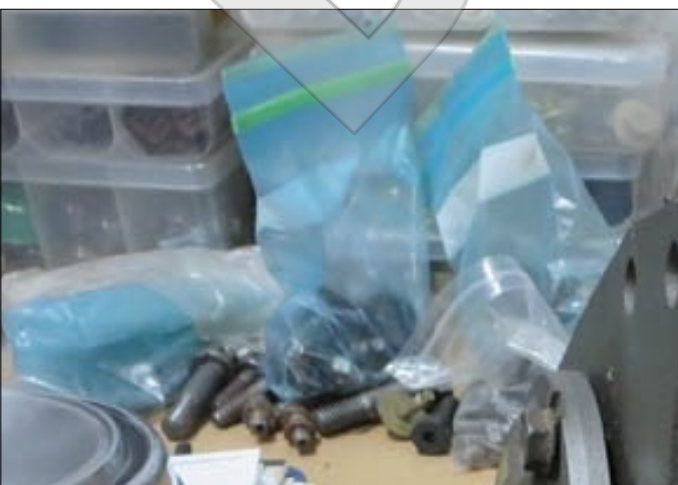
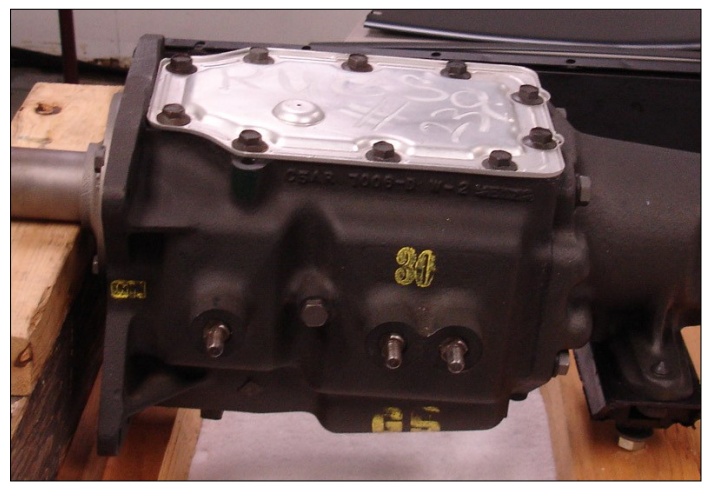
### Reproducing Stamped Marks ((Tip)

First you will need your chosen paint, the stamp, the part (of course) and an old magazine or catalog with shiny/glossy pages. You may need to arrange your work out of direct sunlight, spray paint will dry quickly in many conditions and consider that any breeze may blow the spray towards an unintended surface or it may blow the pages of the magazine closed before you finish your work.

Next, with everything in apply the paint over approximately a quarter of the surface of a single page..

This will provide you with areas to touch the paint stamp to and test out the amount and coverage of the stamp. Paint will pool in some areas and dry quicker in others so tap the stamp into the paint and stamp another page or a piece of paper until you get an acceptable product/outcome then restamp the stamp on the painted page as close as you can to the last time assuring that its an untouched area, then immediately onto the part that needs the

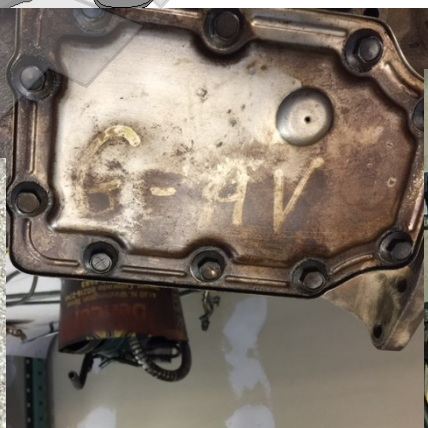
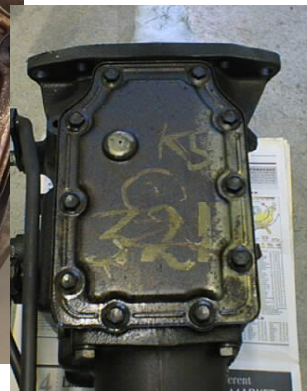
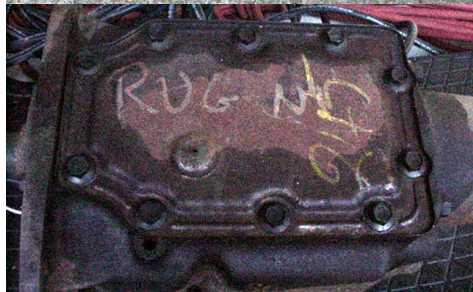
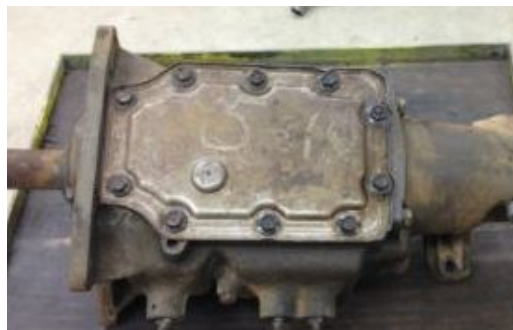
## Extra - Top Cover Plate

Hand writing applied to the cover plate appears to be inconsistent in my findings. This may suggest that it was something done by a worker working on a single shift, at the transmission or car plant, or something else.

At the time of this writing I have no examples from top-loaders installed at the Metuchen with this marking which might suggest that this was an in car plant applied marking. On San Jose installed toploaders the top cover is sometimes marked with the cars second rotation number to assure that the right parts were installed on the right car.
