## Paint Marks - Four Speed Toploaders - The Basics

## Identifying Your Ford Toploader

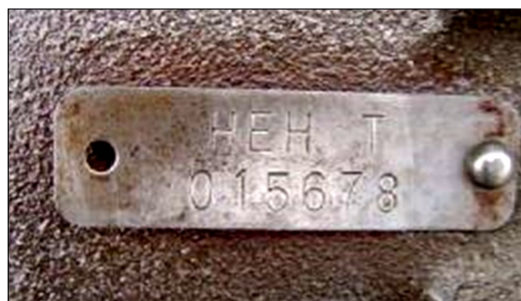
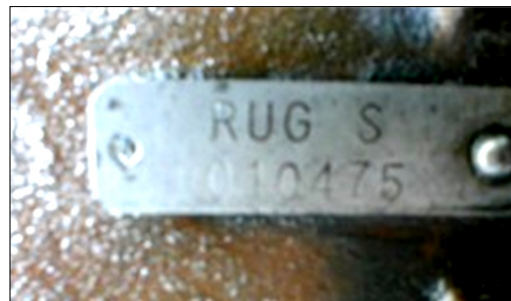
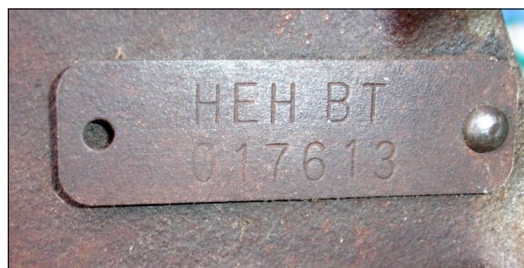
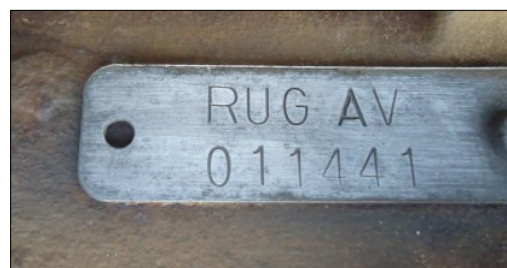
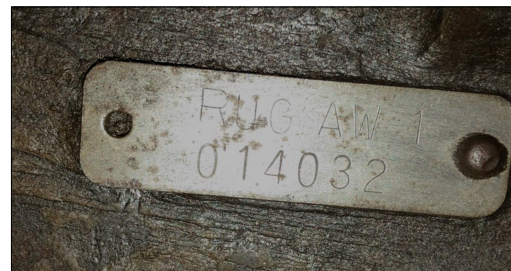
On the passenger side of the transmission about midway between the forward mating flange mounting holes, you should find a small rectangular piece of metal. The identification tag is held to the main case with a single rivet in the forward most hole.

On the top row of printing is the identification code that typically starts with three letters following with a suffix to complete the code. On the lower line tags will have an individual serial number identifying the specific transmission of identification and quality control needs. Some examples are shown at the bottom of the page.

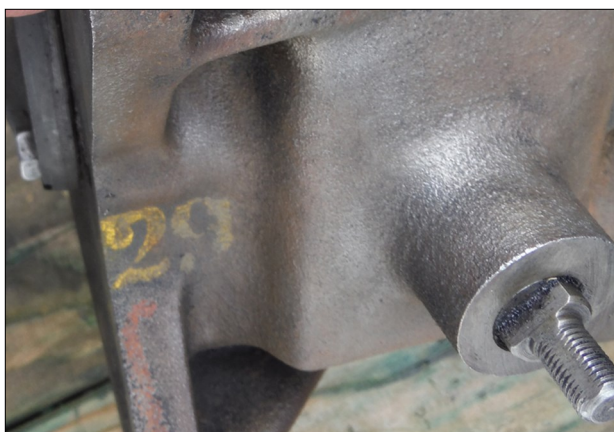
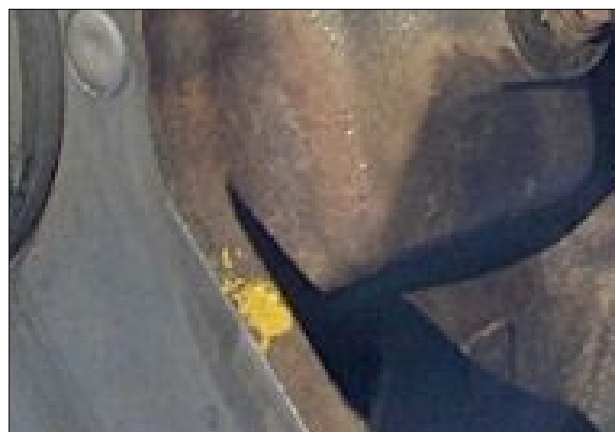
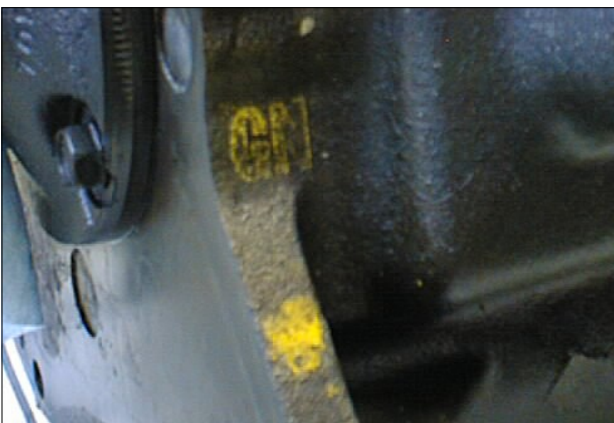
## Driver's Side - Forward Mounting Flange - Stamps & Daubs

The usage of this area of the main transmission body changed over time. In early years the area above the rear shifter shafts was used to show the casting information, this forward flange side was used as a location to indicate the assembler or inspector, a number later moved to the area

above the rear shifter studs, identification letters or later for either a simple some what square or stripe, yellow mark as shown below . These markings appear to use a school bus or strong yellow paint color.

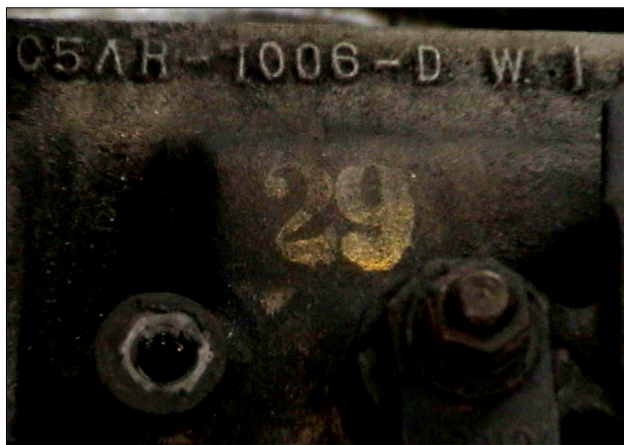
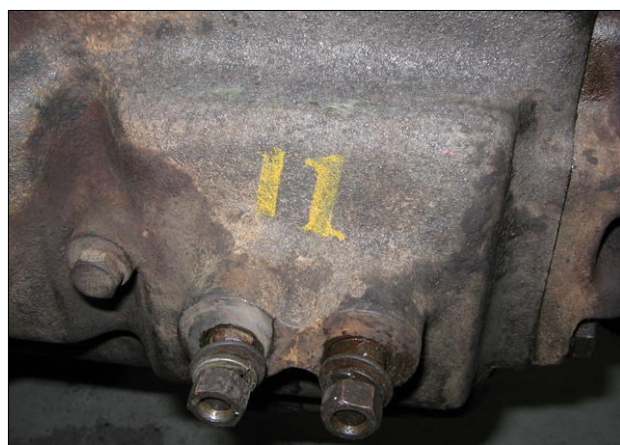
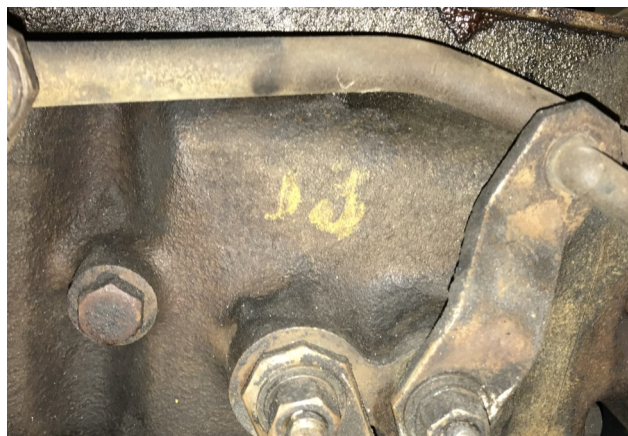
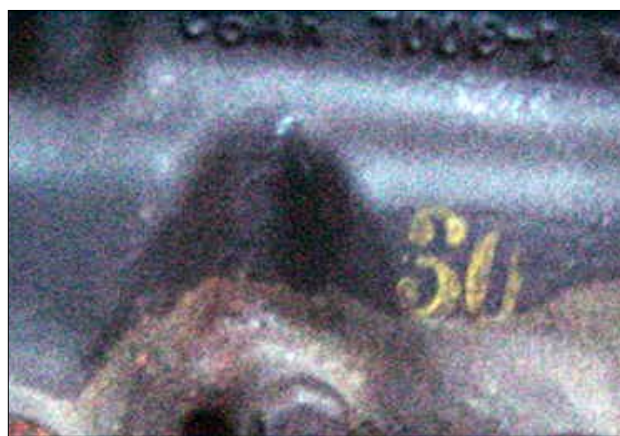
## Driver's Side - Above Rear Shifter Arms - Paint Stamp

On earlier main cases this area has the casting information while later this information was moved up around the top edge of the main case just under the top cover flange.

On later Ford toploaders we find a number indicating either assembler or inspector applied in a school bus yellow. In the following charts I refer to this number as the Assembler Number.

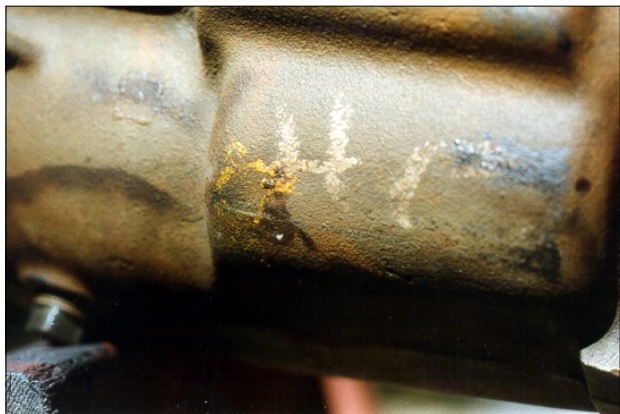
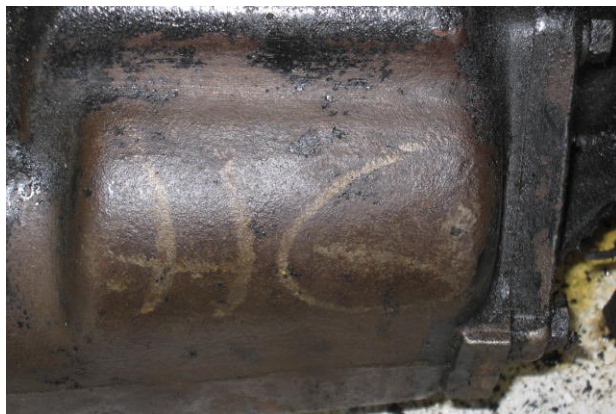
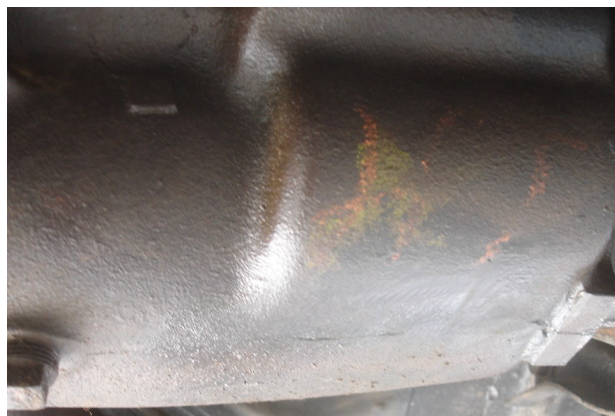
## Driver's Side - Identification Code - Hand Written

On the earlier transmissions the identification marking was applied with a medium tipped applicator. White or a possible orange color have been documented as shown in the pictures below .

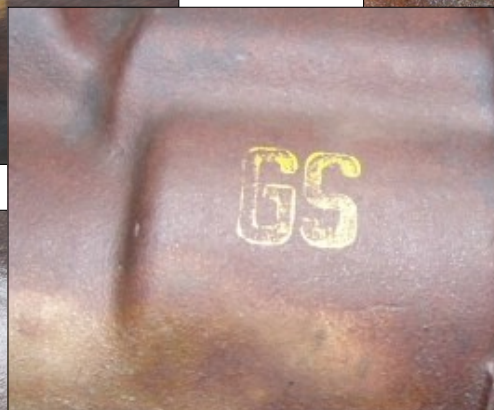
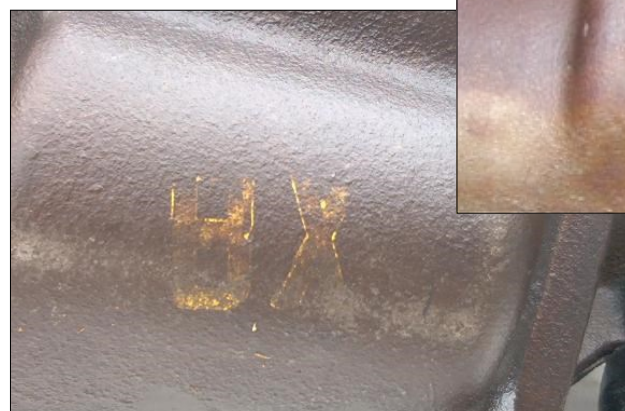
## Driver's Side - Identification Code - Paint Stamp

This surface on the drivers side of the main case typically has the identification code that matches the identification code found on the passenger side metal tag we saw earlier in this article. For this location workers used a premade stamp with a shortened version of the code.

For the stamp numerical versions (RUG-AE1, RUG-AE2 for example) of the same transmission were shortened to just G-AE for all of these variations. Color used was a school bus yellow typically. Workers usually applied the stamp to one these two semi-flat surfaces but they are much more often found at the lower of the two locations.

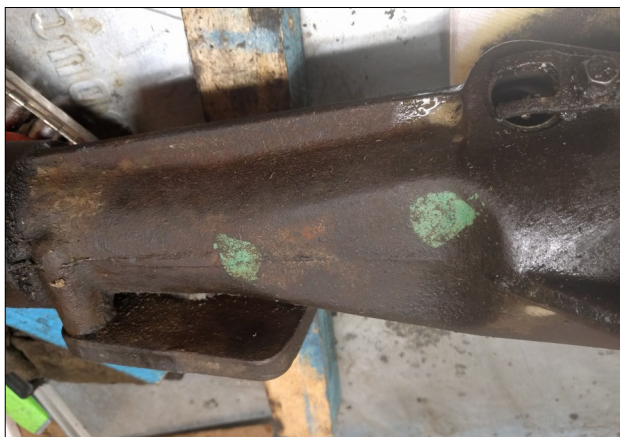
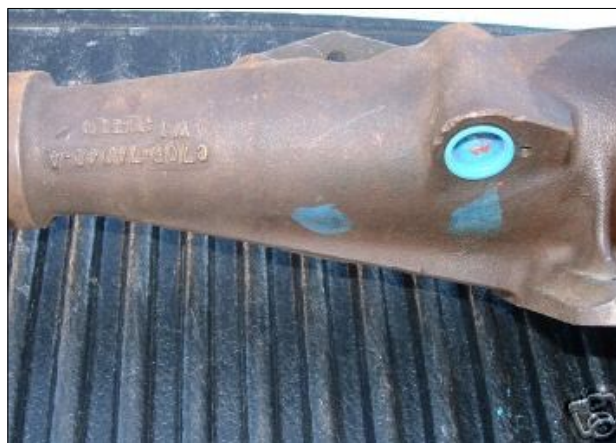
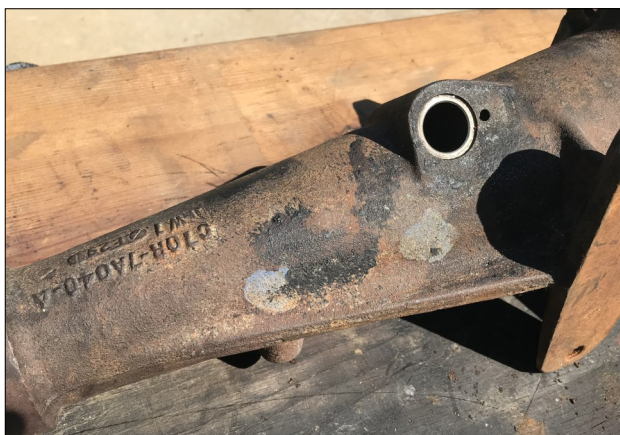
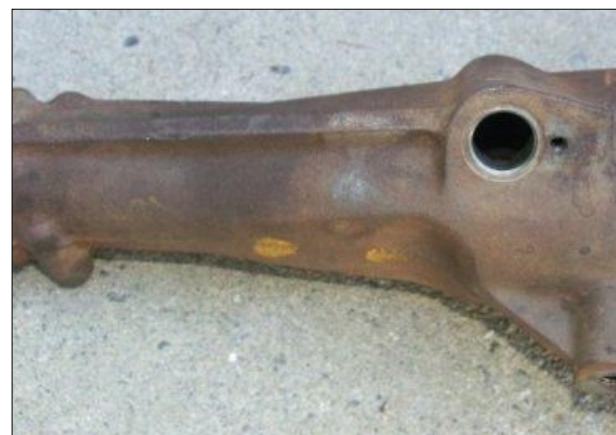
## Tail Shaft Housing - Paint Doubs

On the tail shaft housing we often find two markings. One is at or near the top surface where the speedometer opening. May have been placed to help the installers of the speedo cable locate the hole quicker.

On the bottom of the housing to the rear of the transmission mount we find a mark or marks that may have identified different housings during the assembly of the transmission as we see in other sub assembly processes.

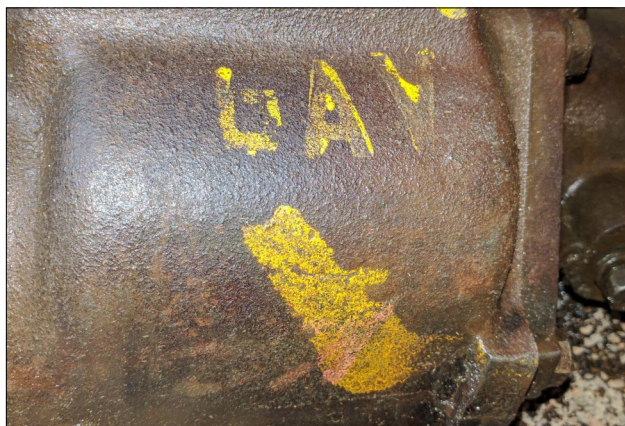
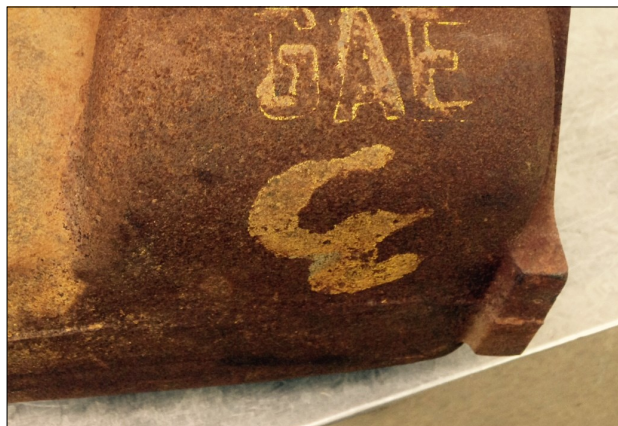
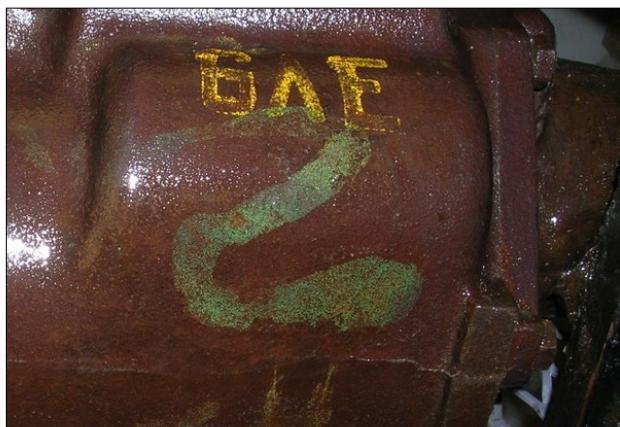
## Lower Main Body Rear - Paint - Hand Written

The main body, bottom and passenger side, are often covered by many marks, lines, letters and numbers. These have been so plentiful and varied there has been no apparent pattern or understanding.. There is one location, lower rear,

that has shown up on just about all of the examples with regularity. I choose to share so that others can look for and compare. This is typically a single digit number (one through three) shown below.

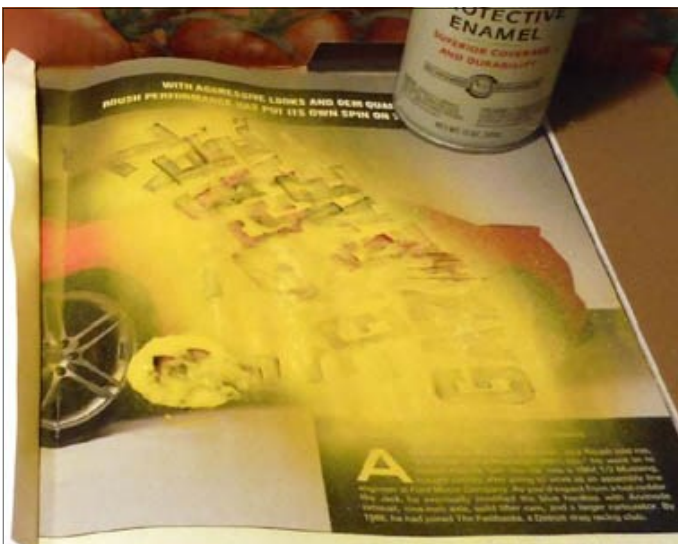
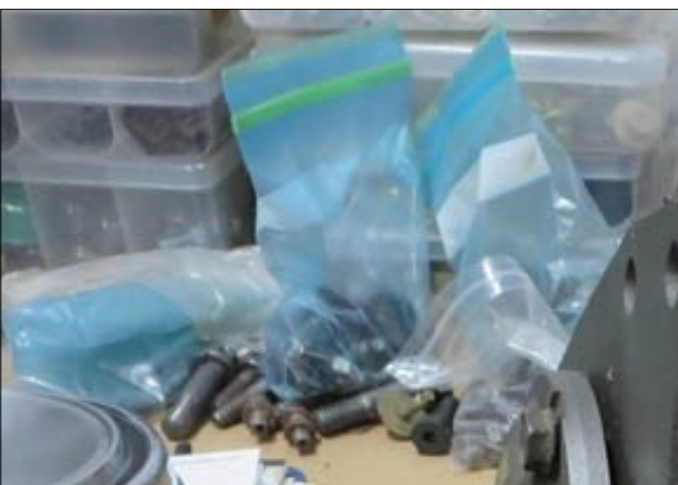
### Reproducing Stamped Marks ((Tip)

Next, apply some spray paint to a section of a page starting approximately a quarter of the surface of a single page..

This will provide you with areas to touch the paint stamp to the paint and test the process and readiness. Reapply spray paint over the earlier application if needed. Paint will pool in some areas and dry quicker in others so tap the stamp into the paint and stamp another page or a piece of paper until you get an acceptable product/outcome then restamp the stamp on the painted page as close as you can to the last time assuring that its an untouched area, then immediately onto the transmission location.

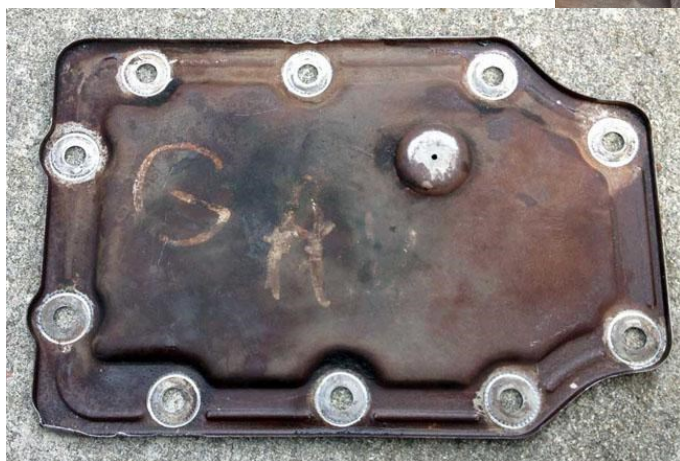
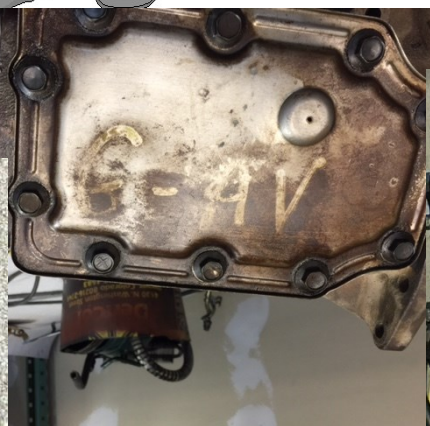
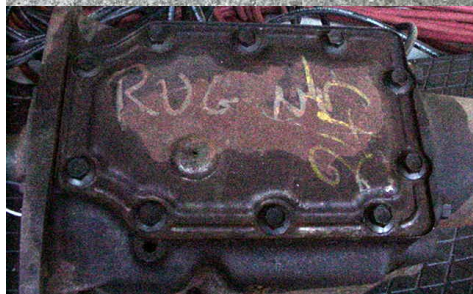
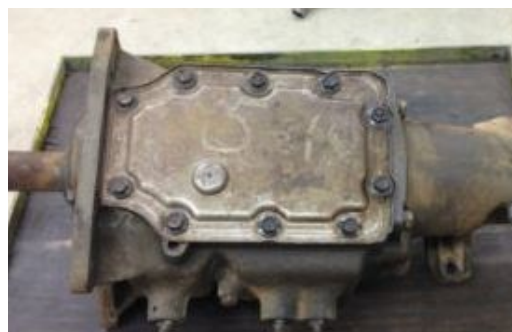
## Extra - Top Cover Plate

Hand writing applied to the cover plate appears to be inconsistent in my findings. This may suggest that it was something done by a worker working on a single shift, at the transmission or car plant, or something else.

At the time of this writing I have no examples from toploaders installed at the Metuchen with this marking which might suggest that this was an in car plant applied marking. On San Jose installed toploaders the top cover is sometimes marked with the cars second rotation number to assure that the right parts were installed on the right car.
