## Paint Marks - Four Speed Toploaders - The Basics

## Identifying Your Ford Toploader

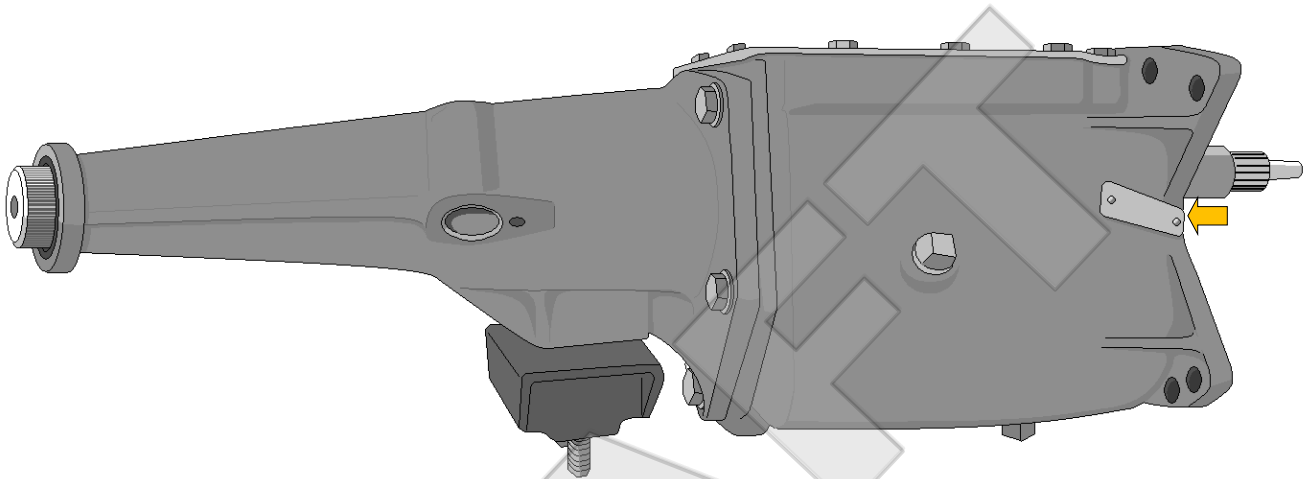
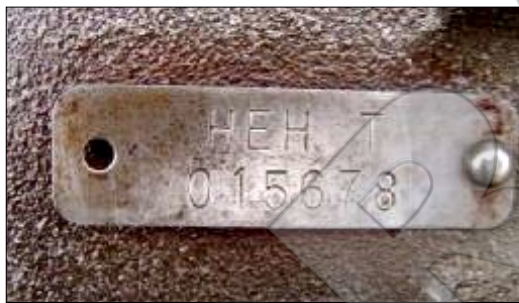
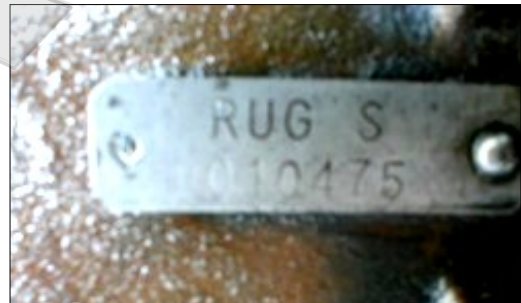
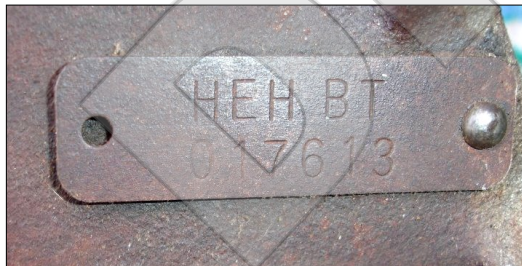
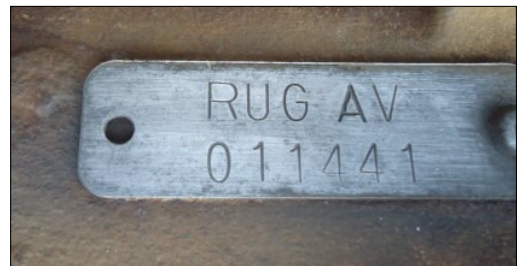
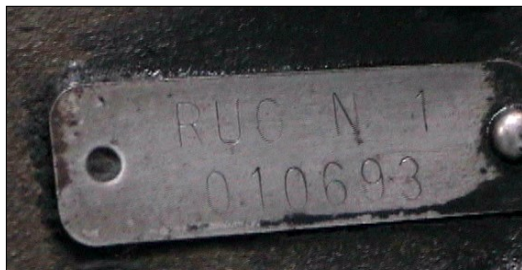
On the passenger side of the transmission about midway between the forward mating flange mounting holes, you should find a small rectangle piece of metal. The identification tag is held to the main case with a single rivet in the forward most hole.

On the top row of printing is the identification code that typically starts with three letters following with a suffix to complete the code. On the lower line tags will have a individual serial number identifying the specific transmission of identification and quality control needs. Some examples are shown at the bottom of the page.

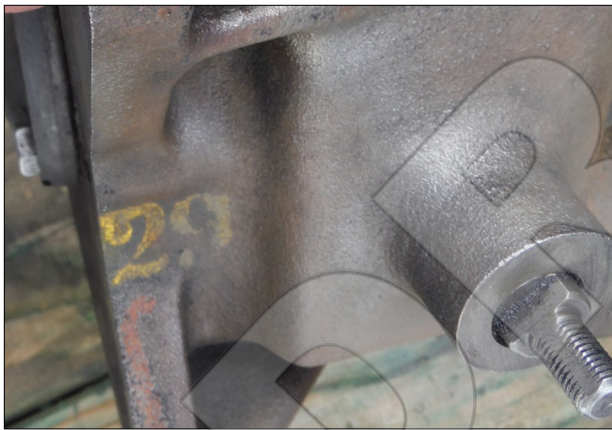
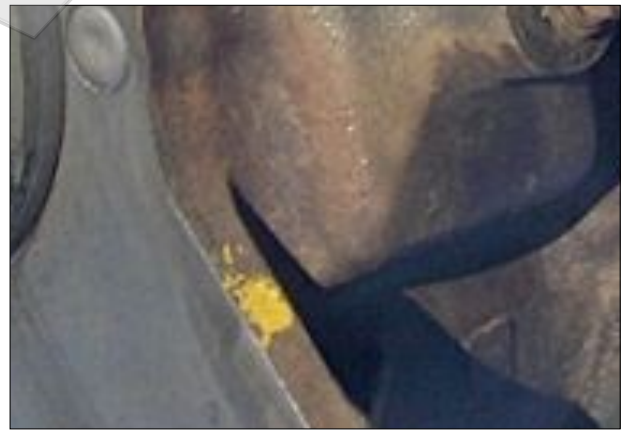
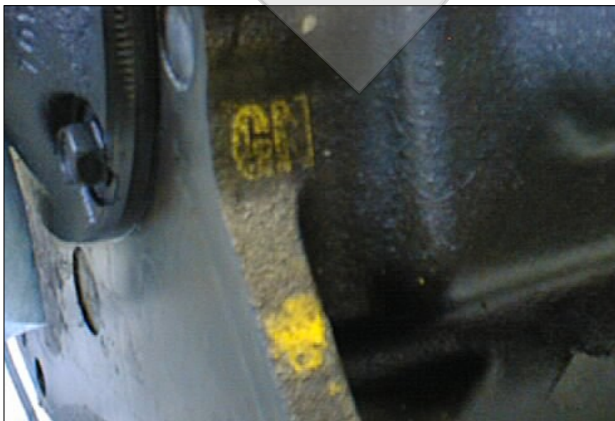
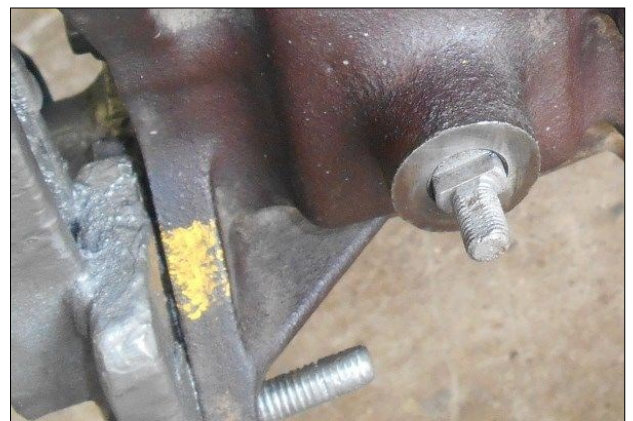
## Driver's Side - Forward Mounting Flange - Stamps & Daubs

The usage of this area of the main transmission body changed over time. In early years the area above the rear shifter shafts was used to show the casting information, this forward flange side was used as a location to indicate the assembler or inspector, a number later moved to the area

above the rear shifter studs, identification letters or later for either a simple some what square or stripe, yellow mark as shown below . These markings appear to use a school buss or strong yellow paint color.

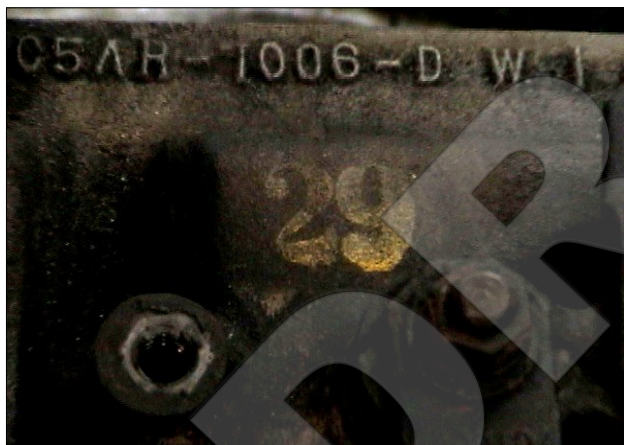
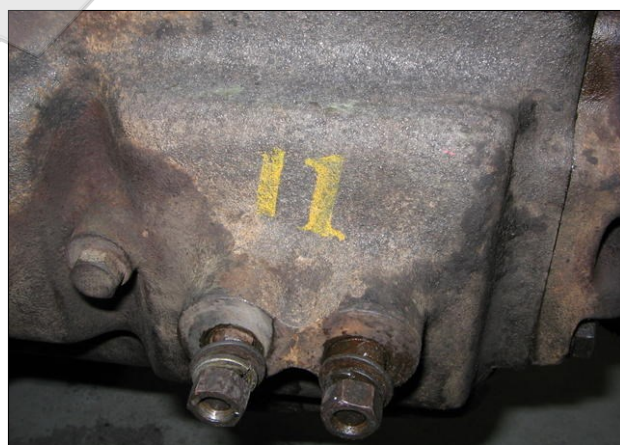
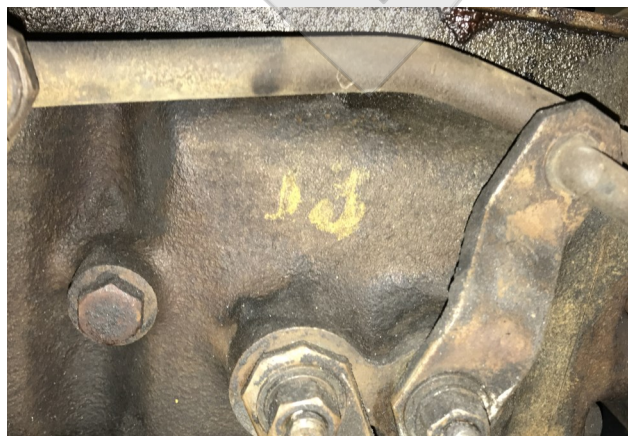
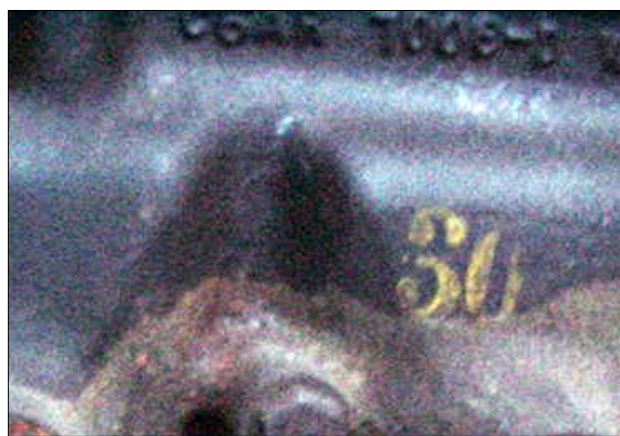
## Driver's Side - Above Rear Shifter Arms - Paint Stamp

On earlier main cases this area has the casting information while later this information was moved up around the top edge of the main case just under the top cover flange.

On later Ford toploaders we find a number indicating either assembler or inspector applied in a school bus yellow. In the following charts I refer to this number as the Assembler Number.

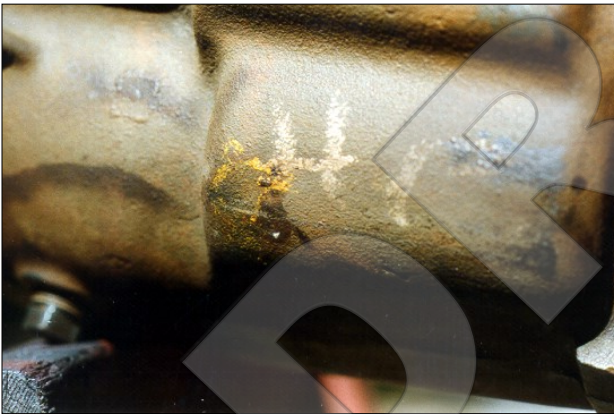
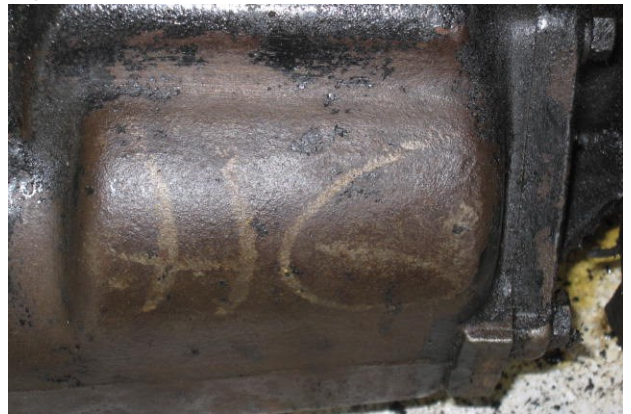
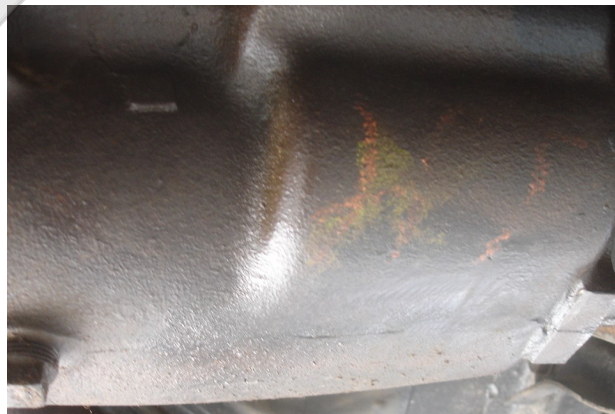
## Driver's Side - Identification Code - Hand Written

On the earlier transmissions the identification marking was applied with a medium tipped applicator. White or a possible orange color have been documented as shown in the pictures below .

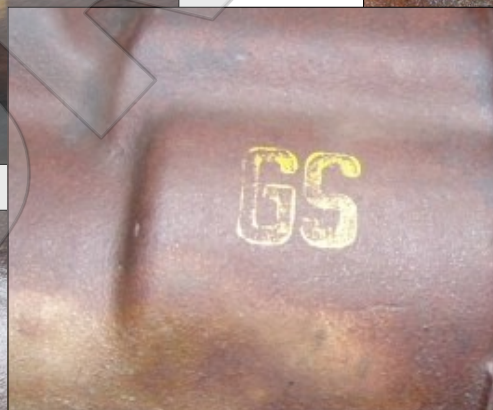
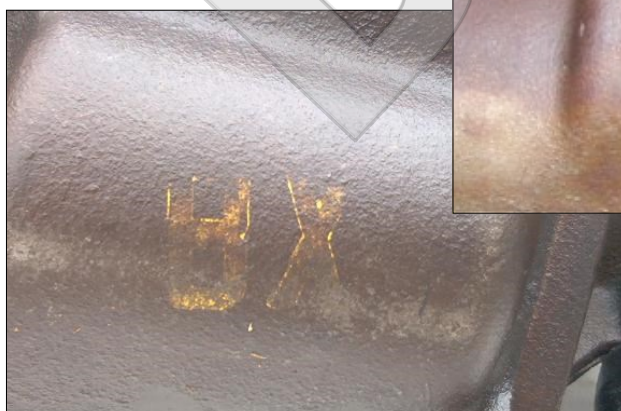
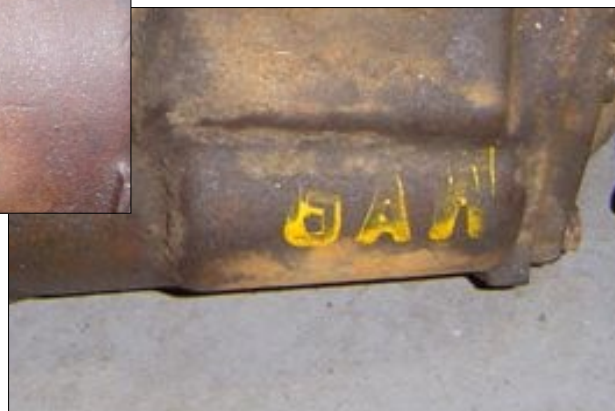
## Driver's Side - Identification Code - Paint Stamp

This surface on the drivers side of the main case typically has the identification code that matches the identification code found on the passenger side metal tag we saw earlier in this article. For this location workers used a premade stamp with a shortened version of the code.

For the stamp numerical versions (RUG-AE1, RUG-AE2 for example) of the same transmission were shortened to just G-AE for all of these variations. Color used was a school bus yellow typically. Workers usually applied the stamp to one these two semi-flat surfaces but they are much more often found at the lower of the two locations.

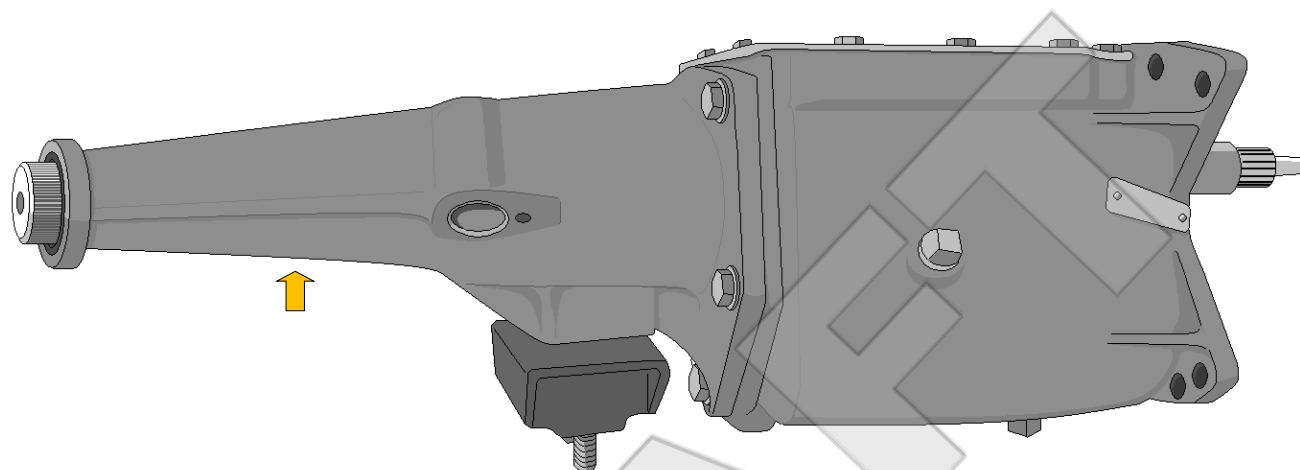
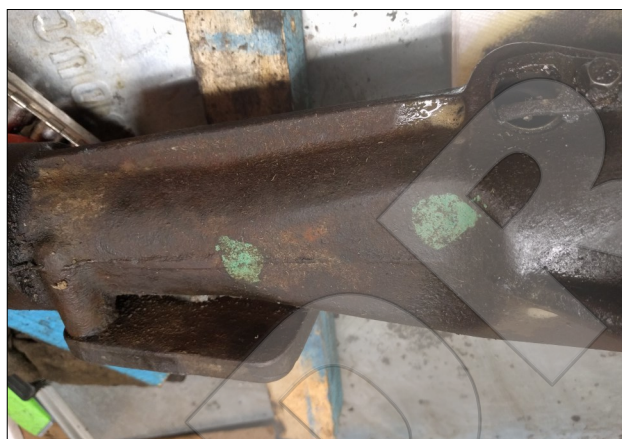
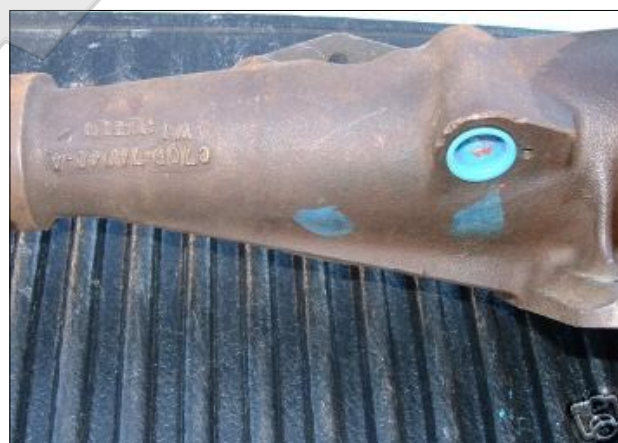
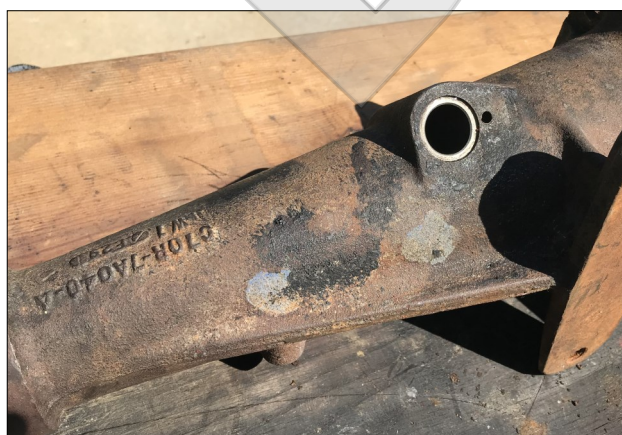
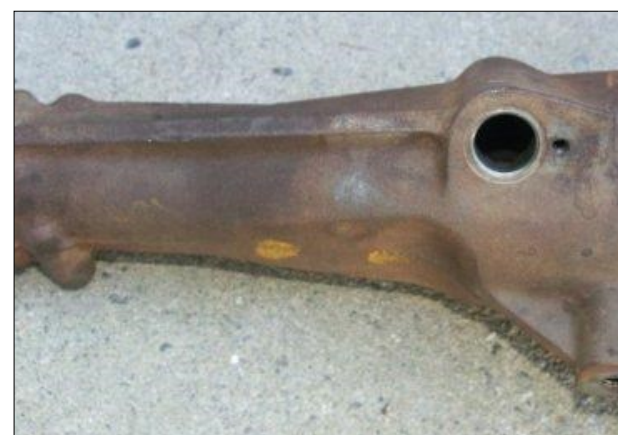
## Tail Shaft Housing - Paint Doubs

On the tail shaft housing we often find two markings. One is at or near the top surface where the speedometer opening. May have been placed to help the installers of the speedo cable locate the hole quicker.

On the bottom of the housing to the rear of the transmission mount we find a mark or marks that may have identified different housings during the assembly of the transmission as we see in other sub assembly processes.

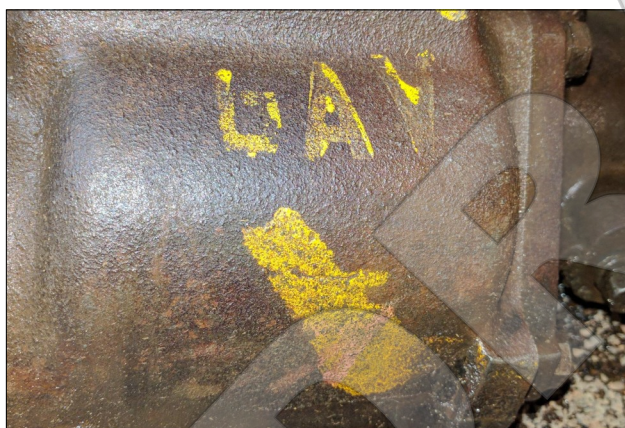
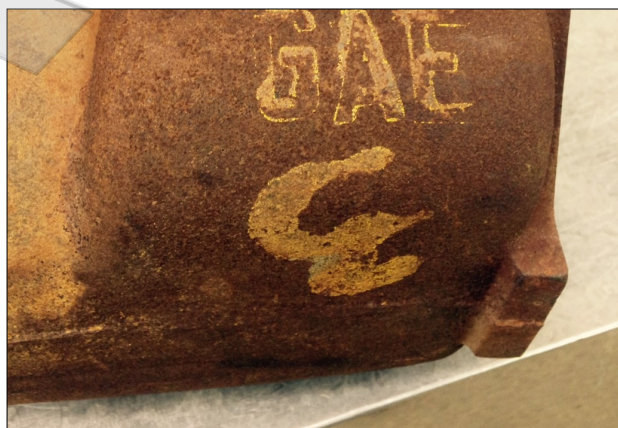
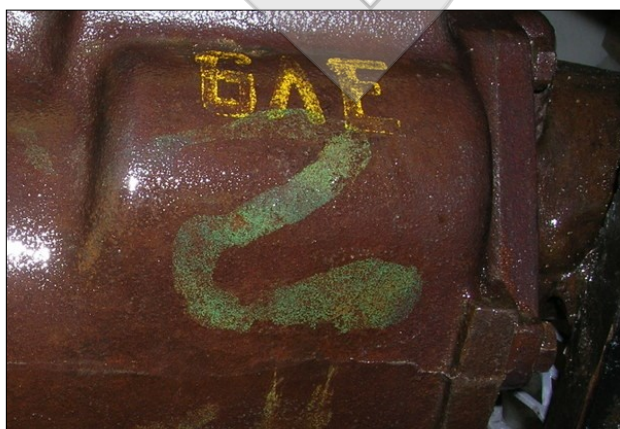
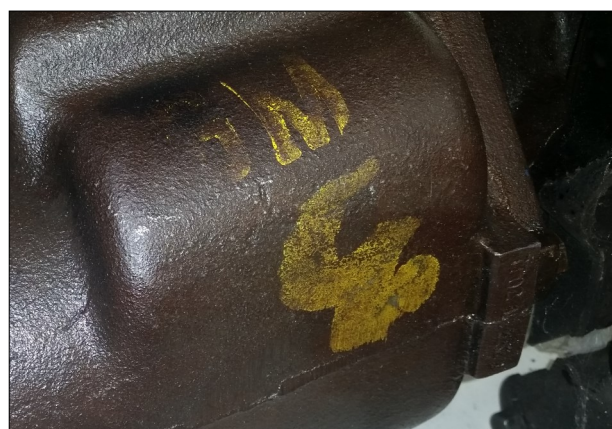
## Lower Main Body Rear - Paint - Hand Written

The main body, bottom and passenger side, are often covered by many marks, lines, letters and numbers. These have been so plentiful and varied there has been no apparent pattern or understanding.. There is one location, lower rear,

that has shown up on just about all of the examples with regularity. I choose to share so that others can look for and compare. This is typically a single digit number (one through three) shown below.

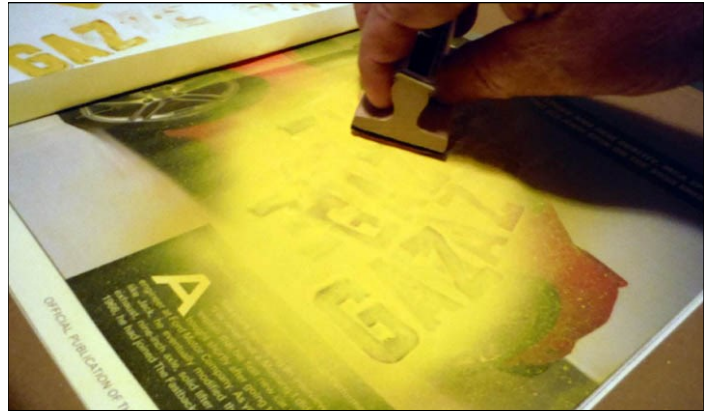
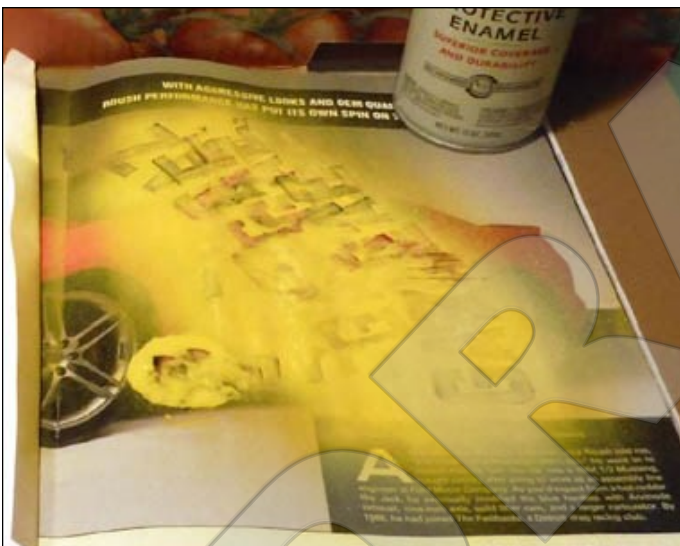
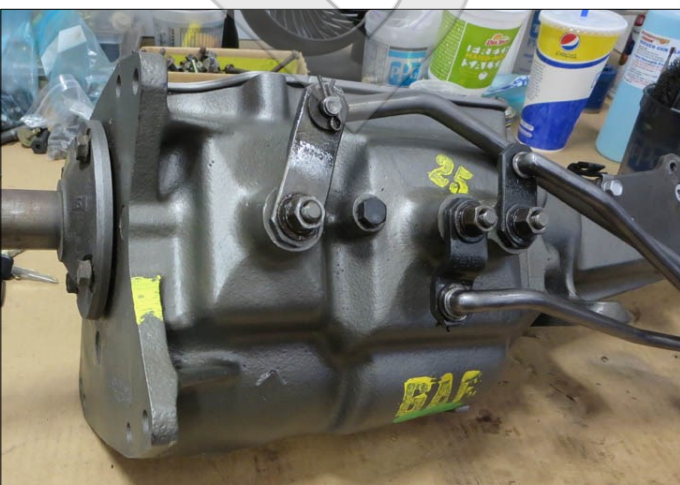
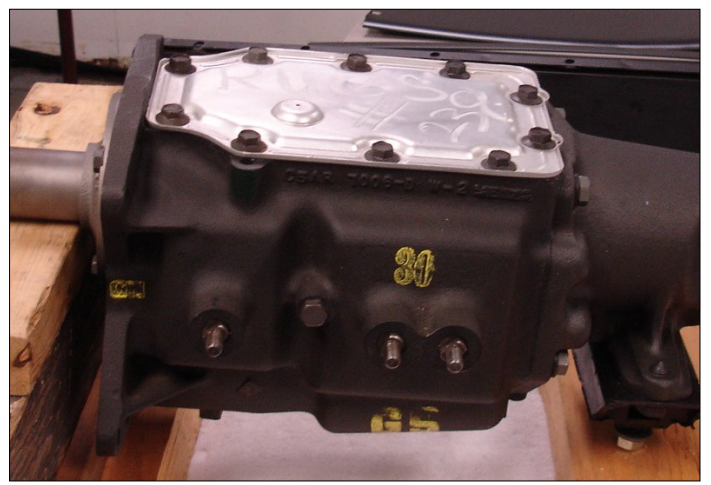
### Reproducing Stamped Marks ((Tip)

First you will need your chosen paint, the stamp, the part (of course) and an old magazine or catalog with shiny/glossy pages. You may need to arrange your work out of direct sunlight, spray paint will dry quickly in many conditions and consider that any breeze may blow the spray towards an unintended surface or it may blow the pages of the magazine closed before you finish your work.

Next, with everything in apply the paint over approximately a quarter of the surface of a single page..

This will provide you with areas to touch the paint stamp to and test out the amount and coverage of the stamp. Paint will pool in some areas and dry quicker in others so tap the stamp into the paint and stamp another page or a piece of paper until you get an acceptable product/outcome then restamp the stamp on the painted page as close as you can to the last time assuring that its an untouched area, then immediately onto the part that needs the

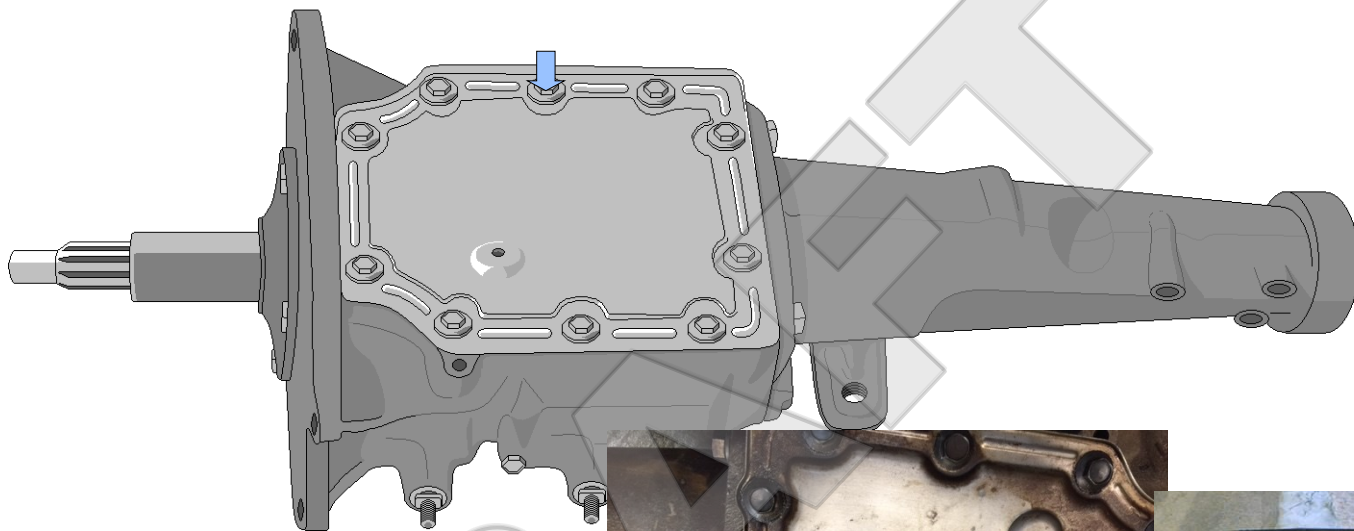
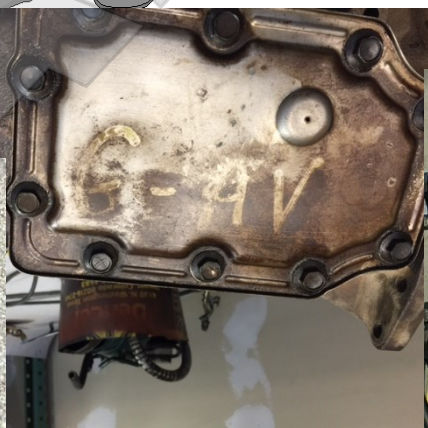
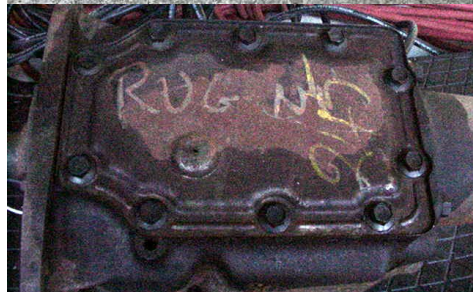
## Extra - Top Cover Plate

Hand writing applied to the cover plate appears to be inconsistent in my findings. This may suggest that it was something done by a worker working on a single shift, at the transmission or car plant, or something else.

At the time of this writing I have no examples from toploaders installed at the Metuchen with this marking which might suggest that this was an in car plant applied marking. On San Jose installed toploaders the top cover is sometimes marked with the cars second rotation number to assure that the right parts were installed on the right car.
