Distributor Diaphragm Repair

With the price of a NOS MotorcraftDD-190, Ford C5AZ-12370-A, Distributor Diaphragm, bouncing around \$100, there had to be a way to repair the most common reason for factory original diaphragm failure, the rubber diaphragm leaking. A friend recommended using Liquid Electrical Tape to seal leaks, even large tears. Here's what I came up with.

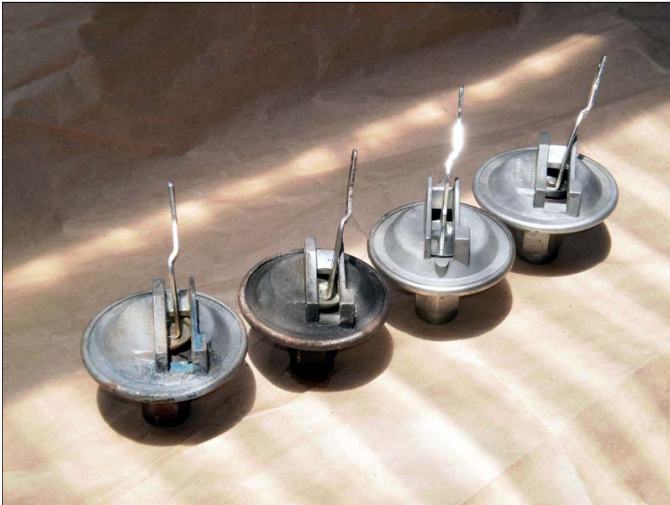
The four test diaphragms. For reference, I marked the control arms with a felt tip: all permanent markings are on the distributor side

- A "0" for the one with a tear (ID as no 1); permanent marked – "12378", "1"

- A bar across the arm for the dirty housing (ID as no 2); permanent marked – "12378", "6"

- Two parallel bars for the first test subject (ID as no 3); permanent marked "Motorcraft", "4"

- A "X" for the fourth (ID as no 4); permanent marked "12378", "Motorcraft", "7", "MC"

Note the different thicknesses of the lower mounting "bars" to the distributor housing.

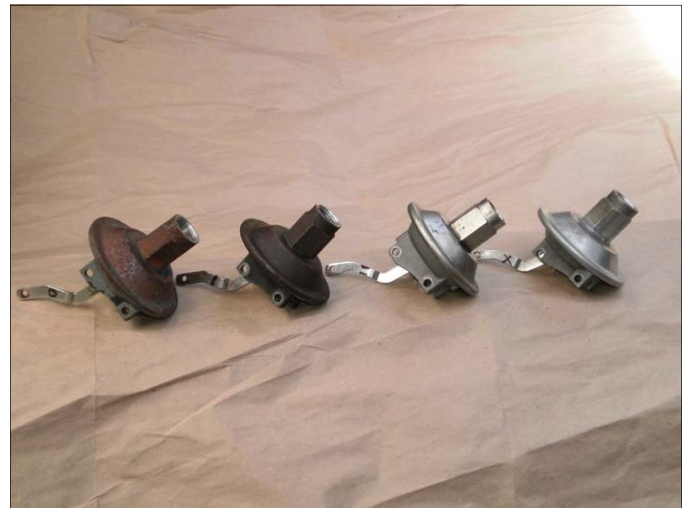
Side view of the test subjects. Same number order.

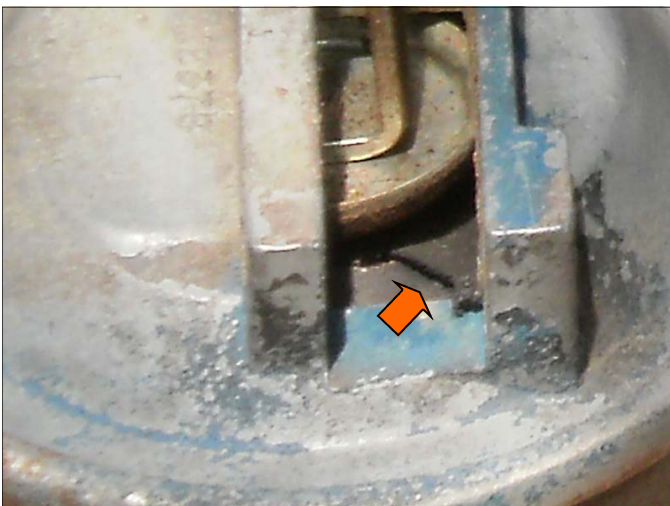
Close up of the tear of No 1.

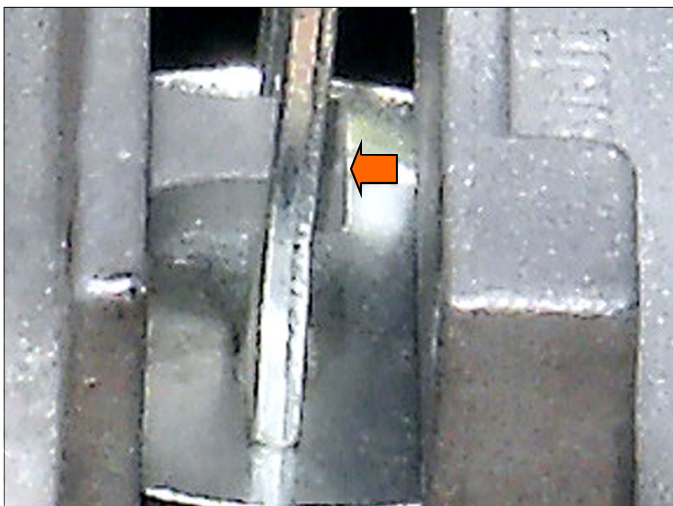
Close up of No 3 diaphragm's control arm. There's a bar from the internal side of the housing that restricts the movement of the control arm.

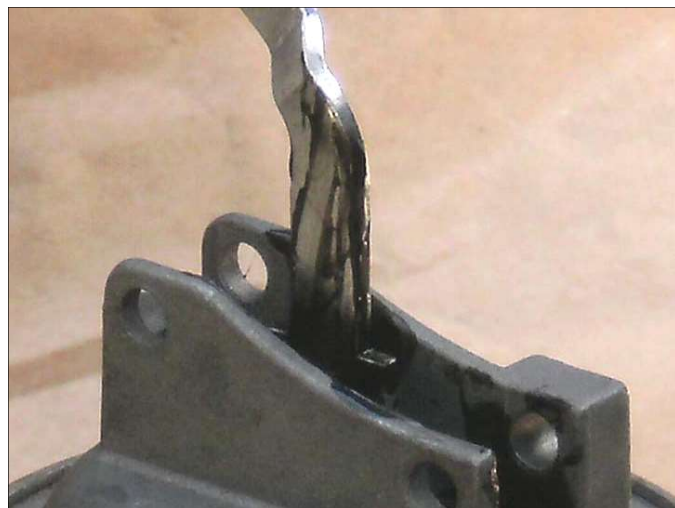
Close up of how sloppy this process can be. No 3.

After the diaphragm repairs have dried, you may be able to clean up your sloppy application technique with a razor blade or X-Acto knife. The liquid tape sticks to metal, but can be scraped away.

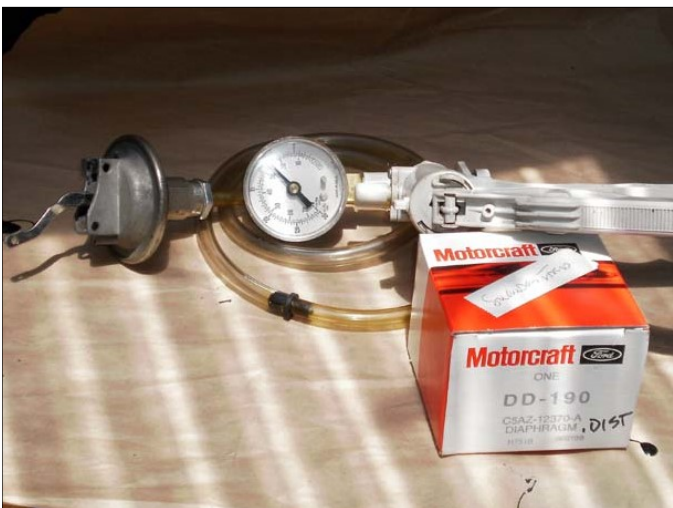
Vacuum testing and maintained on No 3.

After a couple of hours, test the diaphragm again. You should have a steady vacuum around 7-9psi. My first try worked. Twenty four hours later it still held a vacuum.
