Restoration Support

70 Dearborn Unibody (Undercarriage)

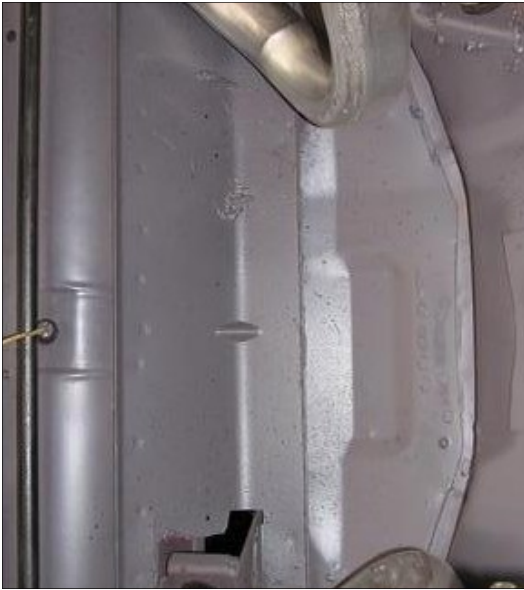
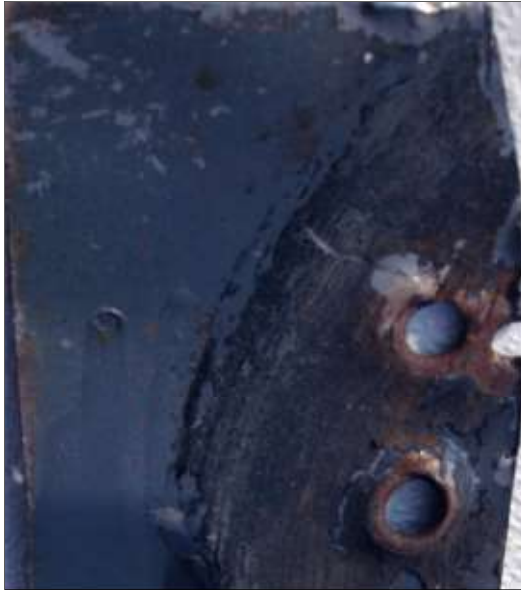
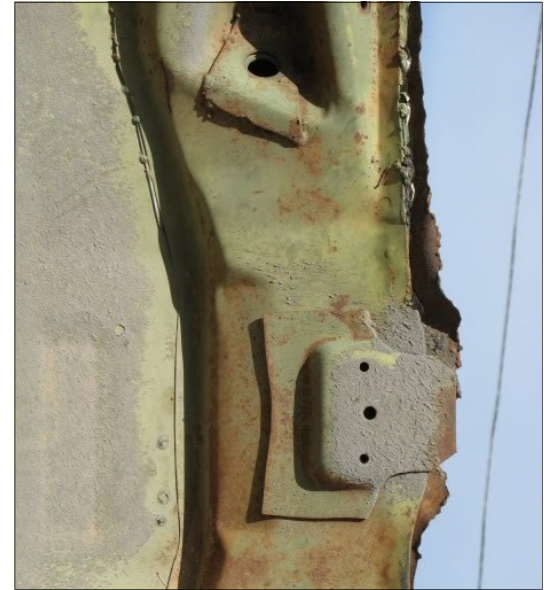
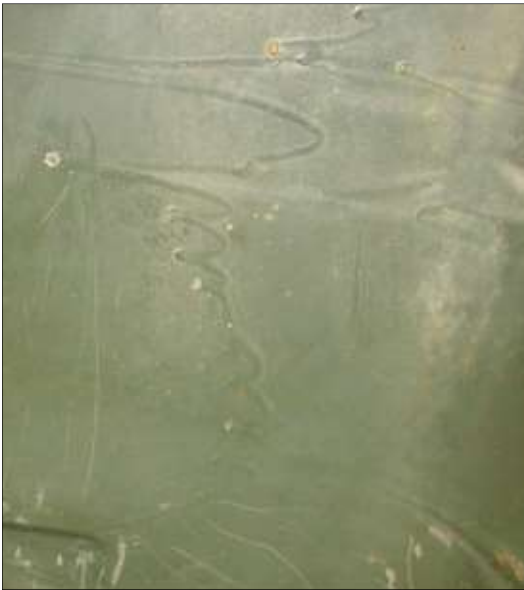
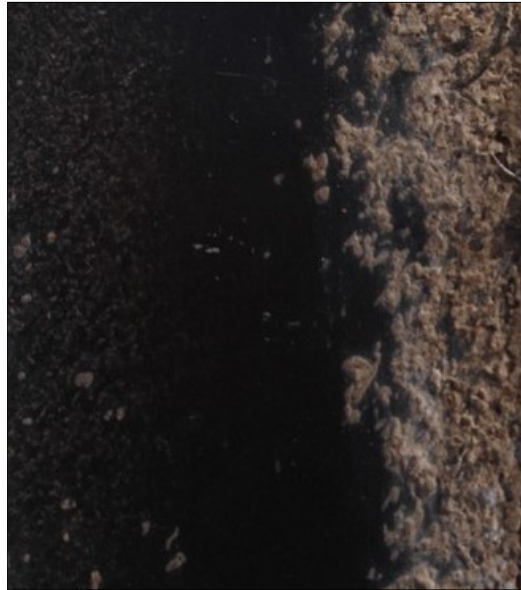
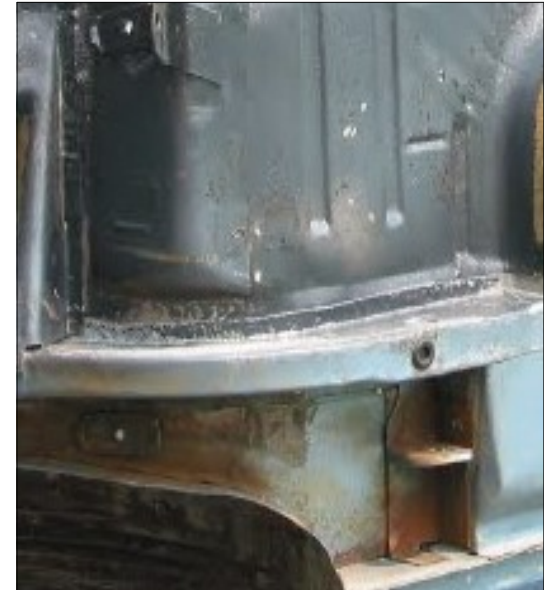
Below are just a few examples to illustrate the wide variety of colors found of batch paint from 1970 Dearborn built Mustangs & Cougars.

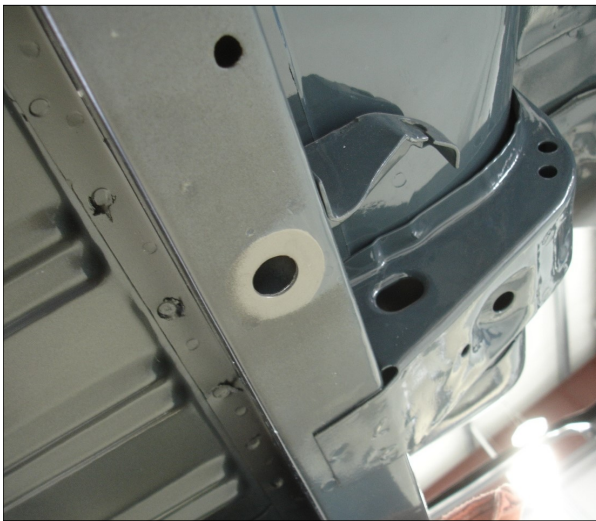
Two additional shadows were produced by the fixture behind the rearmost dolly holes and shadows on the rear frame rail.

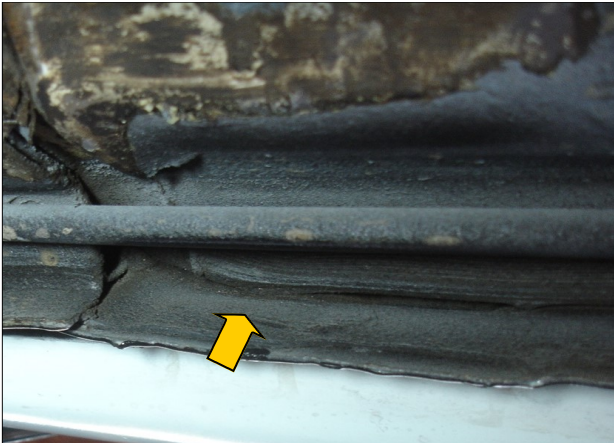
Rocker panel to floor sealant. This is one of the heavier and messier examples of the application.

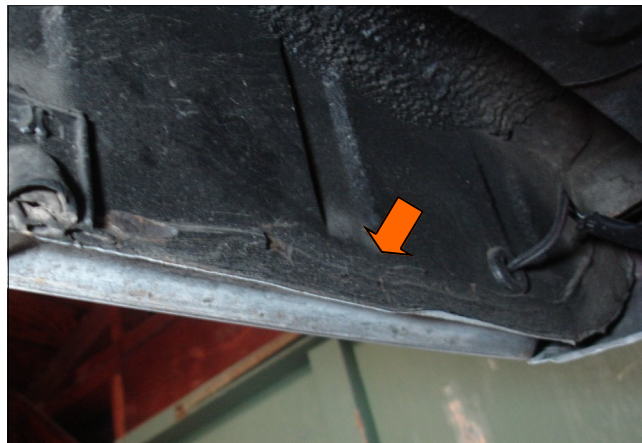
Trunk drop sealant applied and wiped at the bottom edge of the trunk drop to quarter panel pinch seam.

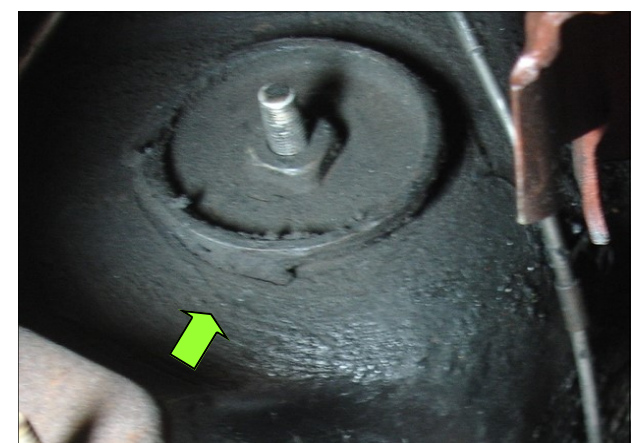
Rear seat belt anchor example. Applied around the anchor then wiped around the anchor

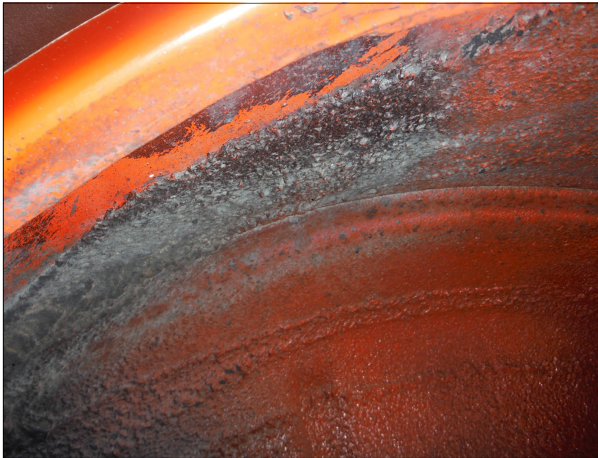
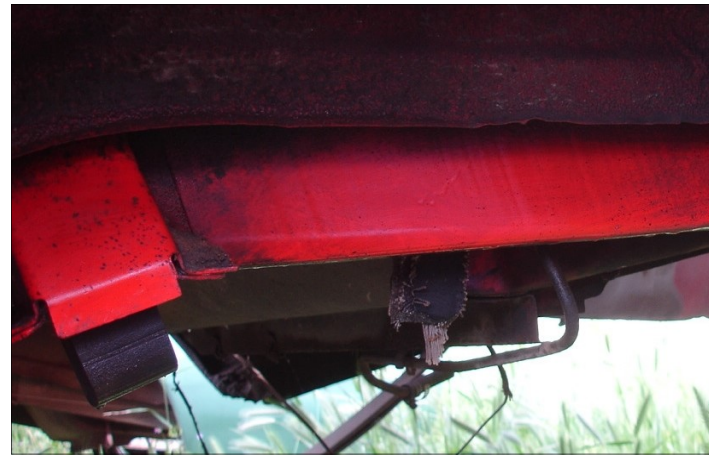
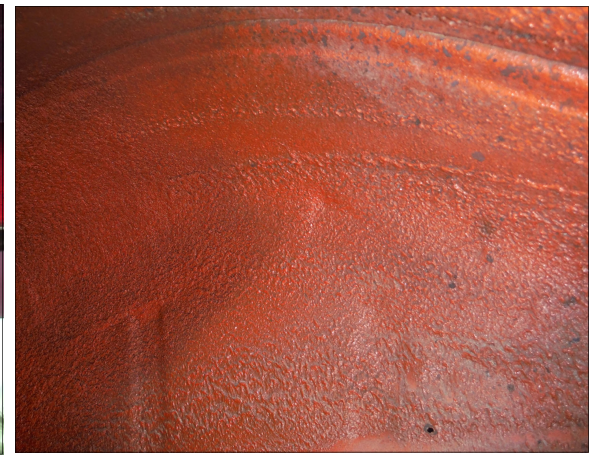
The complete rear wheel well was covered normally with a nice coat of exterior paint as a result of the painter passing a flowing spray gun over the opening as he painted the quarter panel and wheel lip. The paint applied over the sound deadener held up poorly over the years but the pictures give an indication of how nice the paint and the amount was by looking at the frame rails in original examples. In the two pictures above the body color has worn off of the top layer of the sound deadener from driving the car. You can see body color over sound deadener and panel exposed to the painting of the rear wheel well in each of the pictures above .

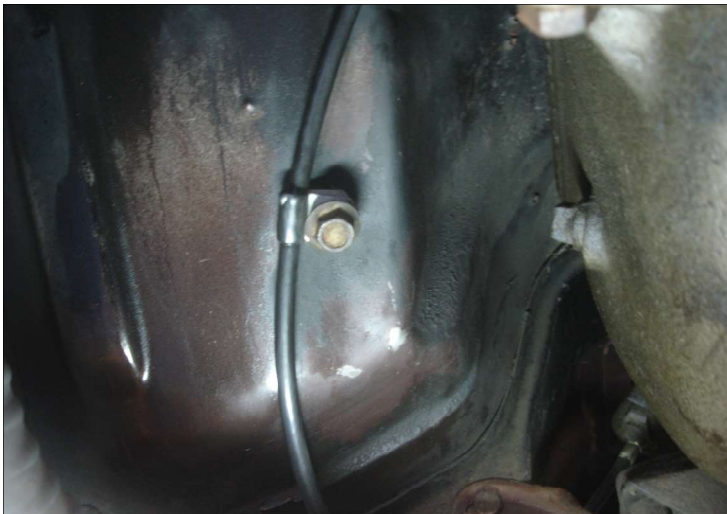
Transition from batch color of the floor/undercarriage to front primer sealer color, then to engine compartment black over both. Heavier at the top and fading away in this area.

And no that's not a factory speedo cable anchor hardware.

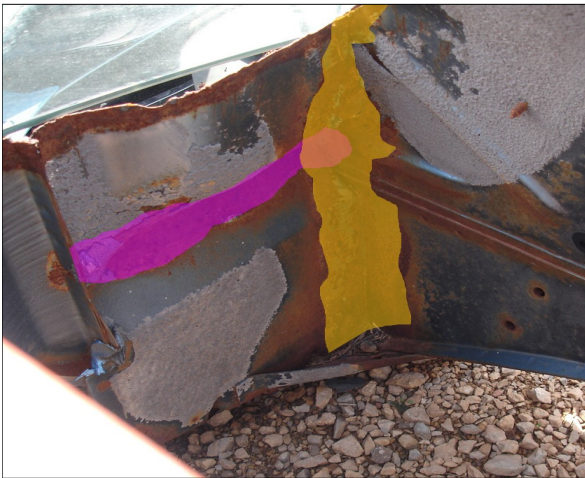
In the picture above the area covered with the spray on sealant is highlighted.

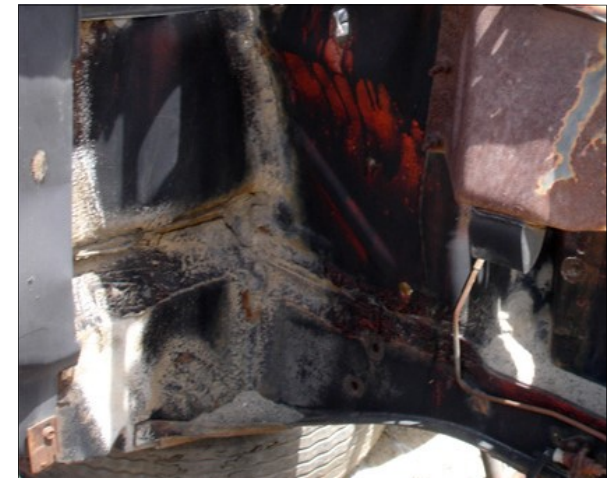
In the example above the worker applied the sealer to a larger area and number of seams in the area.

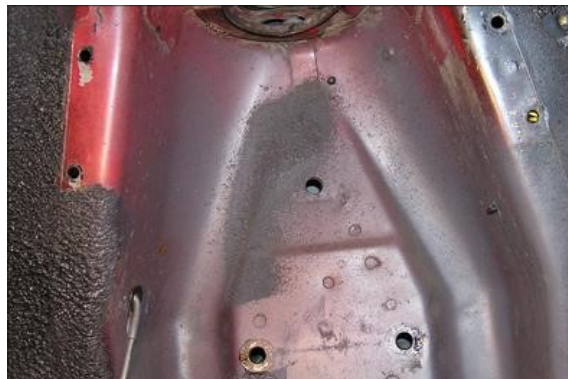
A Red 70 Dearborn Example; Rear of the car is to the left of the picture. Take notice that in this example the red exterior color was applied forward to the shock tower. Over-spray continues in the shock tower and batch color is seen on the forward inner fender panel in the upper right hand corner of the picture.

Example of the typical minimal body color forward application

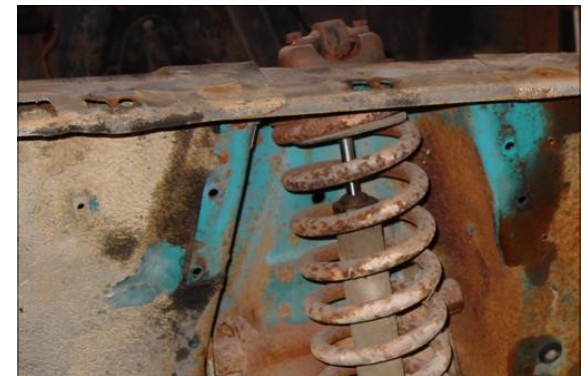
Grabber Blue 70 Dearborn Example: In this example the amount of body color application is much greater (further forward) than the example on the left. Plus the contrast between the Grabber Blue and the batch color is not as noticeable .

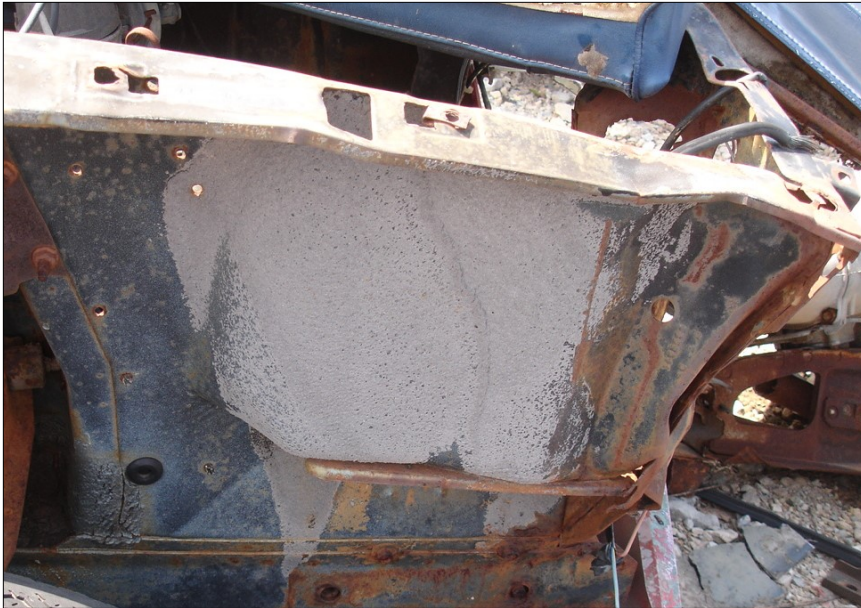
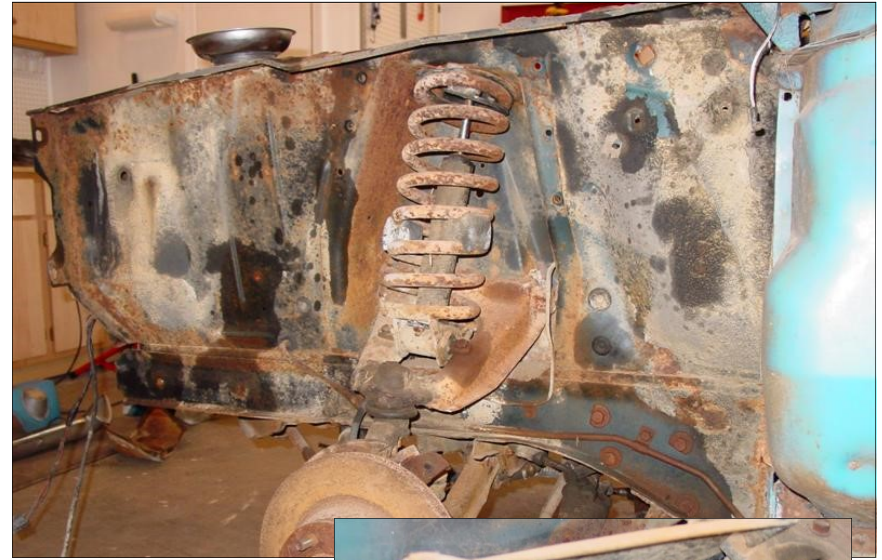
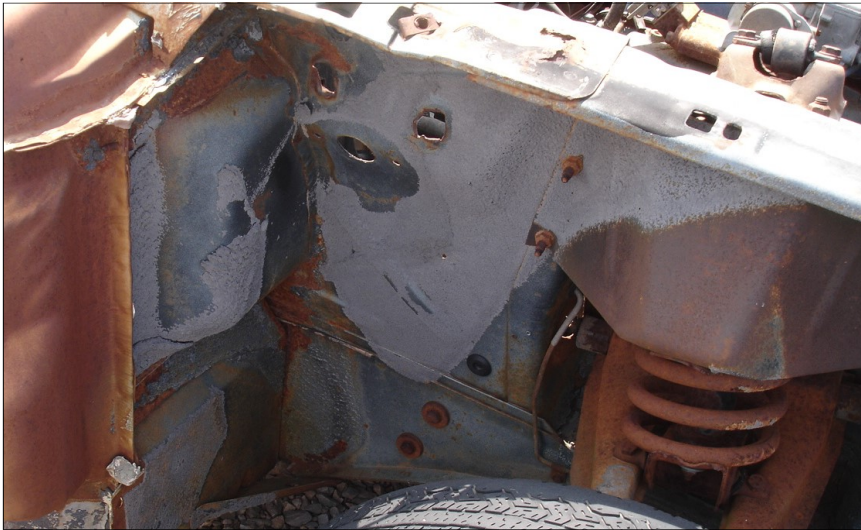
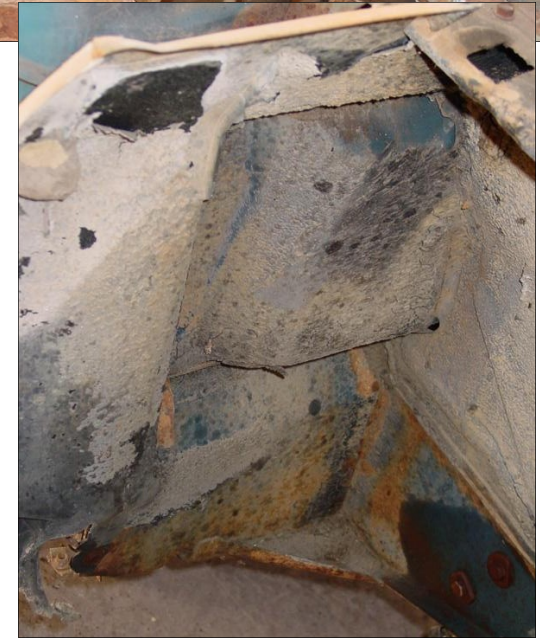
Front Wheel Well: When the engine compartment black was applied to the inner fender panels (engine side and upper lip), firewall (extending up over the cowl to the windshield opening and the radiator support (front and rear surface) it was typical that the black paint, either from a heavy overspray or direct application, would get applied to the wheel side surface of the inner fender panels in front of the shock tower or either side as well as a dusting below the fender lip of the inner fender panel. This fine overspray is often washed/scrubbed away during cleaning of the original surfaces. The extent and how far reward the black extended varied allot as did the exterior paint forward.

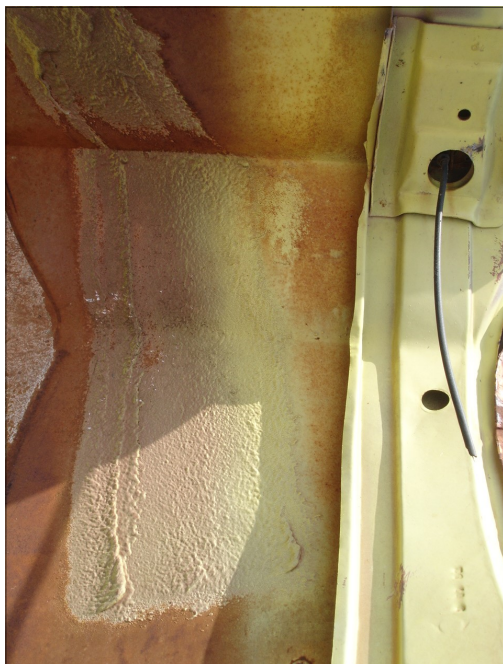
Front Wheel Well Sound Deadener: Once the car was assembled, but prior to the installation of the front wheels and tires sound deadener was applied, from below the vehicle, on the inner fender panels (in front and behind the shock towers), the firewall section in the wheel well, over the front and rear splash panels/shields as well as the bottom surface of the front fenders. Typically the amount of area covered could be anywhere between a little/minimal (left set of pictures) or allot (right hand set of pictures). Sound deadener was applied by a worker in a pit below the body as it passed over head. The spray pattern will reflect this location and angles it produced.

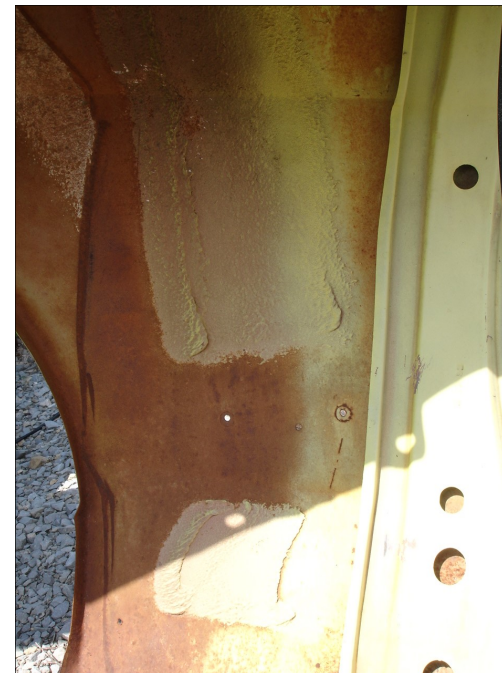
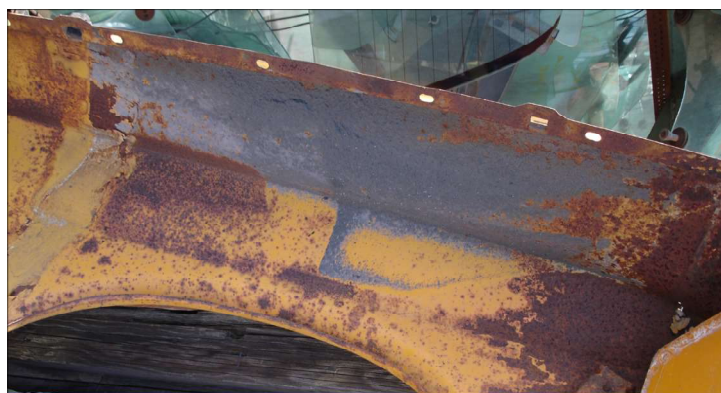
In these two pictures of the back side of a passenger side fender the worker applying the sound deadener appears to have made a long vertical arch in an attempt to seal the splash shield to the fender and deaden the tinny sound of a uncoated fender.

The picture to the left shows the bottom of a 1970 Dearborn painted fender showing the extent of sound deadener applied. Notice the shadows produced by it being installed at time of application. In some examples more of the surface was covered while others have less. In other examples (right) a minimum effort was done. Pattern highlighted in the picture below.

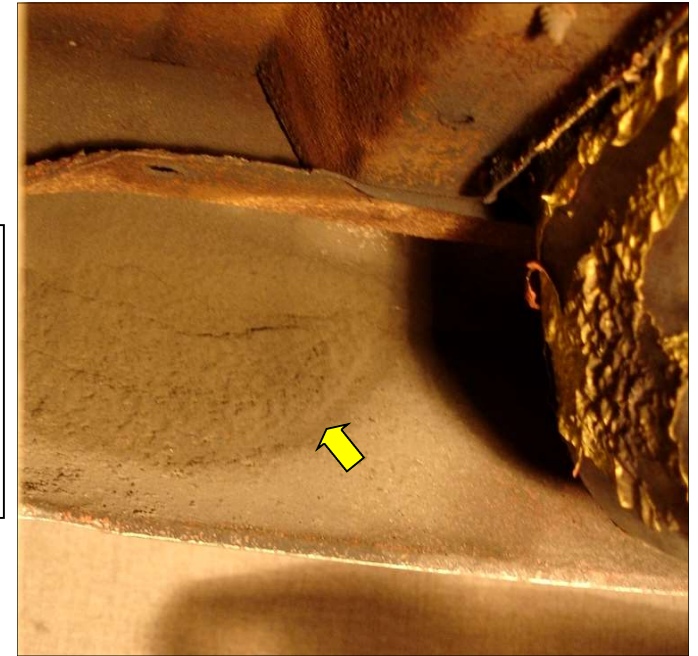
Backside of Rear Valance: In an attempt to soften the drone or hum that can sometimes be produced by sheet metal a small amount of sealer was applied by spray onto the forward surface (facing the rear cross member) of the rear valance approximately over each location where the exhaust pipes would exit below on a dual exhaust car. The location was approximately center between the lower edge and the upper mounting lip and applied prior to being installed on the vehicle. Diameter of the product was approximately four to six inches in diameter as illustrated in the picture to the right. Passenger side shown in picture.
