Reproducing Body Dolly Marks

Dolly Mark Placement

Dolly Reproduction Tools

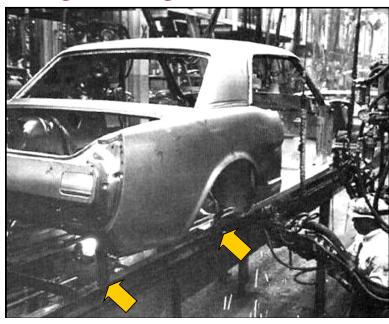
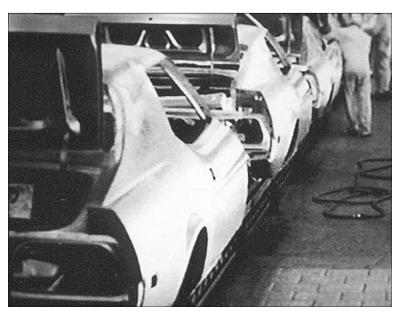
On the bare surface of the frame rails, we should be able to make out the galvanized metal surface, while in the trunk and in the interior of the car (where the car was bolted in place from the top) untreated bare metal should be present.

In the picture above we see an early Mustang in a welding station where it appears that a worker is spot welding the car.

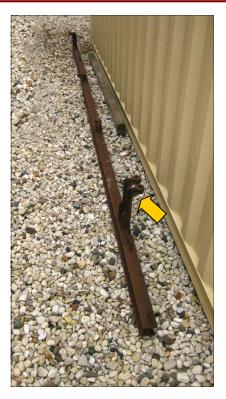
Here is what has been reported as one of the rails or dolly's. Here at the bottom of the picture you can see the rear attachment points (one longer - for vehicles such as Cougars, one shorter for Mustangs)

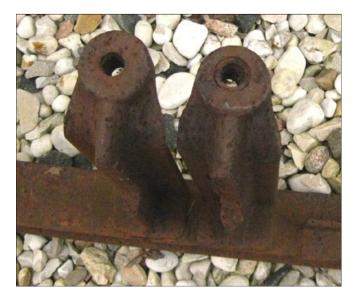
Here is a close up of the rear mounting stands (in this example from 69-70—see last page for explanation). At this point (and one further forward) the car was bolted to the dolly.

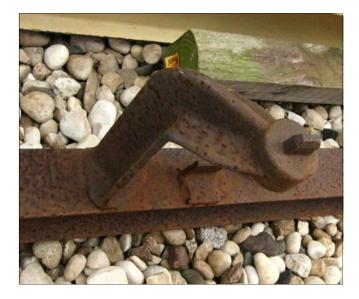
Here is a close up of the forward standard. At this point and one further back the cars simply sat on the stand with locator tab inserted in the cars frame rail.

As mentioned, on the prior pages, each of these spots would leave unpainted locations on the frame when viewed from under the car. That bare metal should show a galvanized surface if mart of the frame rail or just a bare, natural steel finish if located in the interior or the trunk.

The diameter of the circles on the frame rails normally measures about 1 3/4" in diameter but can measure slightly different depending on if the car shifted (elongating the circle) during the building process. The size of the circle seen in the trunk or interior can vary a fair amount between years and plants (even during the same year) so it appears that some of the items used to secure the cars may have been lost, damaged or replaced leading to an inconsistency. Good for the restorer is the fact that most of the time these were tightened enough to leave a distinct impression for us to measure and reproduce

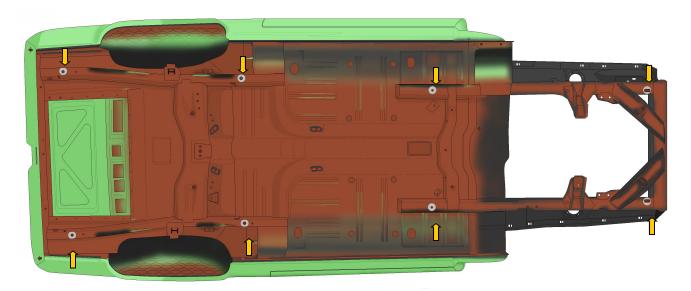
Drawing below illustrates the placement of the stands/dolly marks as found on original cars.

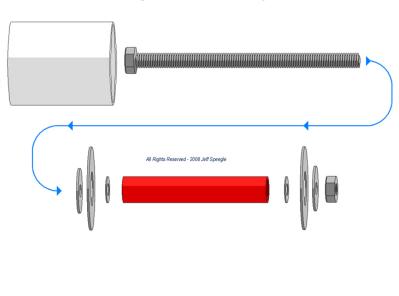
Through Hole Dolly Tool

- The general idea is to epoxy the washer to the bottom of the PVC section so that it will allow the bolt to rotate separately.
- The piece of hose is used on this tool in an effort to keep the heavy handed, tightening the tool too tightly. Just enough tension to hold it in place is needed.

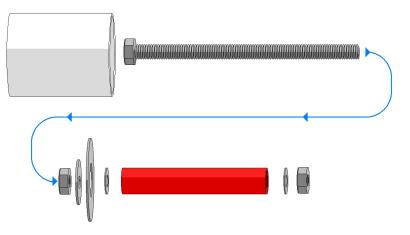
Single Side Dolly Tool

- The general plan is to epoxy the washers and upper nut shown in the picture, to the left, to the bottom of the PCV section. This will allow you to hold the PVC section with one hand while tightening the bolt with a socket and extension when attaching the tool to the car..
- You should weld or epoxy the nut on the end of the single side dolly. This will keep it from turning allowing the rubber hose to expand. Also you don't want the washer or nut at the end becoming disconnected from the tool when you loosen it to remove it. Falling into the frame rail.
- By tightening this tool the rubber hose expands and holds the tool in place.

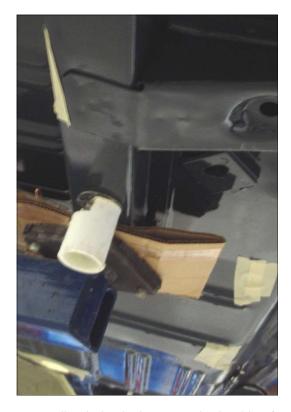
An earlier design had a cut out in the side of the tube to allow me to hold the nut while I tightened the bolt (single sided tool). As I discovered, gluing the nut to the tube and washers allowed me to do away with this extra work.

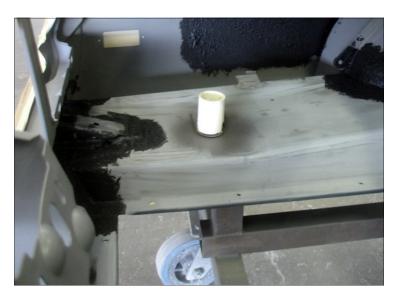
Unfortunately due to the design of this paint dolly at this shop (notice the casters below) this tool had to be inserted up side down for a time. It was installed correctly before the overspray's were applied

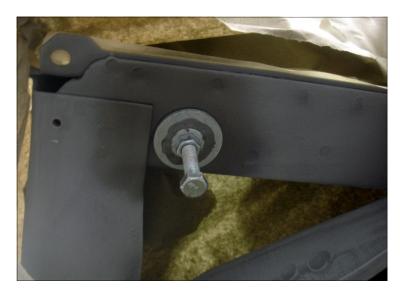
Things do happen. In this case the plastic tube was knocked off and I had to reattach before the overspray was applied

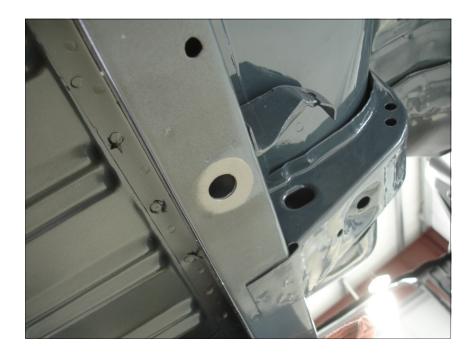
What the final results were on this particular car. On this car the floor pans were shot with batch color used during some of 69 Dearborn production.
