Restoration Support 65 San Jose Unibody (Undercarriage)

This is an ongoing project of mine I expect to be continually updating as new information is documented, studied and discovered.

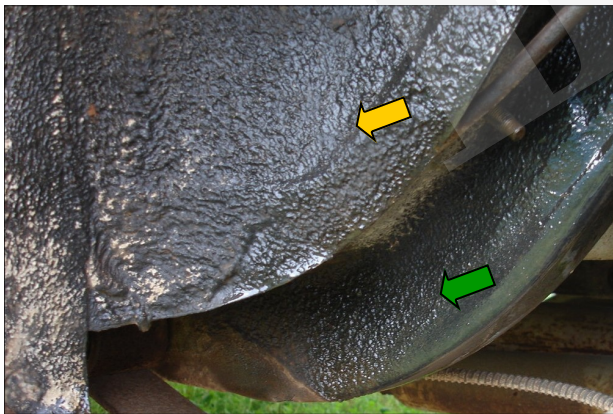
Yellow-Example of sound deadener - Typical application

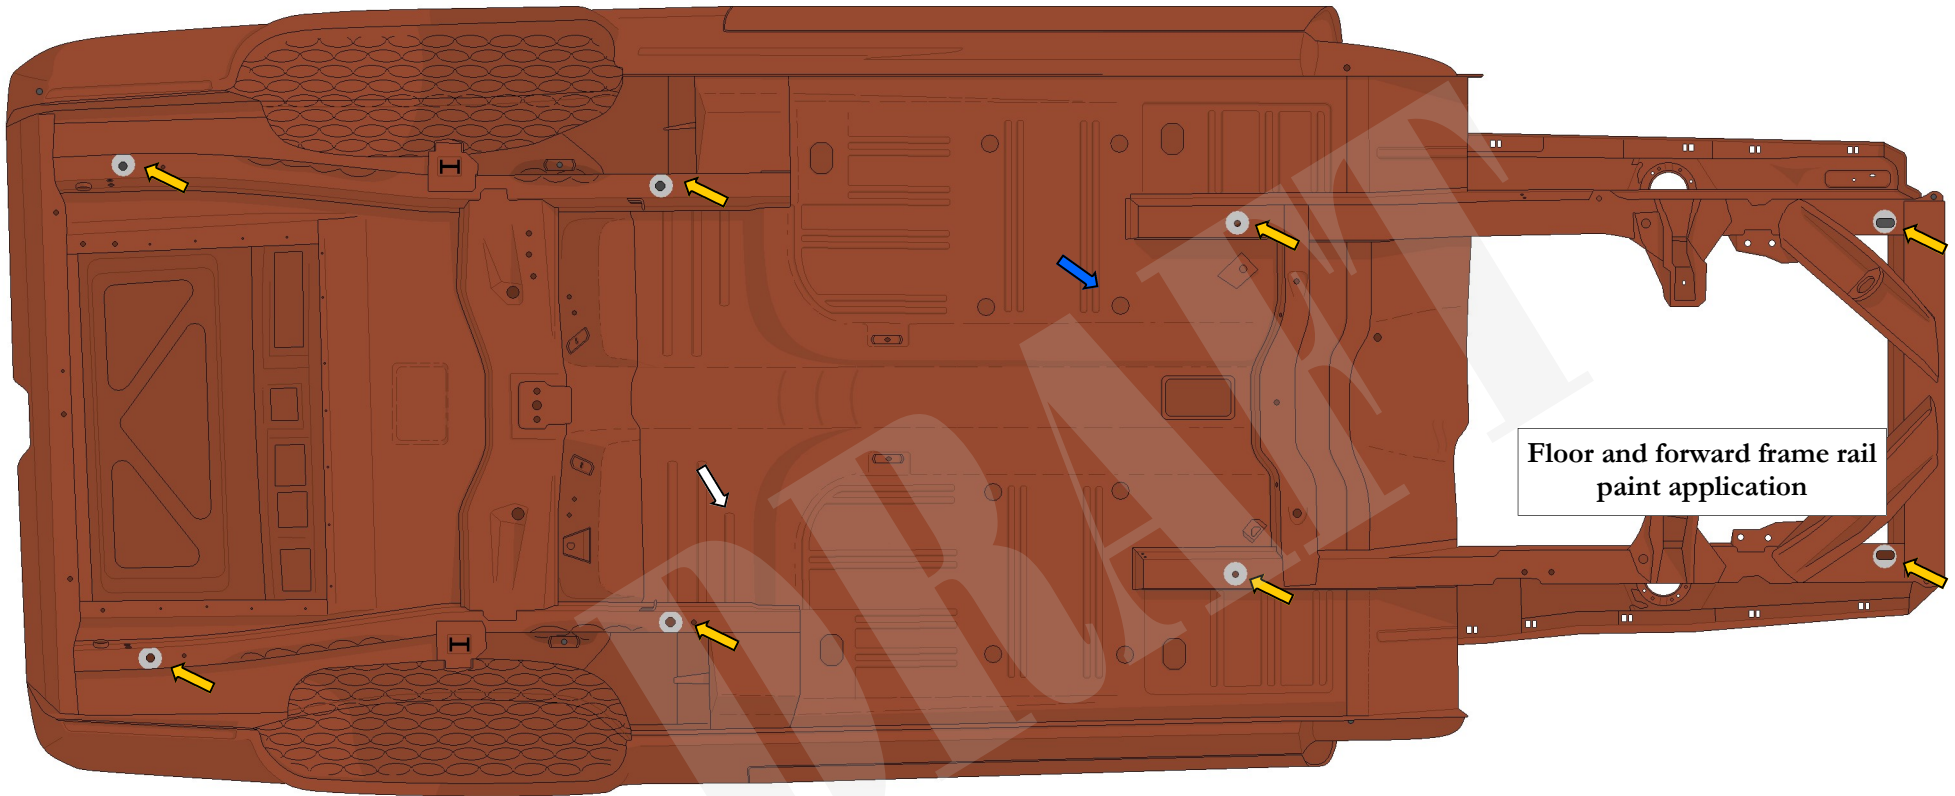
Floor and forward frame rail
paint application

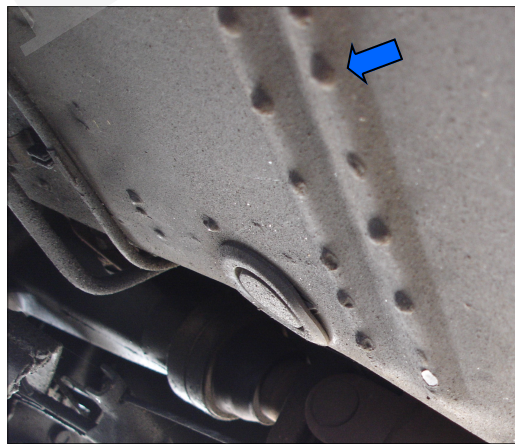
Heavy application produced drips in many areas

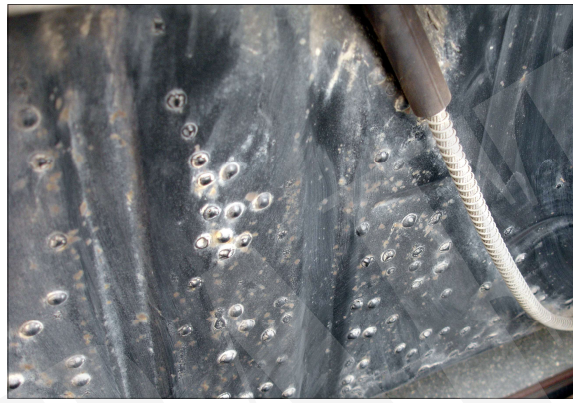
Examples of dark batch colored floor coating.

As mentioned in the text section of this article the color and tint of the epoxy primer sealer applied to the unibody from approximately the firewall rearward during 65 San Jose production varied during the year. These patterns related to specific production periods at the plant. Because there are no records of specific fates any of these cars were finally completed its impossible to determine the exact color each was coated one but predictions can be made from the data collected. The colors shown in the accompanying pictures should not be considered exact color matching samples but only for comparison purposes due to the differences in monitor settings, digital files, printer settings and other circumstances.

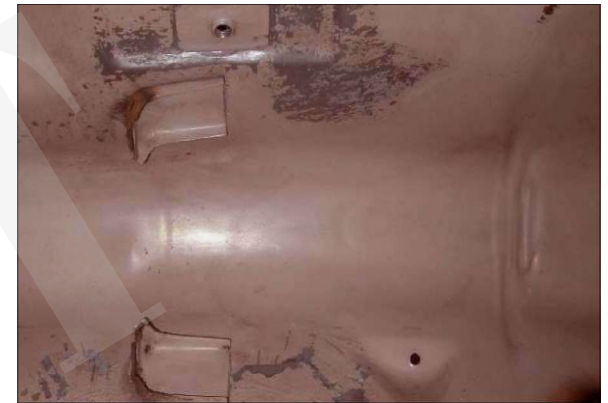
Examples of pinkish/salmon red oxide colored floor coating.

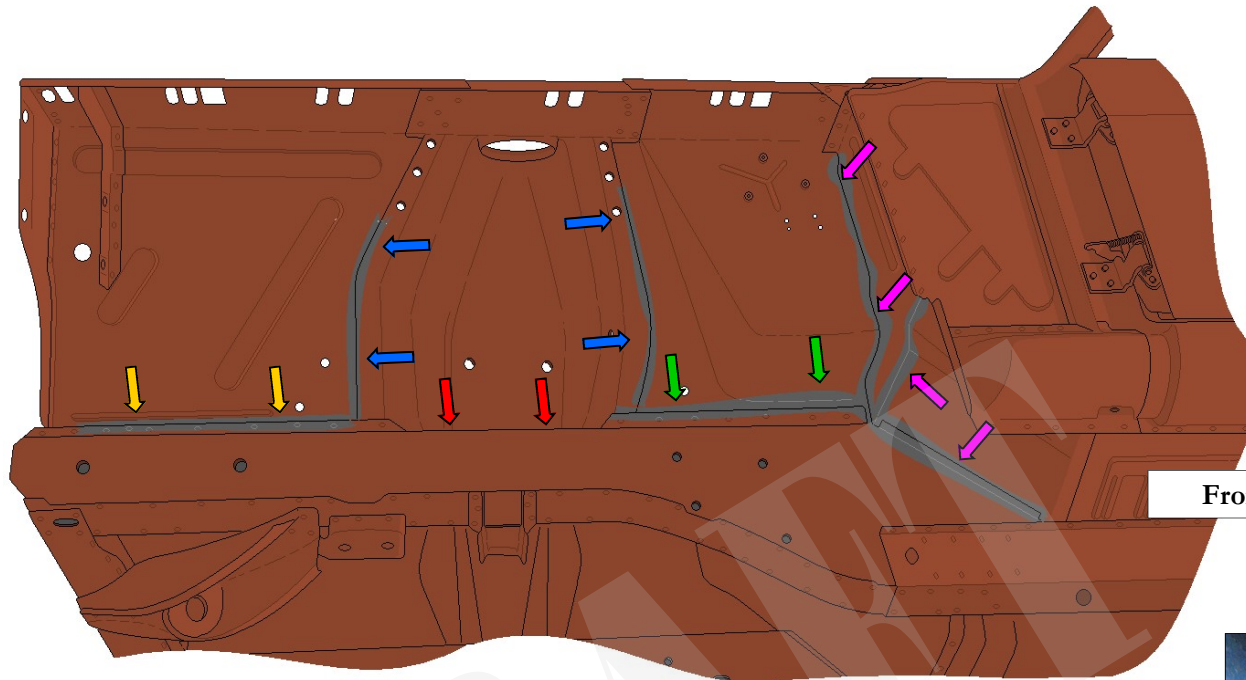
Front wheel well seam sealer

- Seams sprayed and sound deadener applied in the interior area of the car.
 - Inner Fenders - In many examples, black seam sealer was applied (brushed) to the inner fender to frame rail seam in the front wheel wells. No consistent pattern (week or months) have been identified yet. In some cases (earlier brush on application may have been missed for some reason) this step was done with a heavy narrow sound deadener application to those seams then overcoated with the normal sound deadener. (Pg. 8)

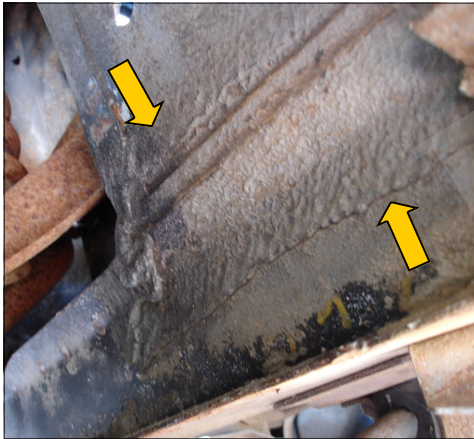
Yellow-Thinly applied, finished with brush along the inner to front frame seam. On late built cars this sealer was skipped or sealed during the sound deadener application step.

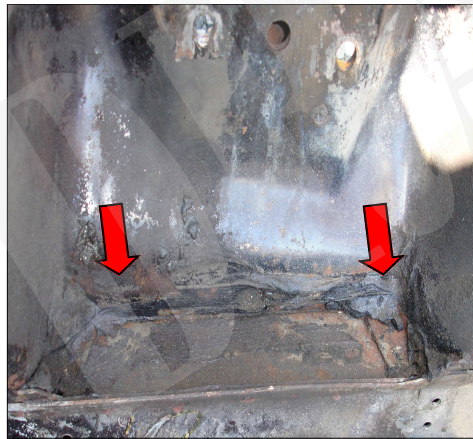
Red- A very thick application of sealer was applied to the valley at the base of the shock tower. **Blue**-Applied to only some of the cars built during the production year often very lightly.

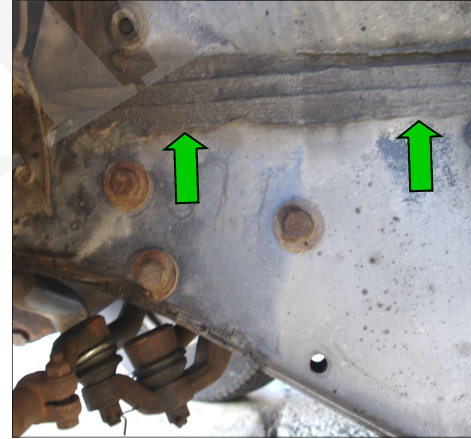
Green-Thinly applied, finished with brush along the inner to front frame seam. On late built cars this sealer was skipped and sealed during the sound deadener application step.

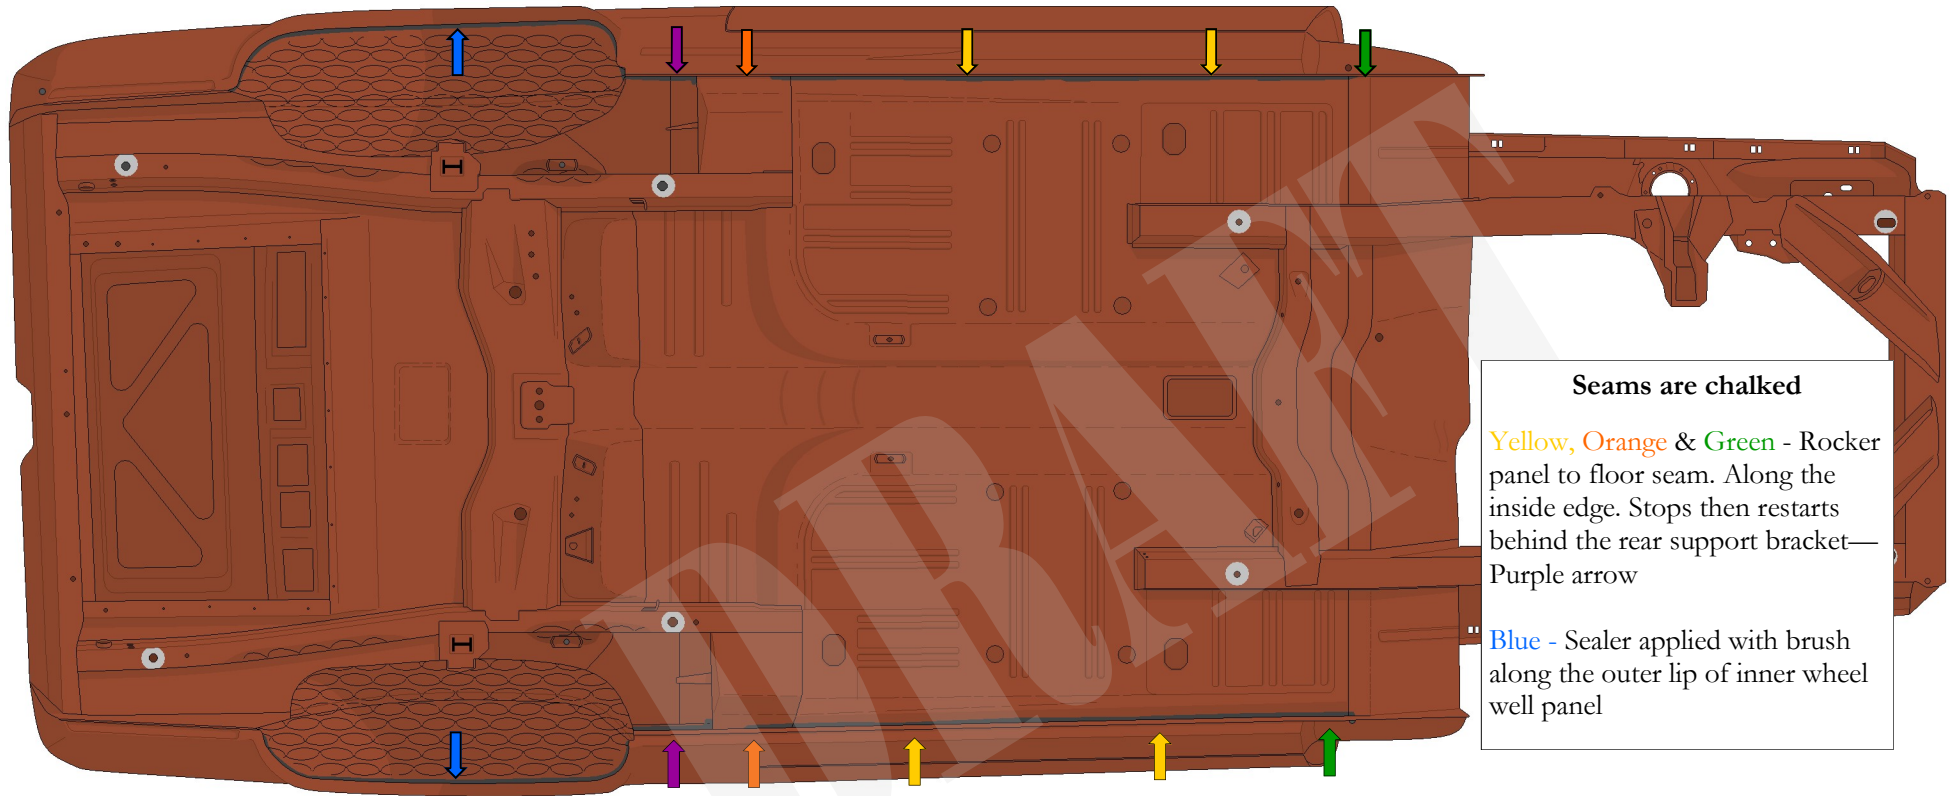
Seams are chalked

Yellow, Orange & Green - Rocker panel to floor seam. Along the inside edge. Stops then restarts behind the rear support bracket— Purple arrow

Blue - Sealer applied with brush along the outer lip of inner wheel well panel

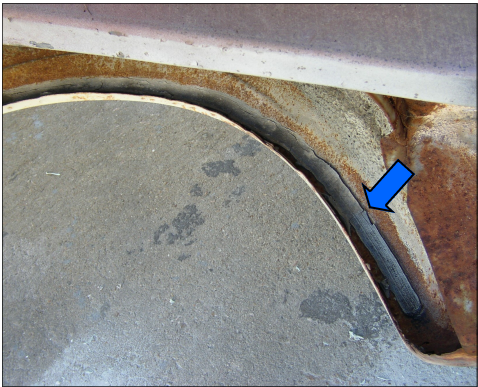
Wheel well lip sealant

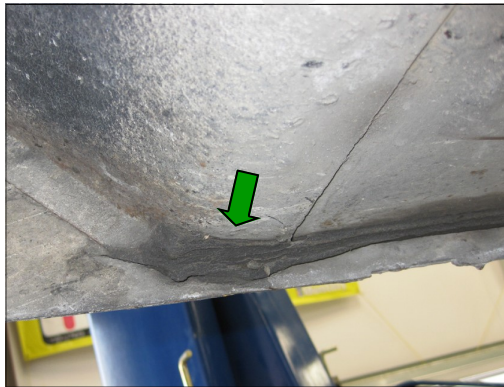
Rocker panel chalking

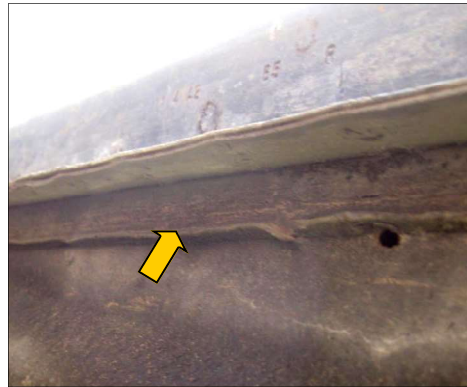
Rocker panel chalking

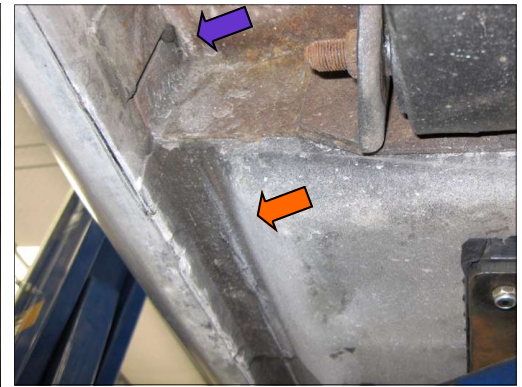
Rocker panel chalking

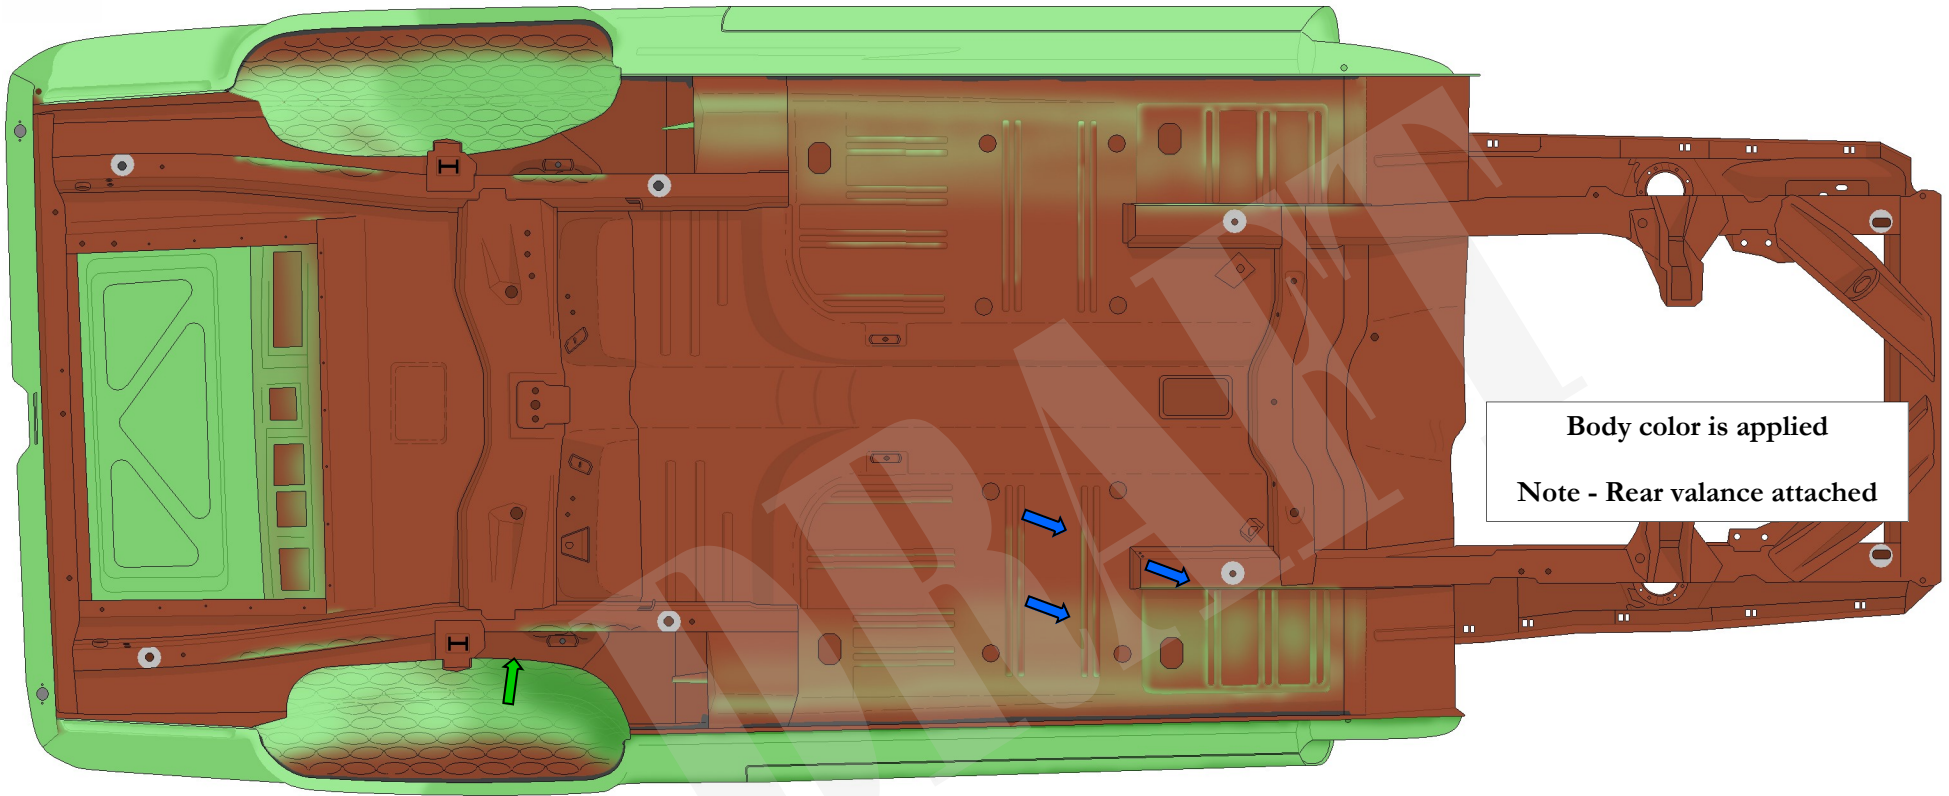
Body color is applied
 Note - Rear valance attached

- 7- Door jambs and exterior of the car were painted. (Pg. 10) During this process, using the spray guns of the period, a fair amount of over spray and direct application ended up on areas other than the exterior body such as the interior of the car, the rear wheel wells, the bottom of the floors and undercarriage and any panels or details that hung down more than the surrounding ones. Front frame rails would be one example. This process pushed allot of body color overspray onto the bottom surface of the floor pans and the panels over the rearend area.

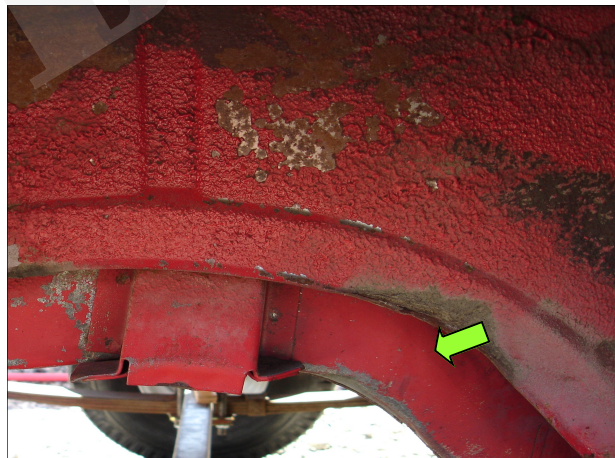
Paint worn from sound deadener in spots from use. Arrow shows nice exterior coat on frame rail

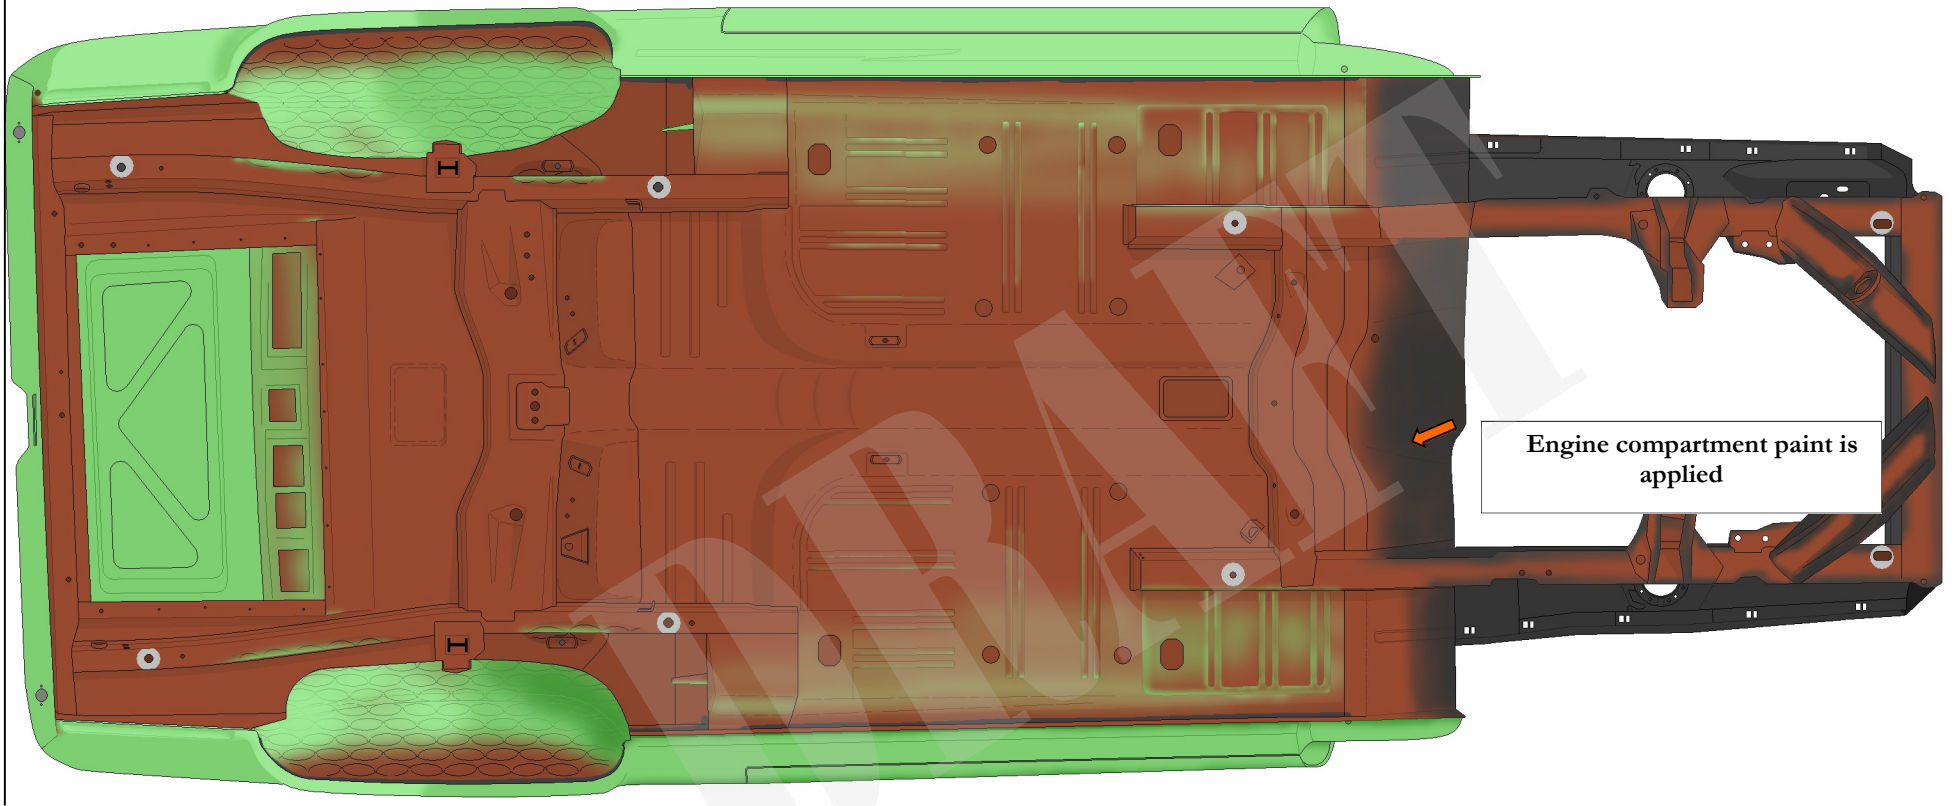
Engine compartment paint is applied

- 8- Engine compartment and inner fender areas were next painted semi-gloss to satin black. (Pg. 11) On the inside of the engine compartment from the cowl to firewall pinchweld downward the black faded away as the panel bends back toward the junction with the floor pan at the bottom. How far varies depending on the worker, how much they bent over, their height and the effort they put forward on the particular car. (Pg. 11) Black paint was applied to all of the inner fender panels in the engine compartment as well as from the top all brackets and mounts along the bottom of the engine compartment. Examples being the strut rod brackets.

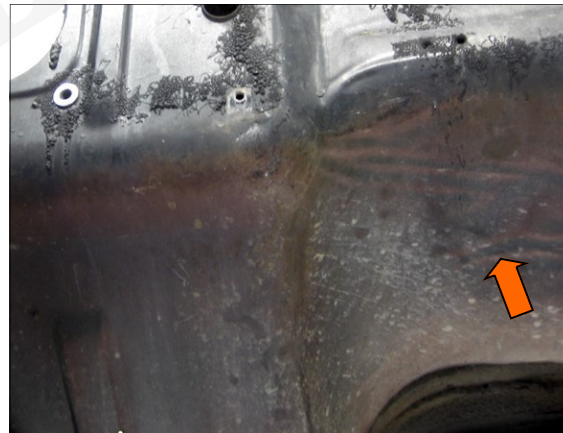
Typical transition/fade of black engine compartment black over firewall red primer.

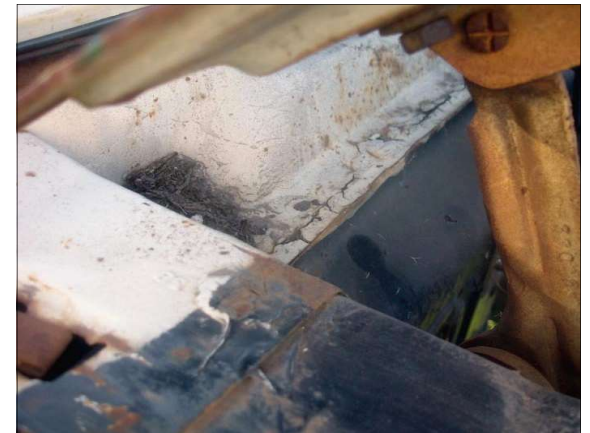
Typical location of black paint to cowl body color
Soft line—not taped

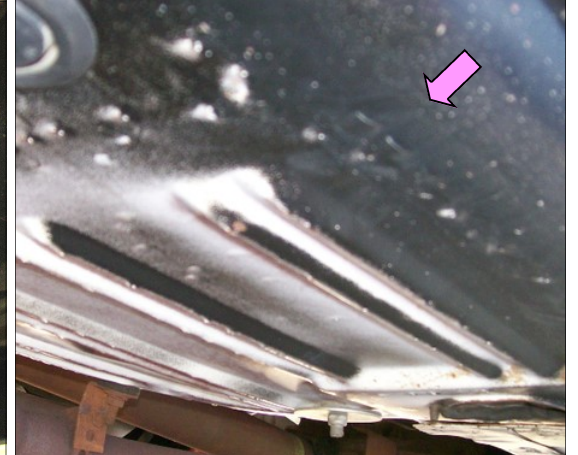
This car received a heavy (more overspray) coat close to the pinch weld likely due to paint gun angle

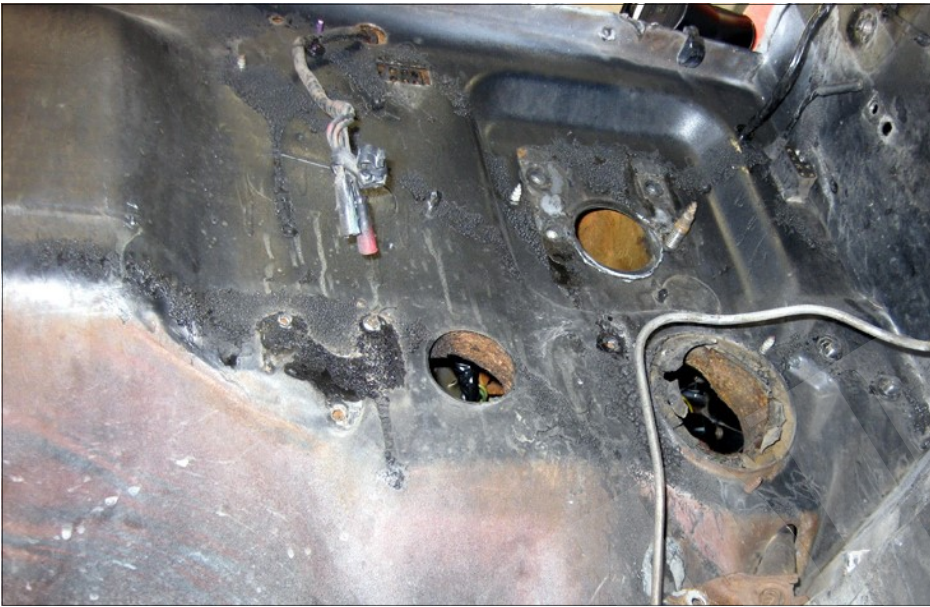
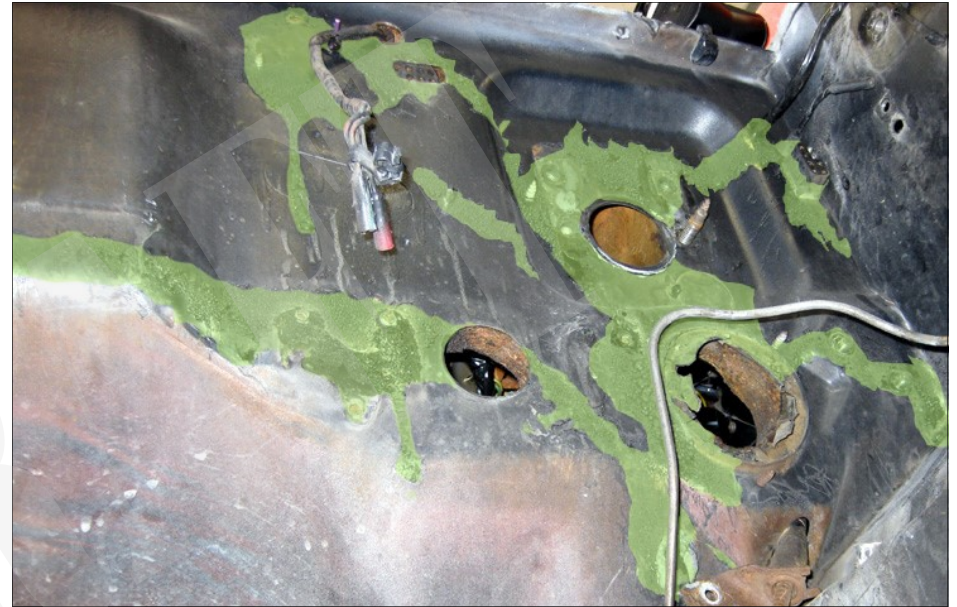
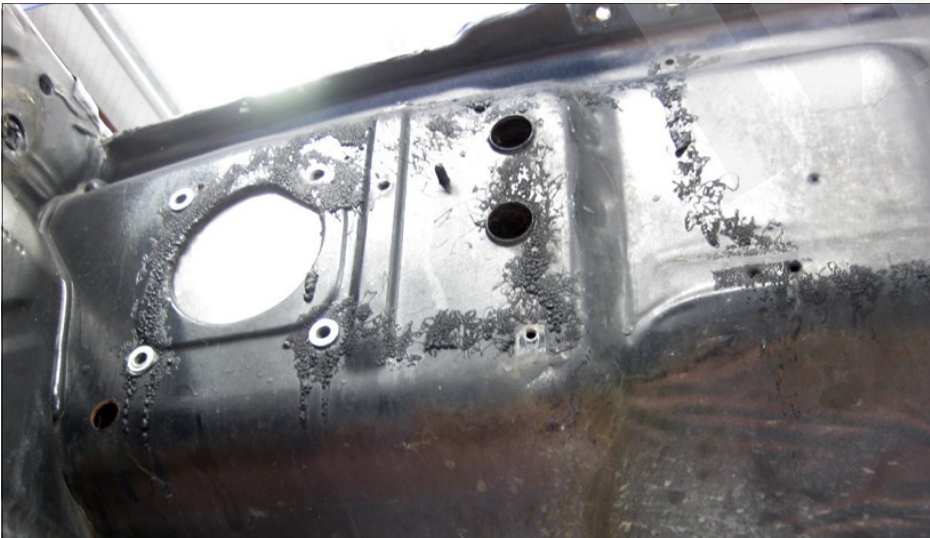
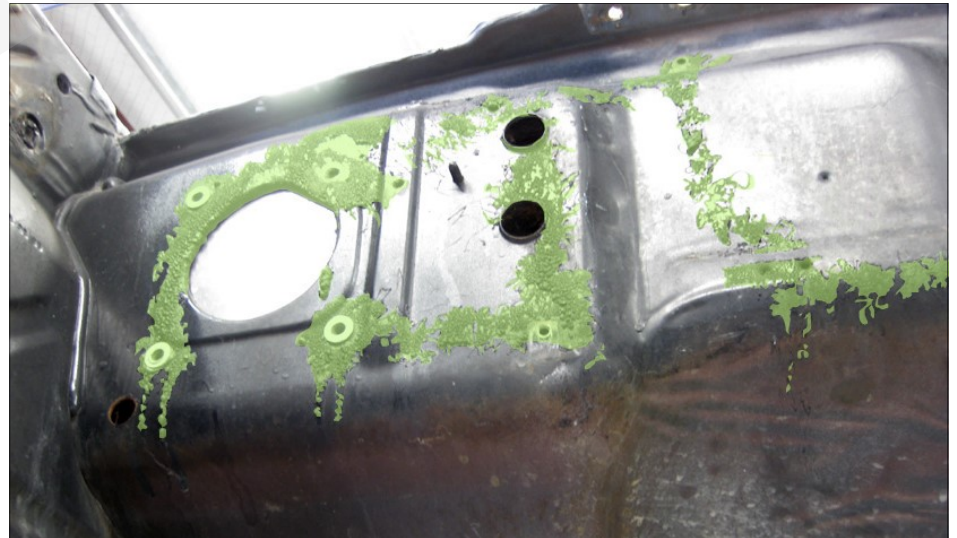
Firewall Sealant

Example of typical sealant applied at or around all firewall attachments and pass-through locations. On the right I've highlighted the spray pattern. As you can see the product is a very fine spray similar to what is produced with spray adhesive (adhesive was the term for Ford used for the product). Sealant applied in a continuous spray carried from point to point.

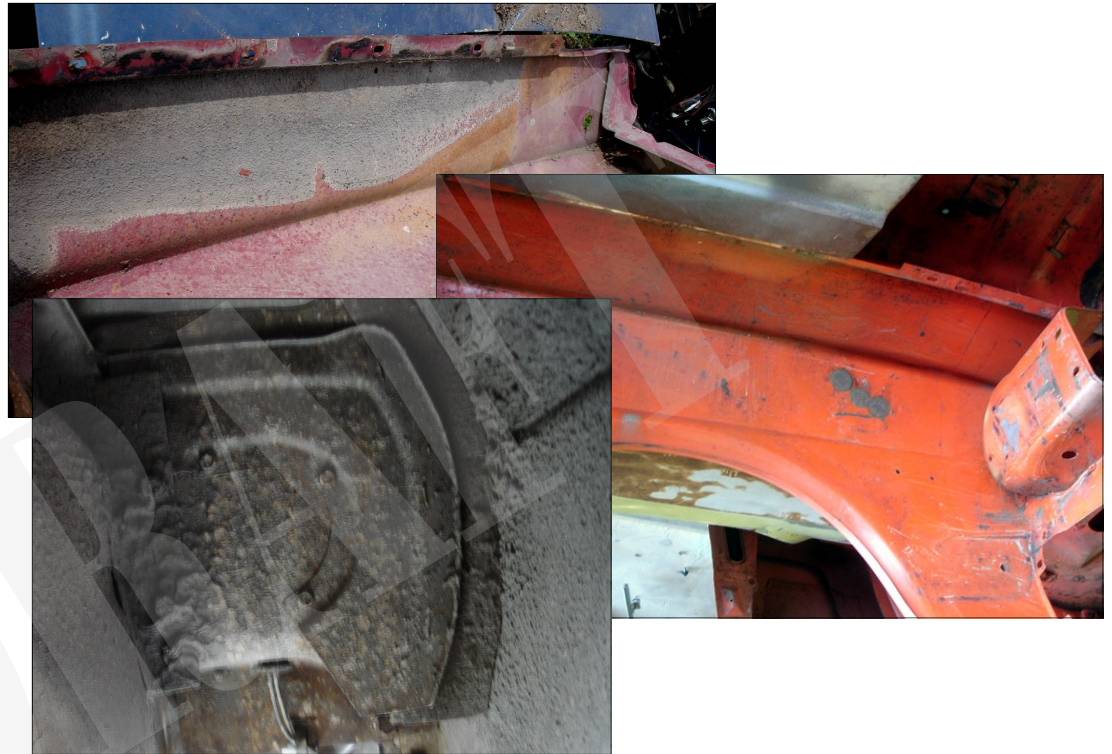
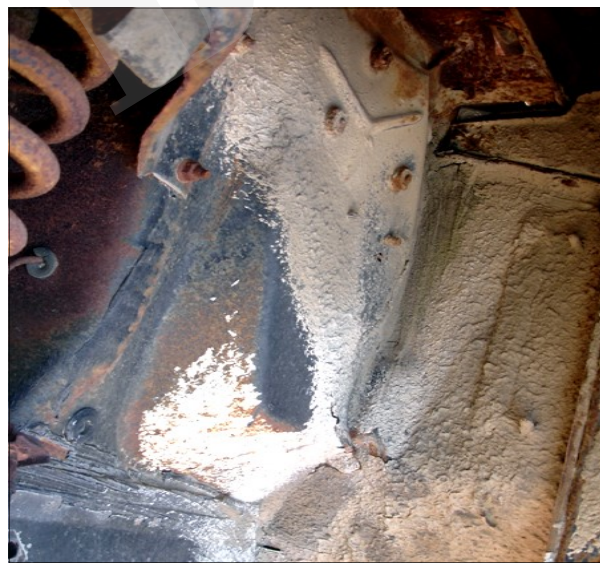
Front Wheel Well Sound Deadener Applied

Once the car was completely assembled (minus front wheels and tires) sound deadener was applied to the front wheel well. The amount and area covered depended completely on the specific worker that applied it and what they did that day. Application falls between a little and a lot with no real identifiable pattern. But all original examples show some on the rear splash shield, firewall section exposed in the wheel well, inner fender panels forward and rearward of the shock tower (normally at a minimum from the lower rear to the top rear edge of the shock/spring cover then from the forward top edge of the shock/spring cover forward and downward.) and finally on the front splash shield.

We often see examples where the bottom side of the fender received a single pass with the application wand but not all cars received this. The sound deadener shown in the two (lower center and right) pictures below has changed colors over time and with exposure to the elements and has turned an off-white in color but the contrast helps us see the areas originally coated in those examples. Originally it was much darker, as shown in the picture below far left.

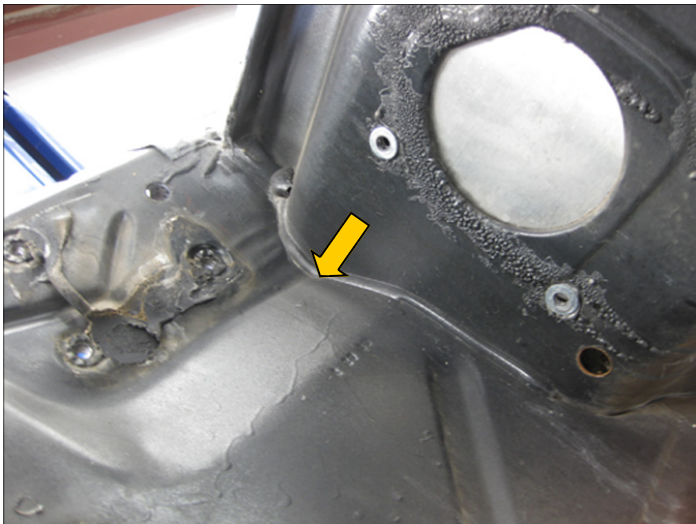
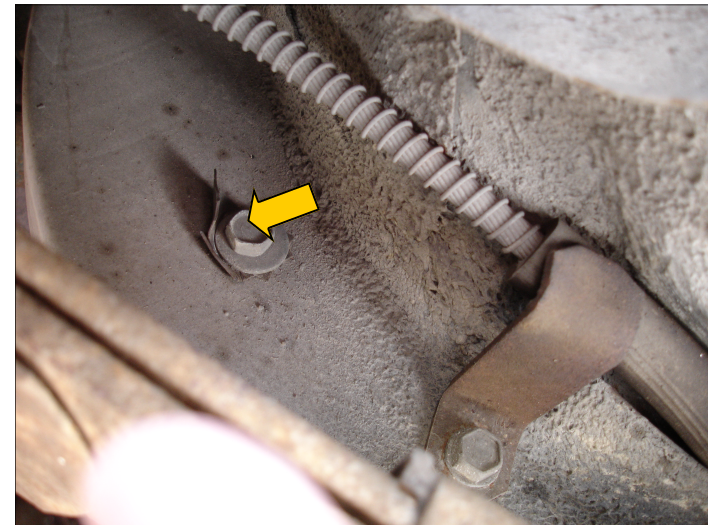
This bolt originally held a thin opaque plastic strap that held the emergency brake cable (one on each side) up and out of the way as the body was lowered onto the rearend. Once the rearend was in place the worker would reach up pull down on the emergency brake cable, breaking the strap, then install the end of the cable into the backing plate.

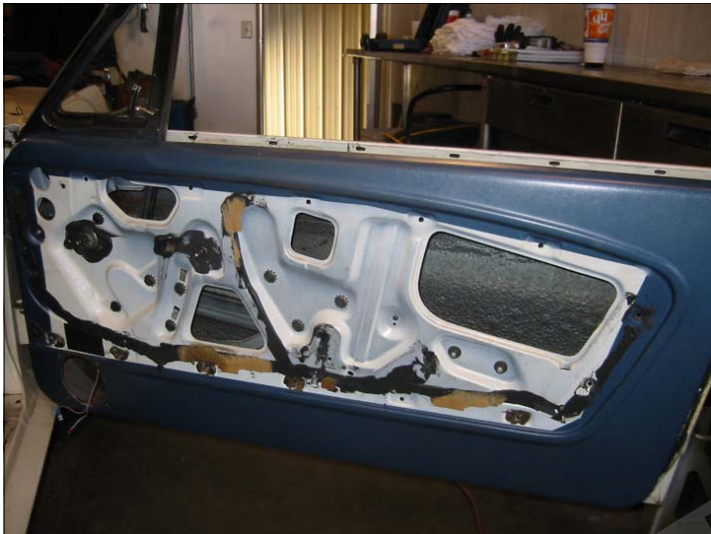
Inner door mask off pattern

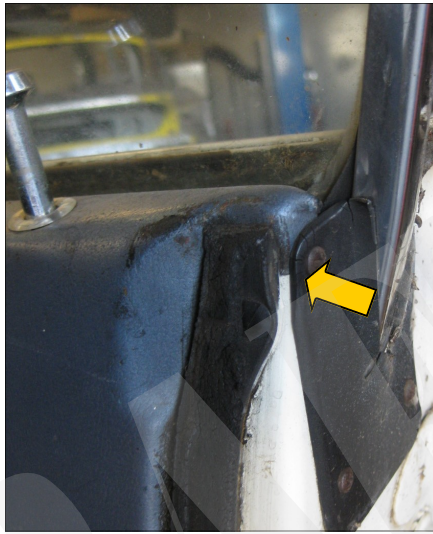
Upper door/interior paint detail

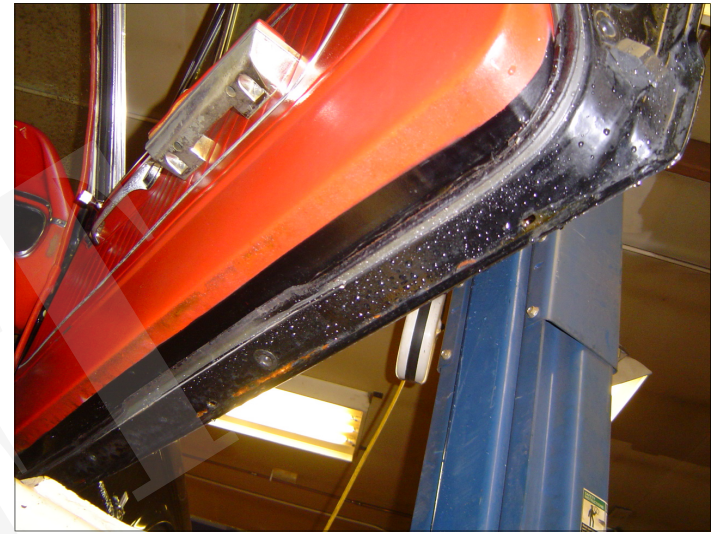
Bottom door edge paint break

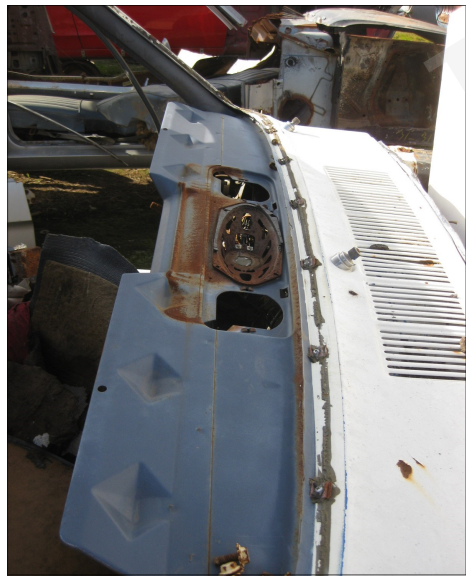
Interior/Dash paint details

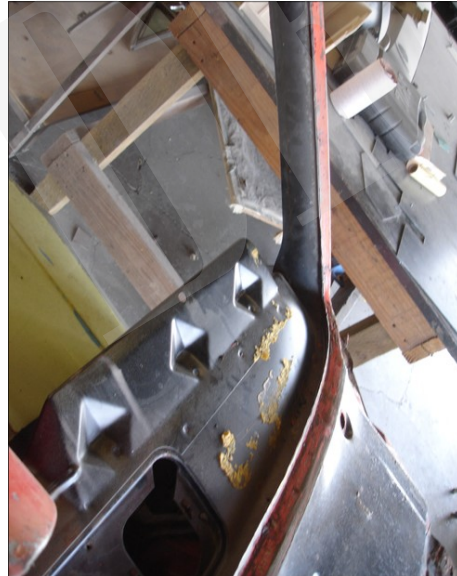
Interior/Dash paint details

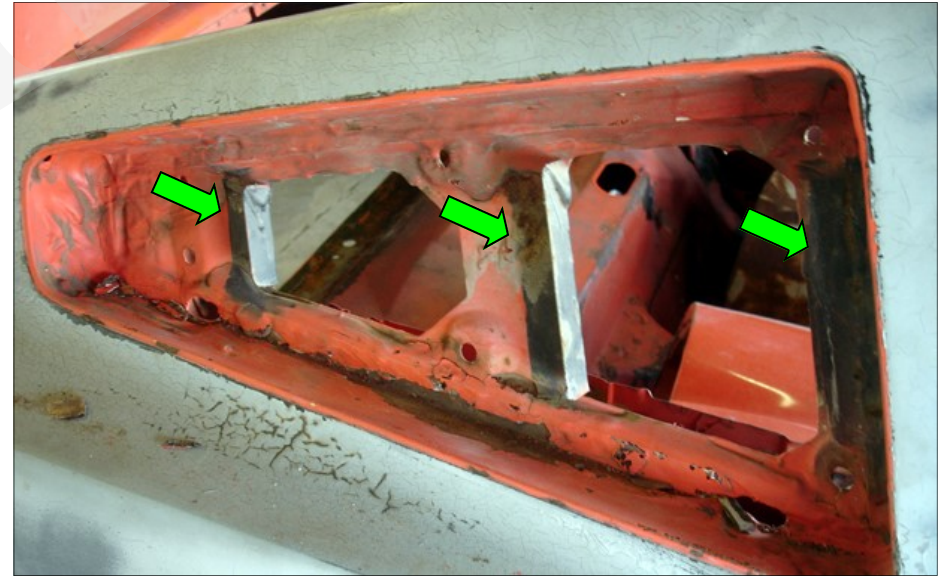
Fastback rear black out detail. What appears to be shadow is a blacked out area
Exterior has been repainted in this example but extractor area not repainted.

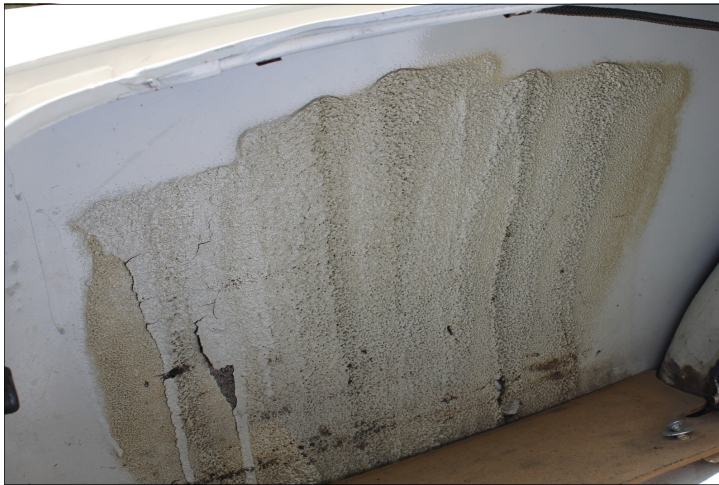
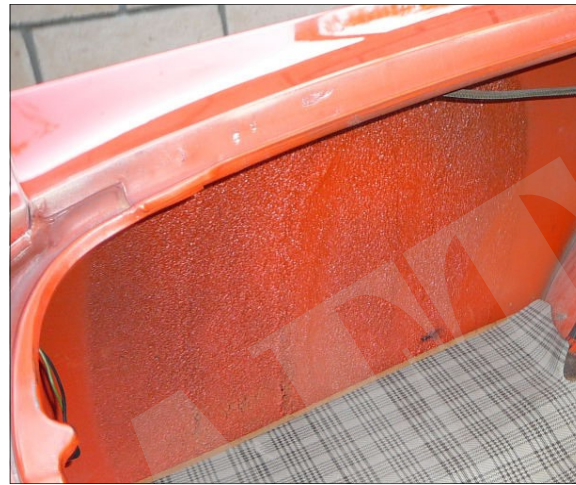
Trunk sound deadener and seam sealer application seal applied

Typical sound deadener application onto the inner surface of the quarter panels.

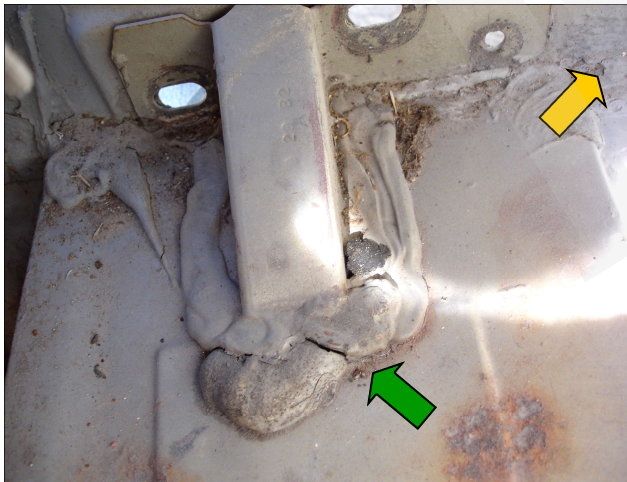
Yellow-Sealant applied then wiped with solvent rag

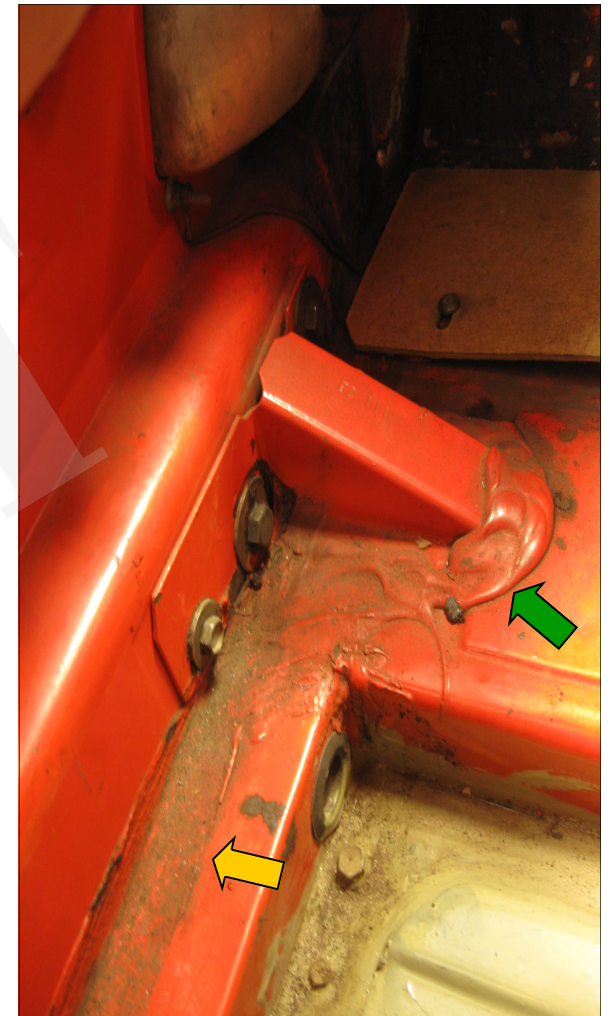
During periods of time in 65 production at San Jose the taillight panel to rear trunk floor seam sealant was applied much neater and did not require nor get, spread out with a rag as the one in the picture (yellow arrow) was. Instead a neat 1/2" bead is found.
