Restoration Support 65 San Jose Unibody (Undercarriage)

This is an ongoing project of mine I expect to be continually updating as new information is documented, studied and discovered.

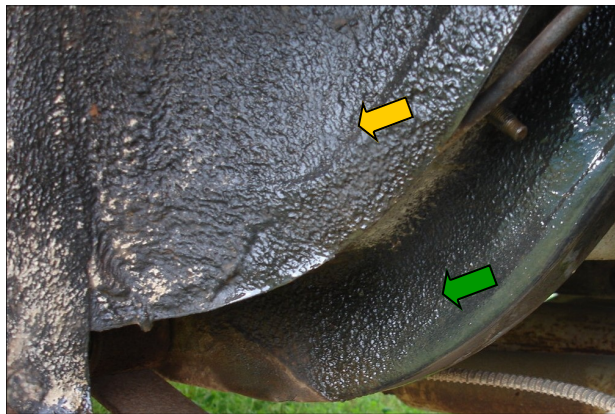
Yellow-Example of sound deadener - Typical application

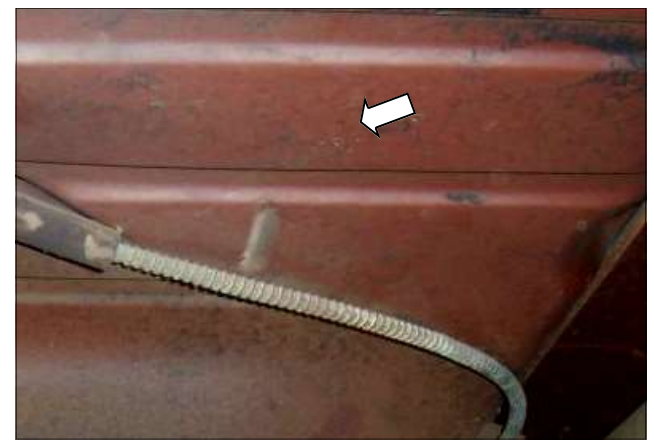
Example of overall finish

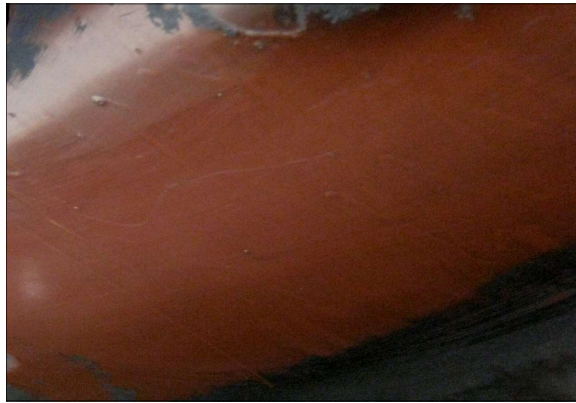
Examples of red oxide to muddy red oxide colored floor coating.

As mentioned in the text section of this article the color and tint of the epoxy primer sealer applied to the unibody from approximately the firewall rearward during 65 San Jose production varied during the year. These patterns related to specific production periods at the plant. Because there are no records of specific fates any of these cars were finally completed its impossible to determine the exact color each was coated one but predictions can be made from the data collected. The colors shown in the accompanying pictures should not be considered exact color matching samples but only for comparison purposes due to the differences in monitor settings, digital files, printer settings and other circumstances.

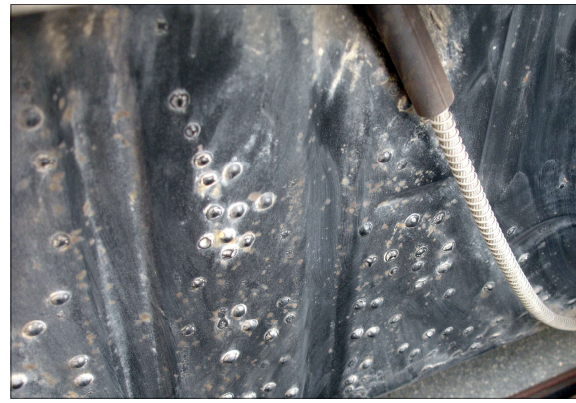
Examples of dark batch colored floor coating.

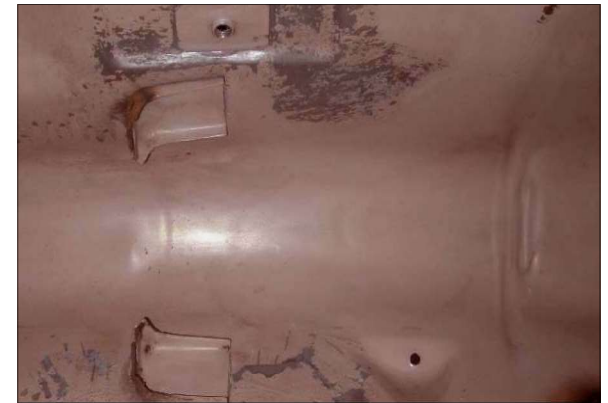
Examples of pinkish/salmon red oxide colored floor coating.

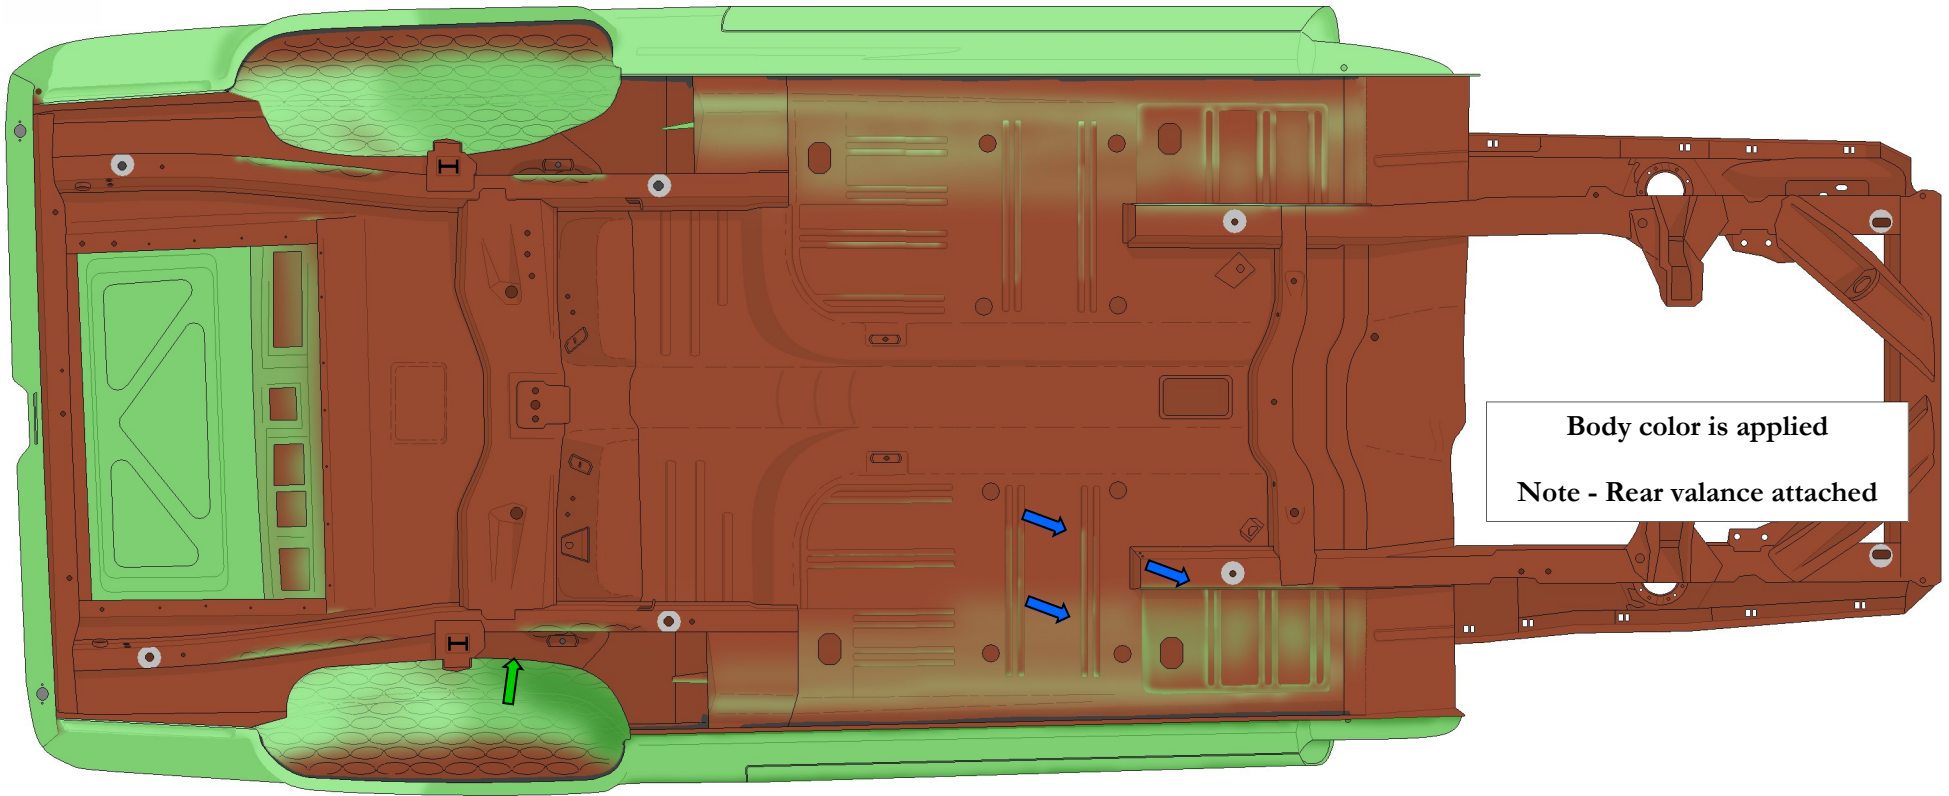
Body color is applied
 Note - Rear valance attached

- Rear valance was attached with two screws only at this point and allowed to hang from those points. Normally the screw holes used were typically the third one in from the ends of the rear valance. This is the one over where the bumper guard or exhaust tip on GT would be located. Because the screws were installed at two different stations typically you will find two different type of screws installed.

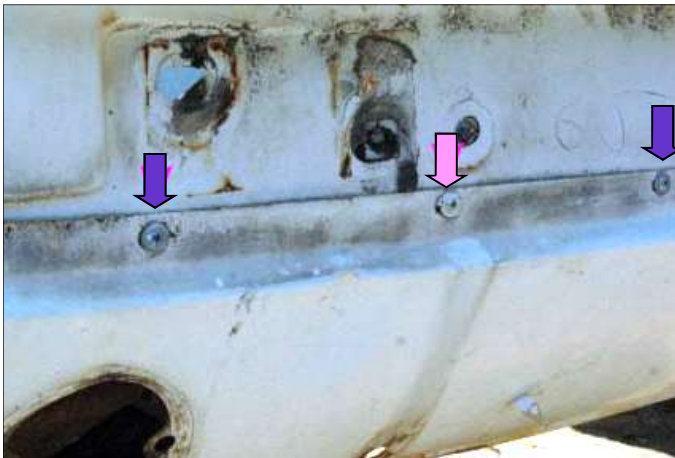
Rear valance hung by two screws (pink arrow) Others added after body color applied (Purple arrows)

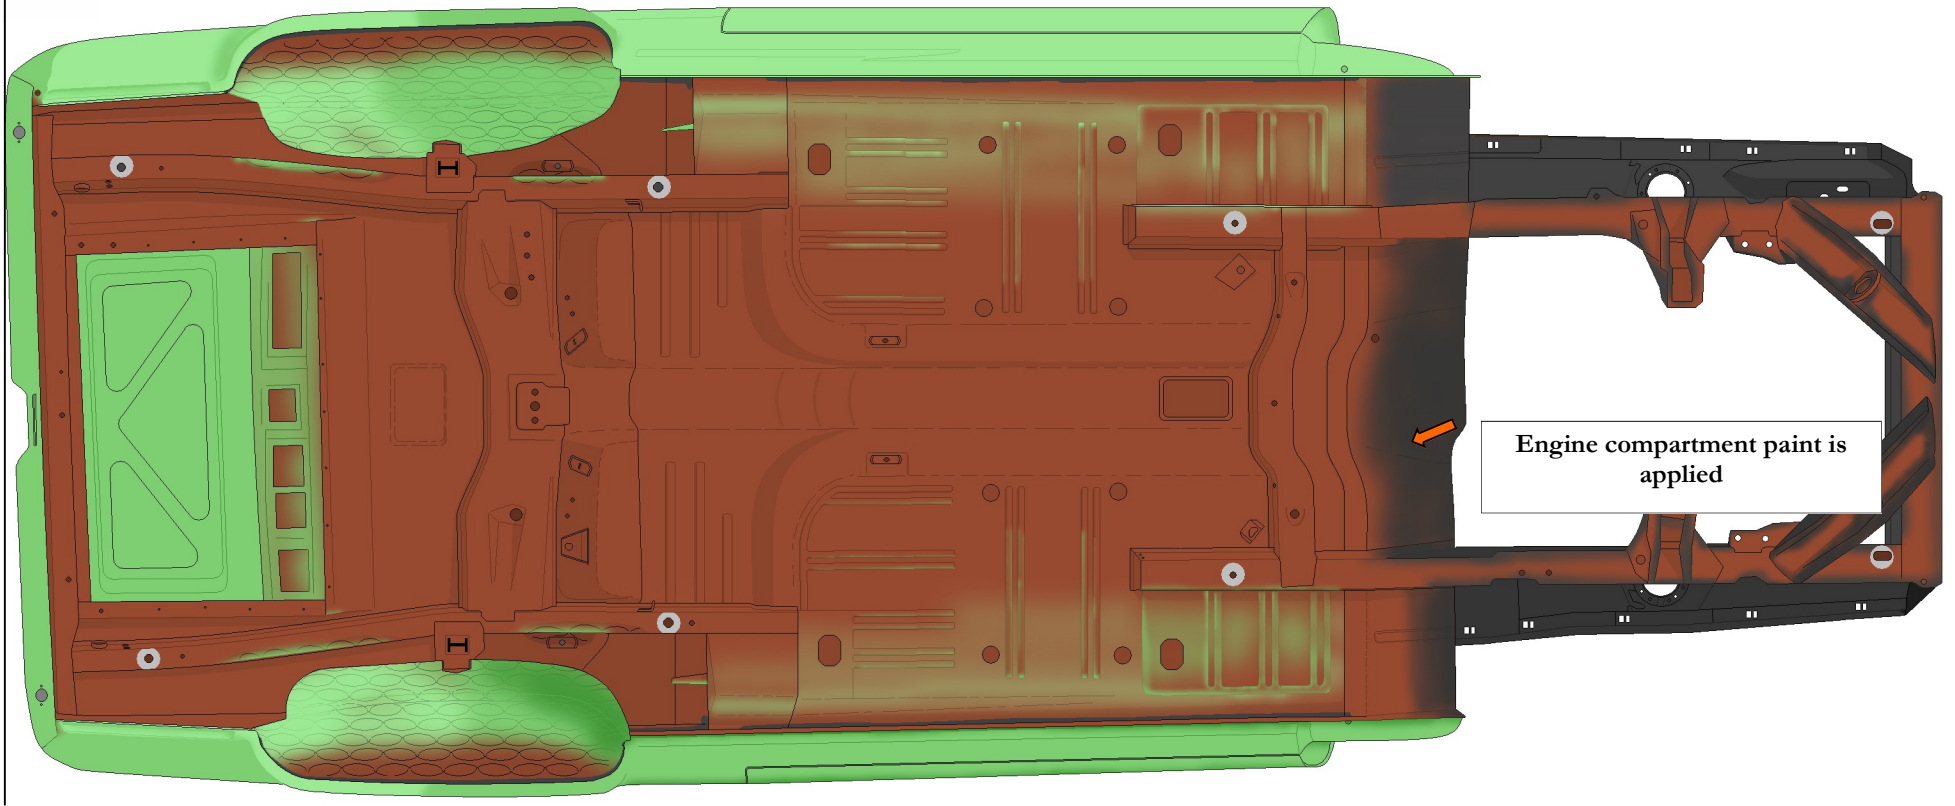
Engine compartment paint is applied

- Next, by hand, the front frame rails and the engine compartment walls were sprayed with red oxide colored epoxy primer from a second source separate from the floor color. This use of two different sources for the red epoxy primer often produced a visible difference that can be seen on original paint car.

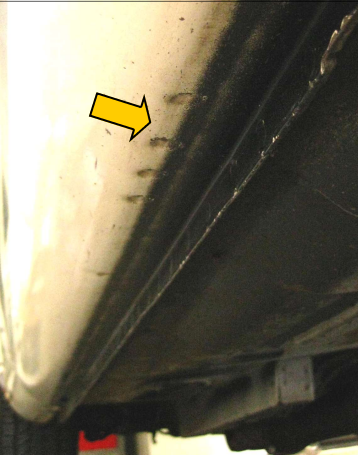
Rocker panel pinch weld black-out-often it is not this wide

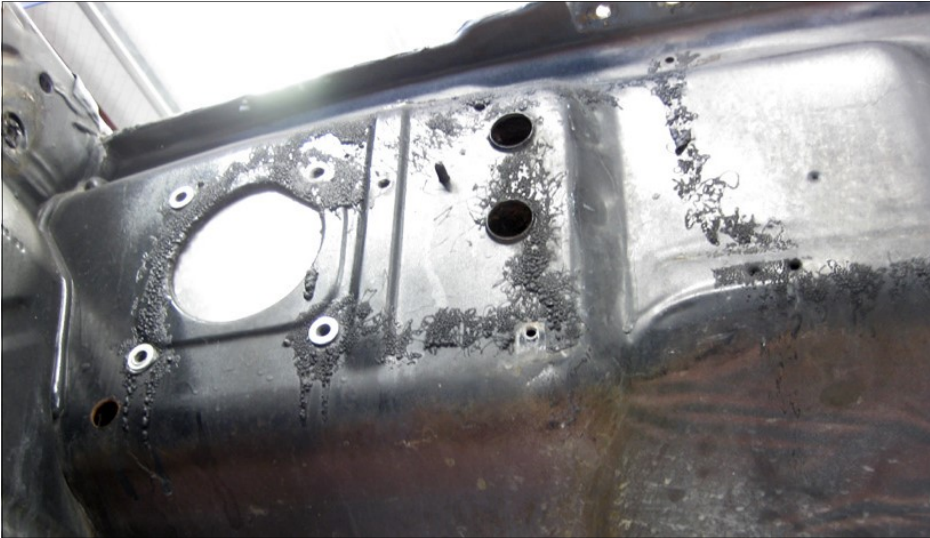
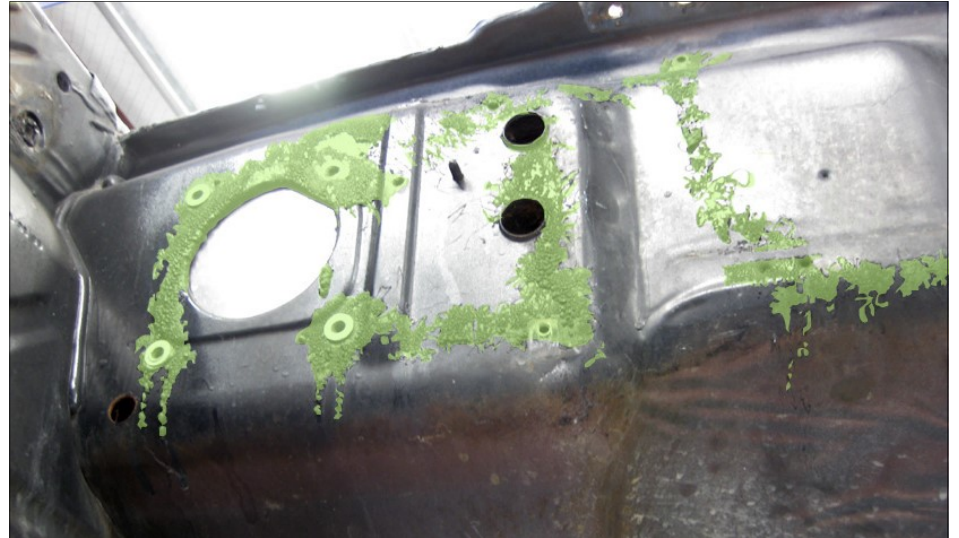
Firewall Sealant

Example of typical sealant applied at or around all firewall attachments and pass-through locations. On the right I've highlighted the spray pattern. As you can see the product is a very fine spray similar to what is produced with spray adhesive (adhesive was the term for Ford used for the product). Sealant applied in a continuous spray carried from point to point.

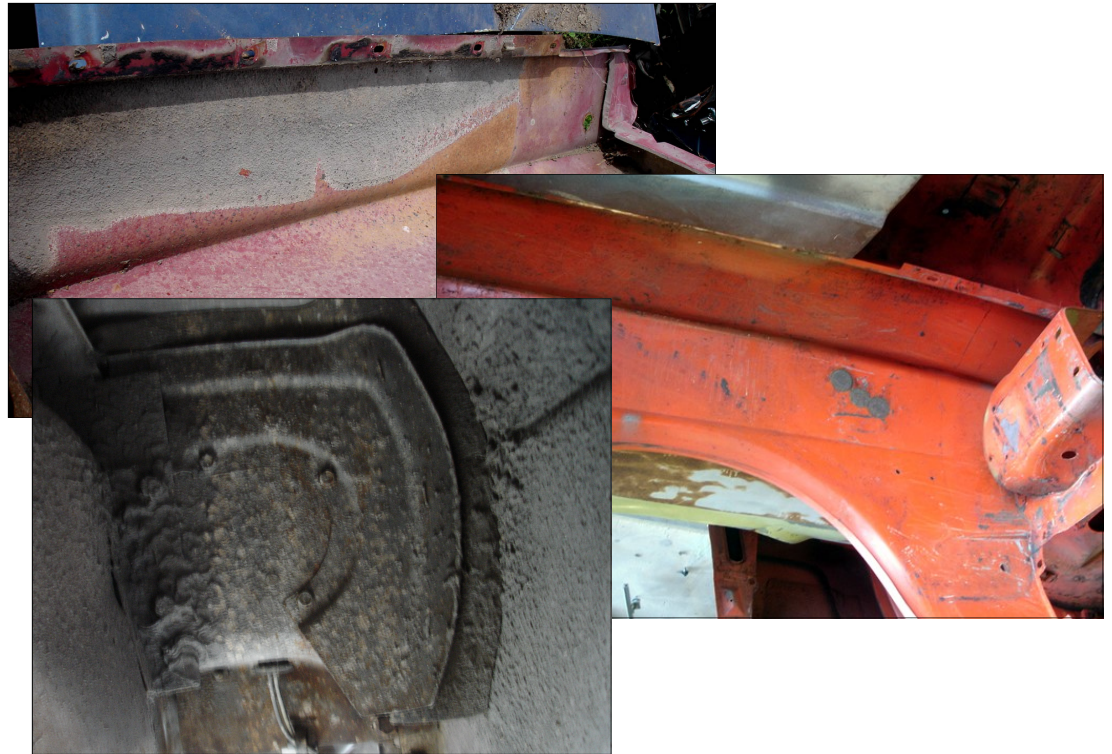
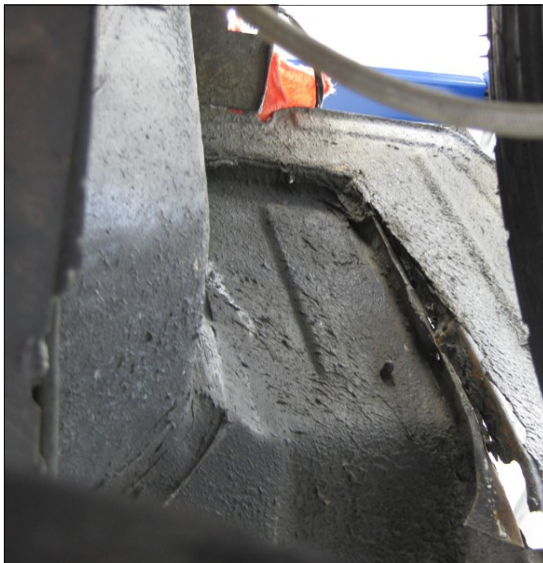
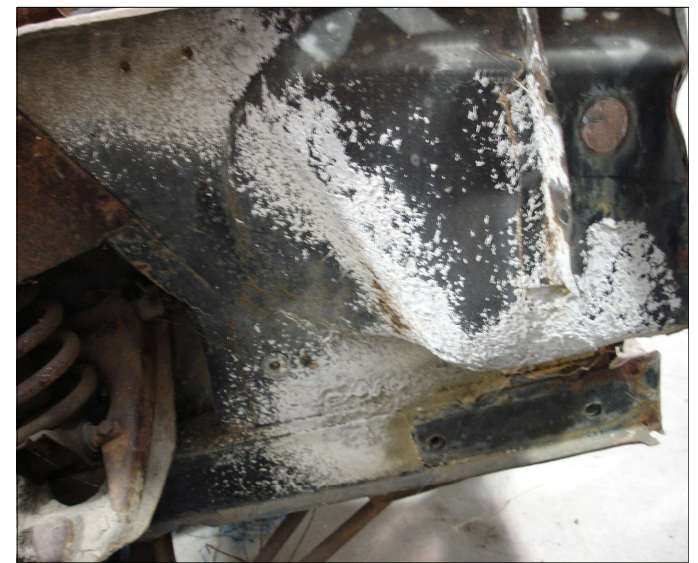
Front Wheel Well Sound Deadener Applied

Once the car was completely assembled (minus front wheels and tires) sound deadener was applied to the front wheel well. The amount and area covered depended completely on the specific worker that applied it and what they did that day. Application falls between a little and allot with no real identifiable pattern. But all original examples show some on the rear splash shield, firewall section exposed in the wheel well, inner fender panels forward and rearward of the shock tower (normally at a minimum from the lower rear to the top rear edge of the shock/spring cover then from the forward top edge of the shock/spring cover forward and down ward.) and finally on the front splash shield.

We often see examples were the bottom side of the fender received a single pass with the application wand but not all cars received this. The sound deadener shown in the two (lower center and right) pictures below has changed colors over time and with exposure to the elements and has turned an off white in color but the contrast helps us see the areas originally coated in those examples. Originally it was much darker, as shown in the picture below far left.

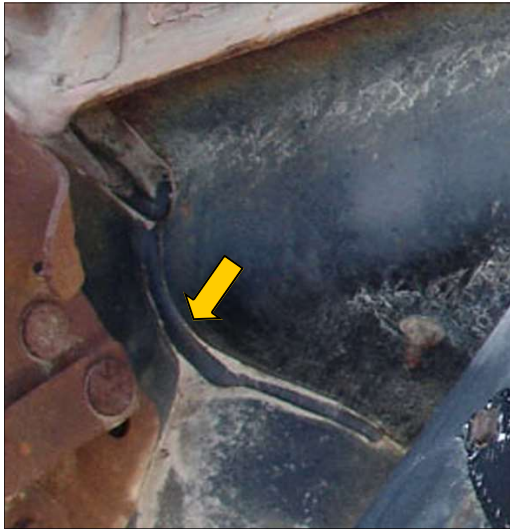
The strip of unsprayed chalking was typical along the passenger side of the firewall to rear inner fender panel seam. It normally stops midway down the seam and does not continue further. Likely due to reach issues as it was applied from above.

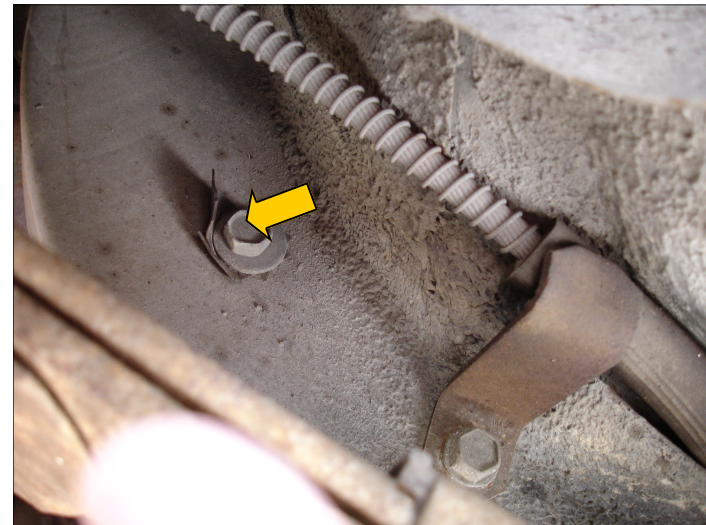
This bolt originally held a thin opaque plastic strap that held the emergency brake cable (one on each side) up and out of the way as the body was lowered onto the rearend. Once the rearend was in place the worker would reach up pull down on the emergency brake cable, breaking the strap, then install the end of the cable into the backing plate.

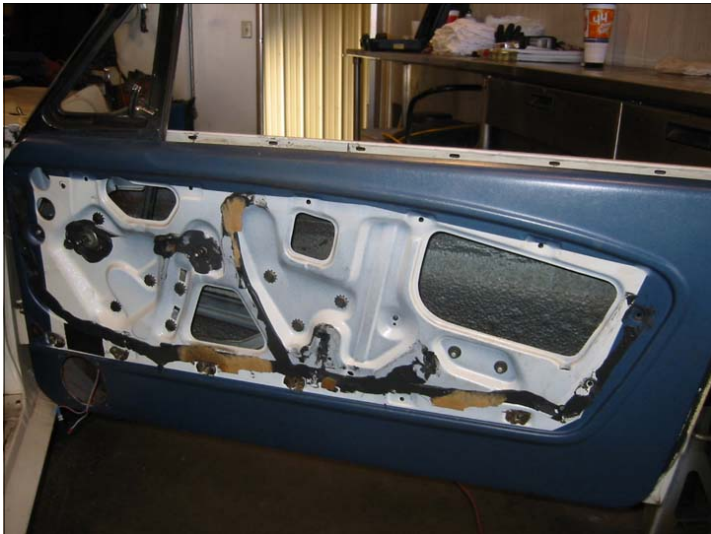
Inner door mask off pattern

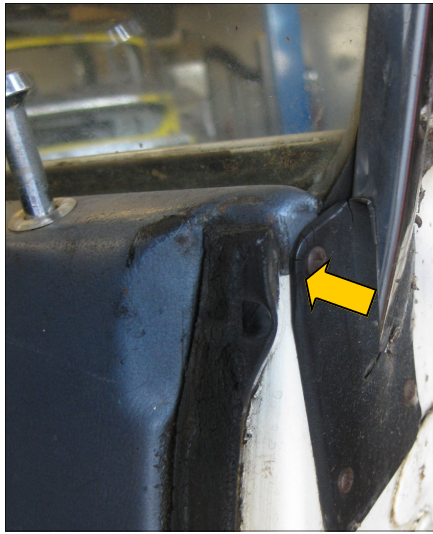
Upper door/interior paint detail

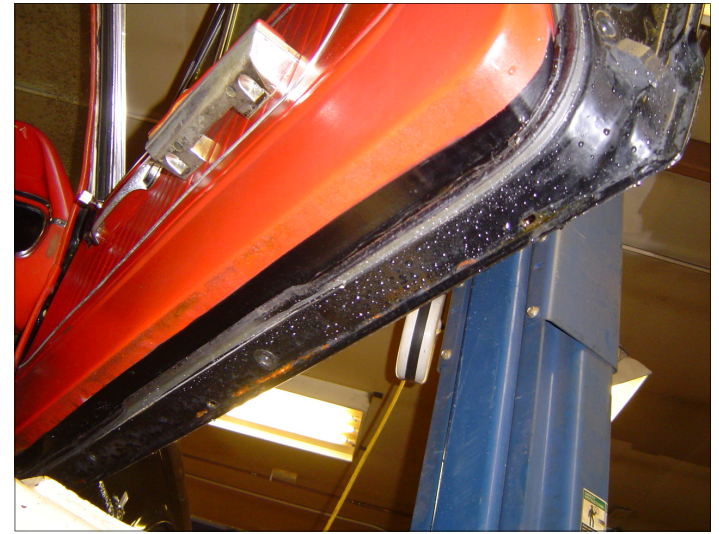
Bottom door edge paint break

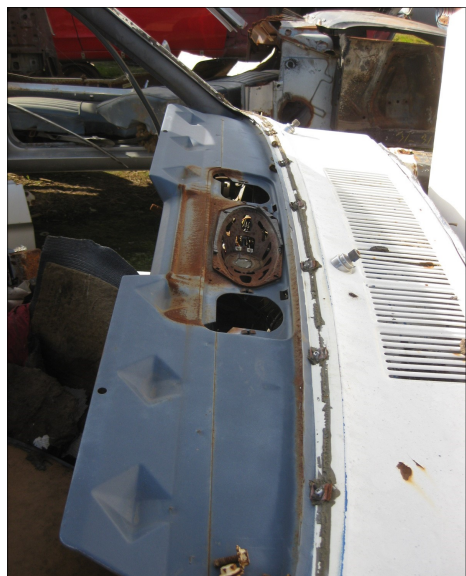
Interior/Dash paint details

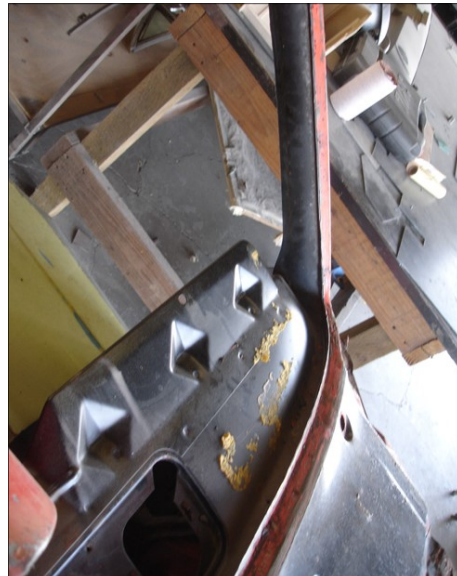
Interior/Dash paint details

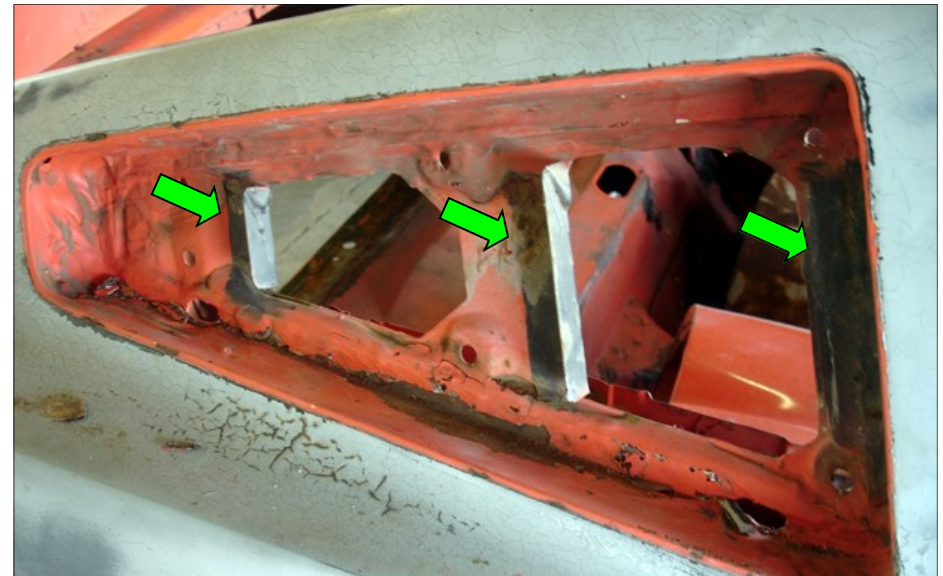
Fastback rear black out detail. What appears to be shadow is a blacked out area
Exterior has been repainted in this example but extractor area not repainted.

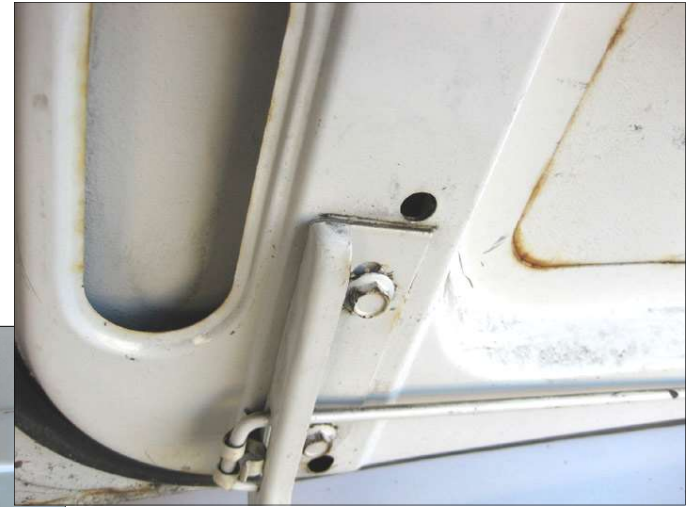
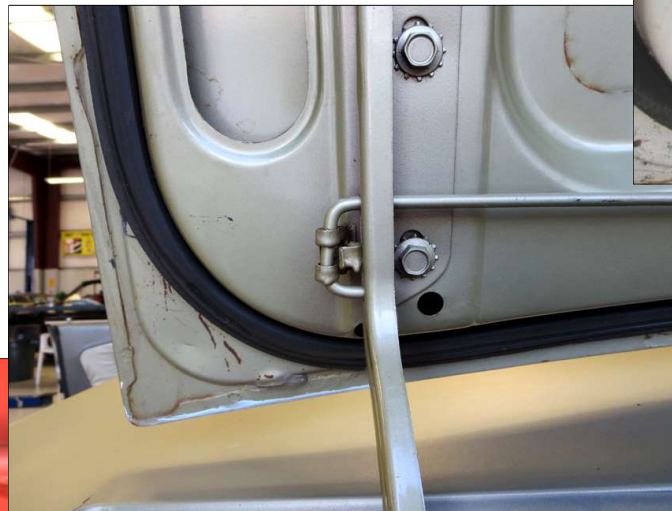
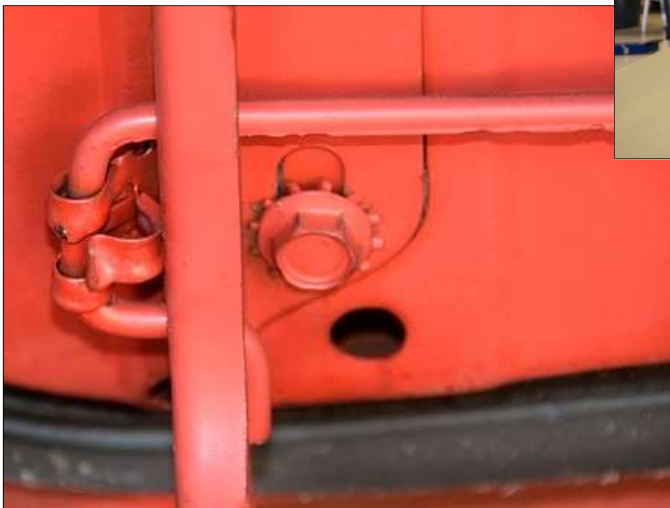
Miscellaneous Paint and Sealant Details

At San Jose on fastback models, workers placed on the trunk lid spring, an clip typically used to secure electrical wires to the body, to the driver's end of the spring. As shown in the pictures.

It's believed that this made the process of installing the trunk lid spring easier and kept the rod from falling out during the process. Because of this, the electrical clip was painted body color along with the surrounding metal as illustrated in the examples to the left. Original unrestored cars with this detail have been found. So far it appears this practice was done on cars built during October 1964 and was stopped sometime between January to March 1965.
