# Restoration Support 66 San Jose Unibody (Undercarriage)

*This is an ongoing project of mine I expect to be continually updating as new information is documented, studied and discovered.*

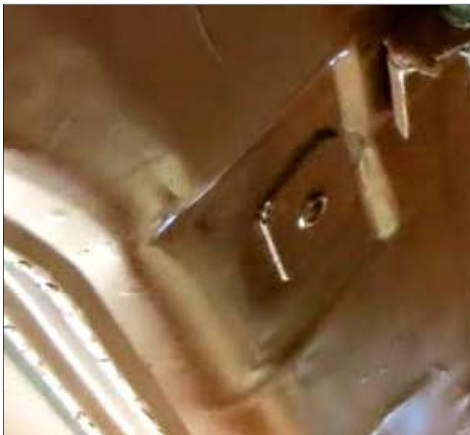
Front seat belt anchors without sealant.

There were periods of time at San Jose during the 1966 production run where the front inner seat belt anchors were sealed with a runny thinly sprayed on sealer applied before the floor color as applied as shown in the accompanying pictures on this page. At this time not pattern as to when this was done or not done have been established though earliest identified example with the spray sealant was from mid November. The final look, after the red oxide has been applied, often appears to be paint runs localized around the anchor.

- During much of the 1966 production at San Jose where the front inner seat belt anchors were sealed at this point with a thin runny sealant applied over and around the attachment bracket. Pattern has not been identified as to which cars did or didn't receive the sealant. Initial findings suggest that more cars were sealed than not sealed after mid October 1965. (Pg 5)

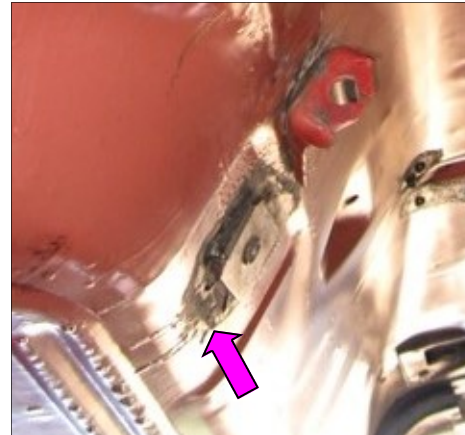
Front seat belt anchor with sealant. Top coat (red oxide) removed during cleaning

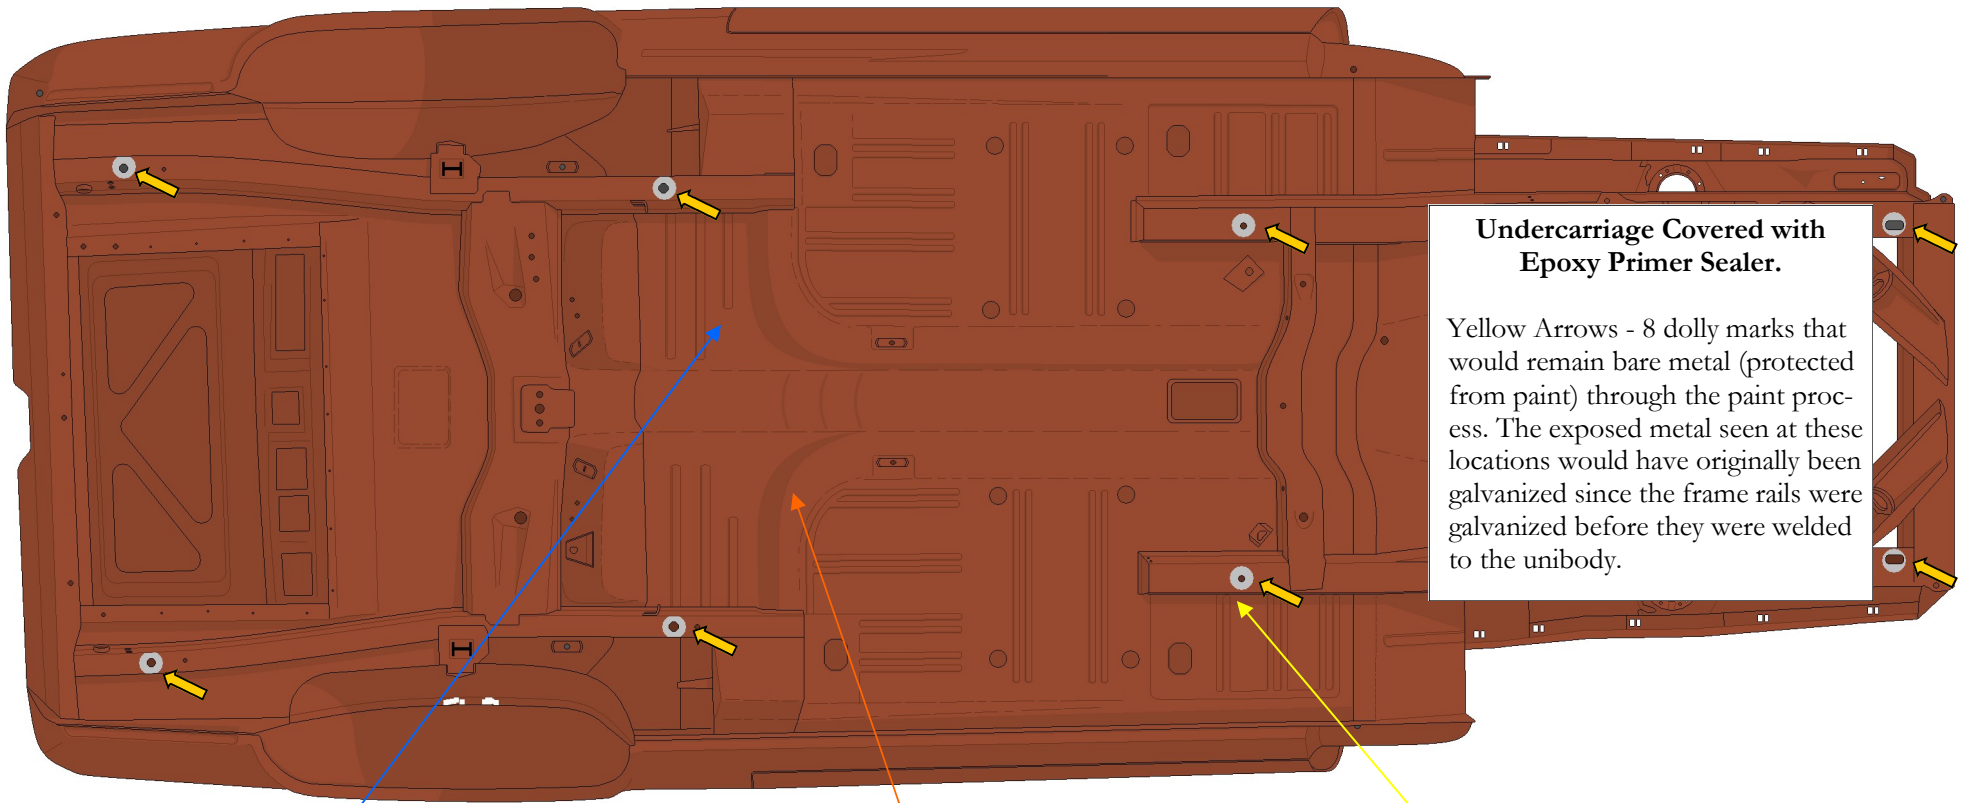
**Undercarriage Covered with Epoxy Primer Sealer.**

Yellow Arrows - 8 dolly marks that would remain bare metal (protected from paint) through the paint process. The exposed metal seen at these locations would have originally been galvanized since the frame rails were galvanized before they were welded to the unibody.

- Undercarriage is sprayed with a brownish red epoxy primer sealer in a slightly shiny (nothing like red oxide primer) final look. Color or tone appears to be more consistent through the year than what was found in 65 production at the same plant and can normally be seen as a reddish brown to muddy red, depending on time period though a period of pale red oxide color was applied near the beginning of the production year.

With the body sitting fairly level, red oxide epoxy primer sealer applied to the undersides of the car from firewall rearward, as it passed over a series of spray jets arranged below the track system the body traveled over. This application stopping approximately four inches short of the rear cross member. This process produced multiple runs to collect on the lowest

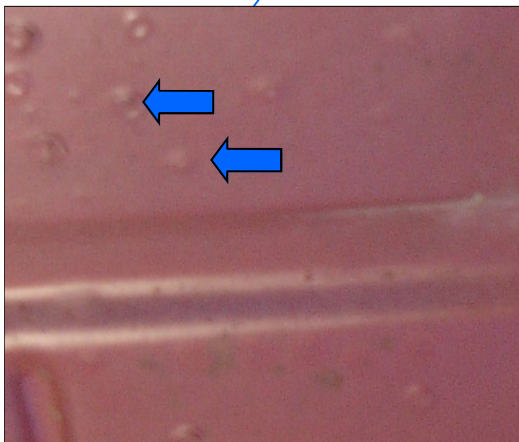
Heavy application produced drips in many areas

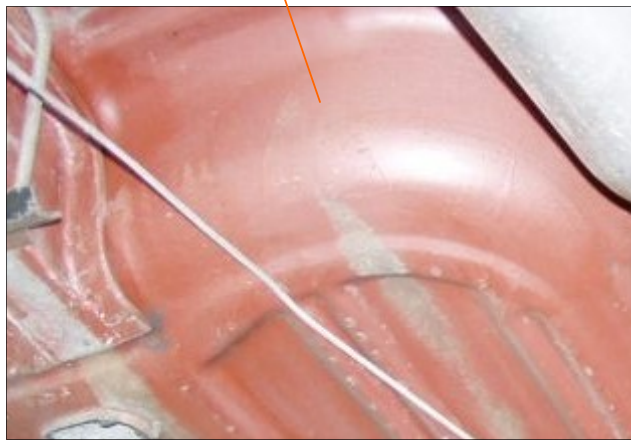
Example of overall finish

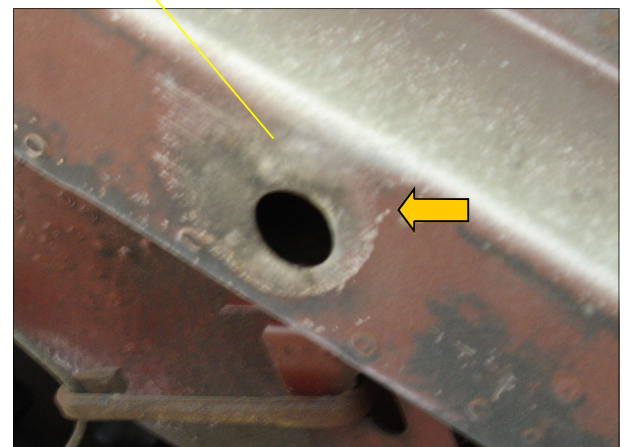
Example of dolly mark

- The unibody was assembled from subassemblies, on a pair of moving skids that were each attached at 4 different spots (8 total) to the body. Four of these attachments passed through the body and were tightened from above to hold the body tightly to the skids, in the interior and trunk areas, which produce round bare areas below the attachment fixture. Visible on a completed car from below, this process results in eight round sections (showing the galvanized metal of those panels) on the finished product. (Page 5)

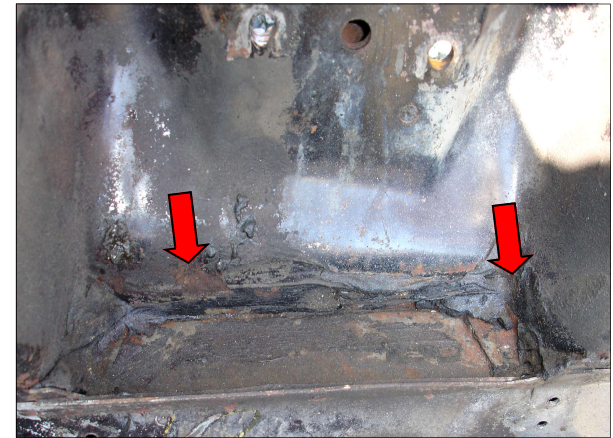
Red- A very thick application of sealer was applied to the valley at the base of the shock tower.

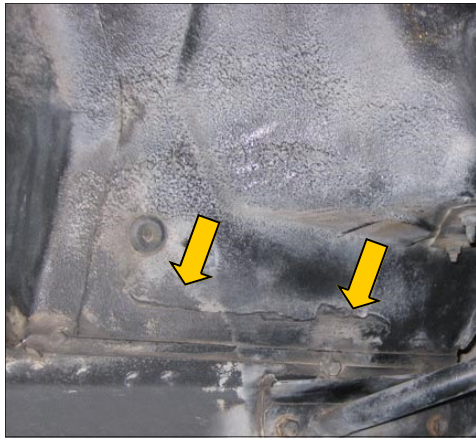
Yellow-Thinly applied, finished with brush along the inner to front frame seam. On late built cars this sealer was skipped and sealed during the sound deadener application step.

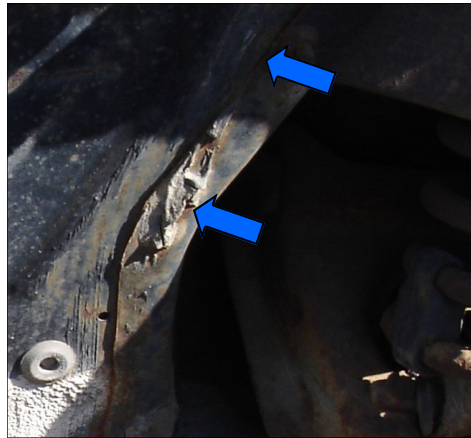
Blue-Very thinly applied along shock tower to inner joint. Was applied to only some of the cars built earlier in the production year.

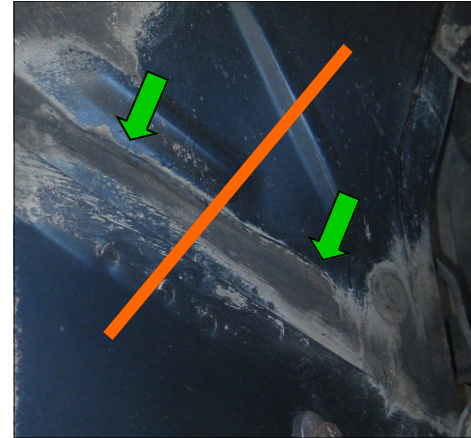
Green-Thinly applied, finished with brush along the inner to front frame seam. On late built cars this sealer was skipped and sealed during the sound deadener application step.

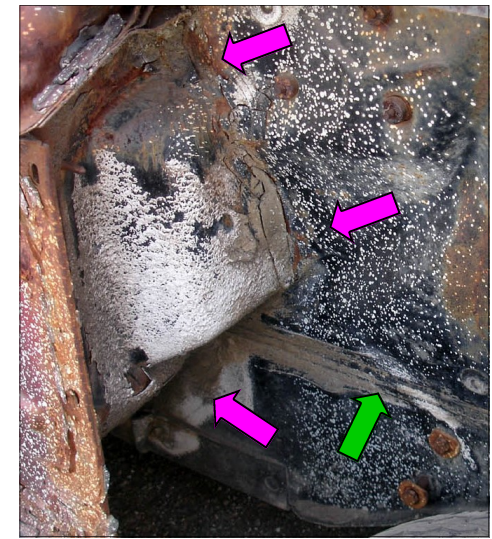
Purple-Heavy seam sealer application. Often filled corner between frame or inner panel to firewall/cowl panel

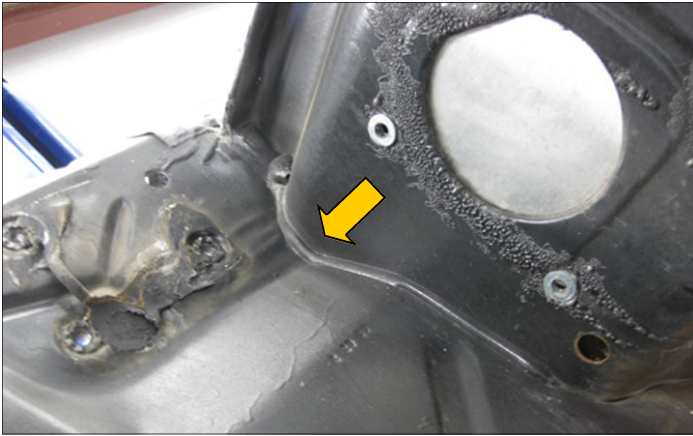
The strip of unsmeared chalking was typical along the passenger side of the firewall to rear inner fender panel seam. It normally stops midway down the seam and does not continue further. Likely due to access issues as it was applied from above.

- Seams sprayed and sound deadener applied in the interior area of the car
- Firewall (engine side) - Sealer applied from a chalking gun (not brushed) along the inner fender panel to firewall seam on passenger side.(Pg 8)

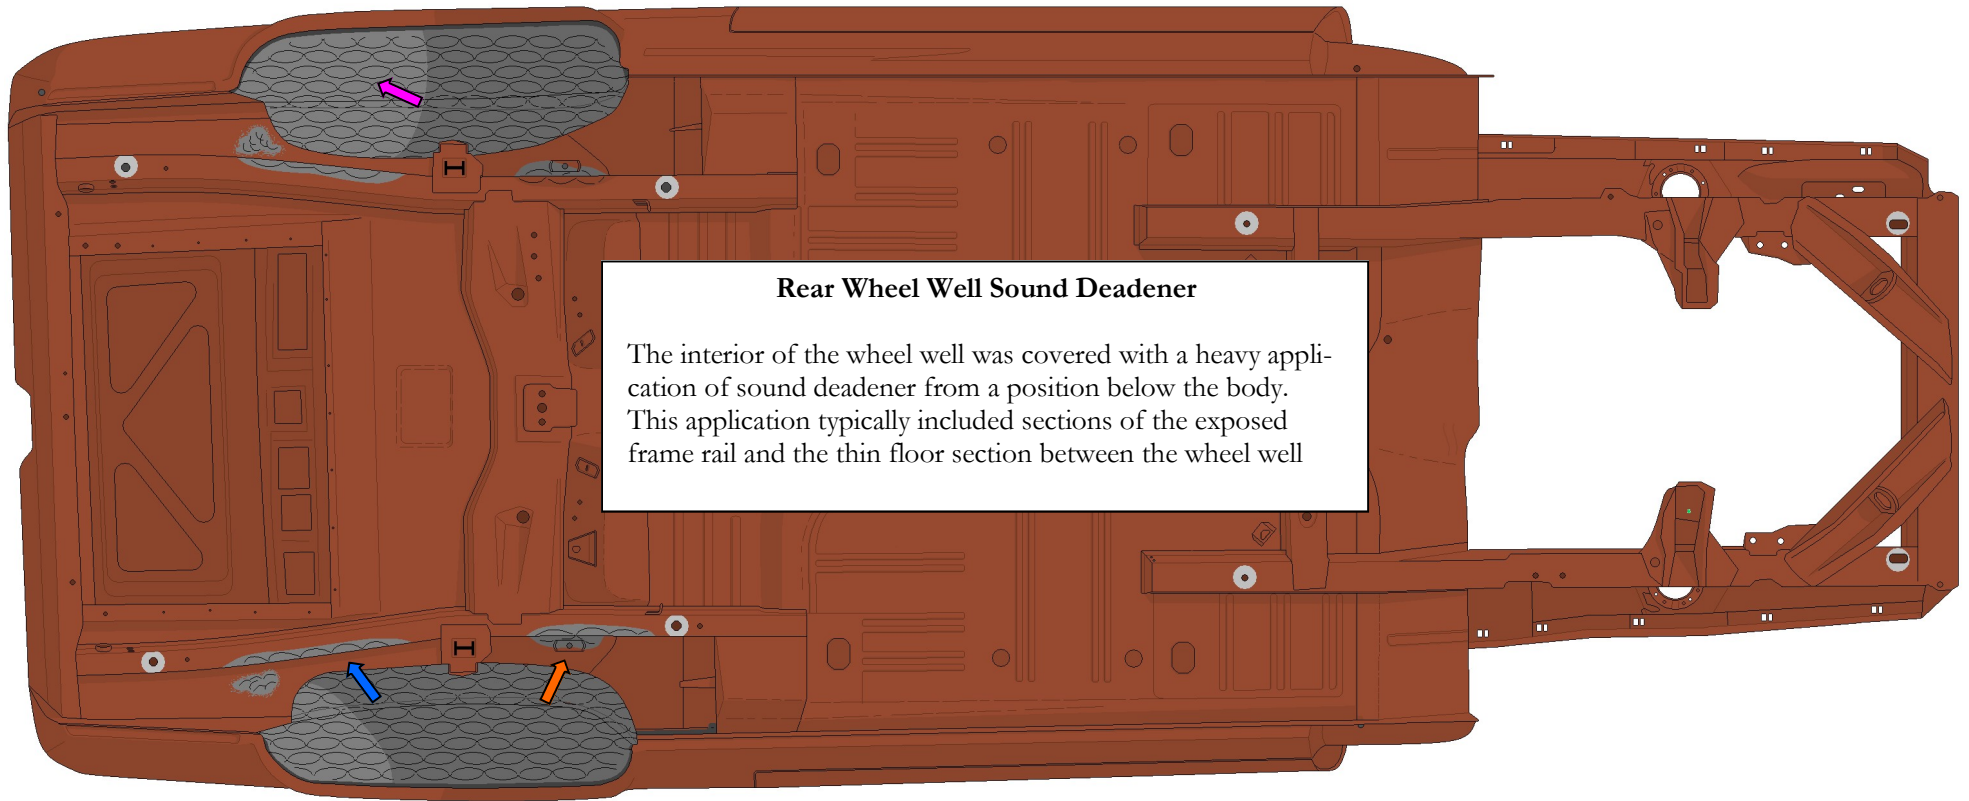
**Rear Wheel Well Sound Deadener**

The interior of the wheel well was covered with a heavy application of sound deadener from a position below the body. This application typically included sections of the exposed frame rail and the thin floor section between the wheel well

- Rear Wheel Well - In the rear wheel wells the sound deadener was applied by a worker standing below the body so overspray was common onto the small sections of floor between the frame rail and wheel housing panel lip as well as onto the frame rail in those areas. (Pg 9)

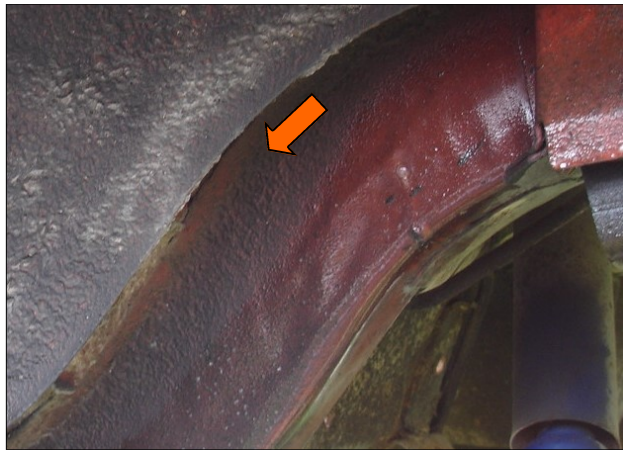
Visible sound deadener overspray on the frame rail though exterior paint has worn off.

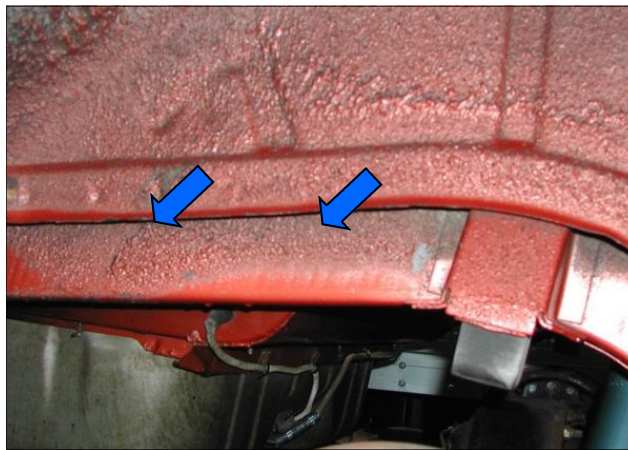
Another example of sound deadener and exterior color on frame and wheel well.

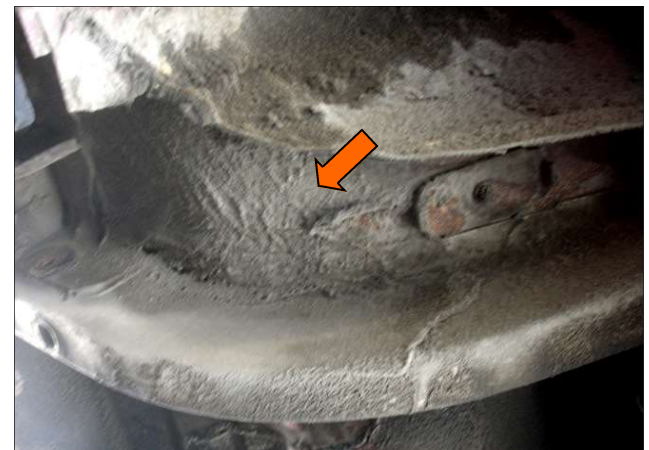
Heavy application on frame and floor section.

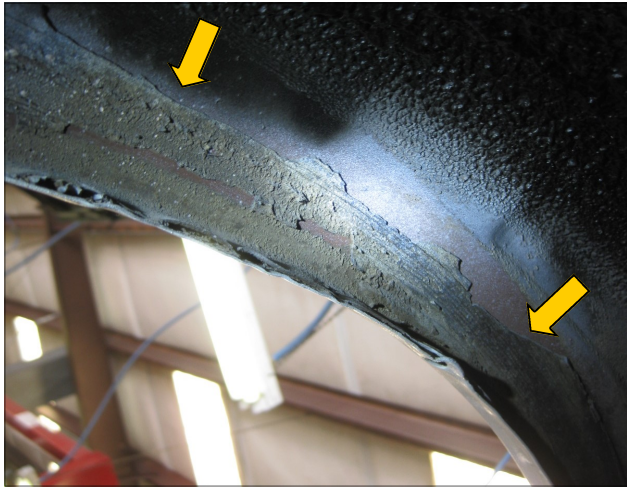
Example of lip sealant

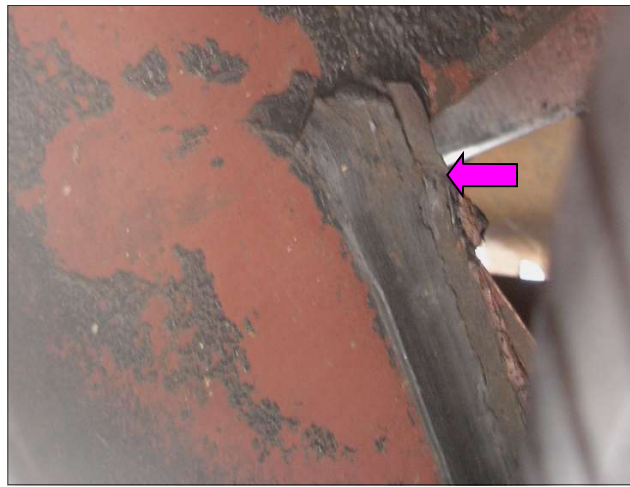
Rear wheel well to trunk drop seam seal paint removed

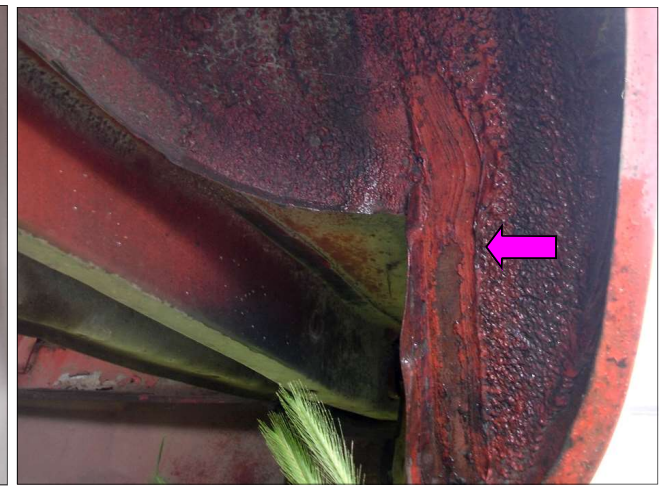
Rear wheel well to trunk drop seam seal

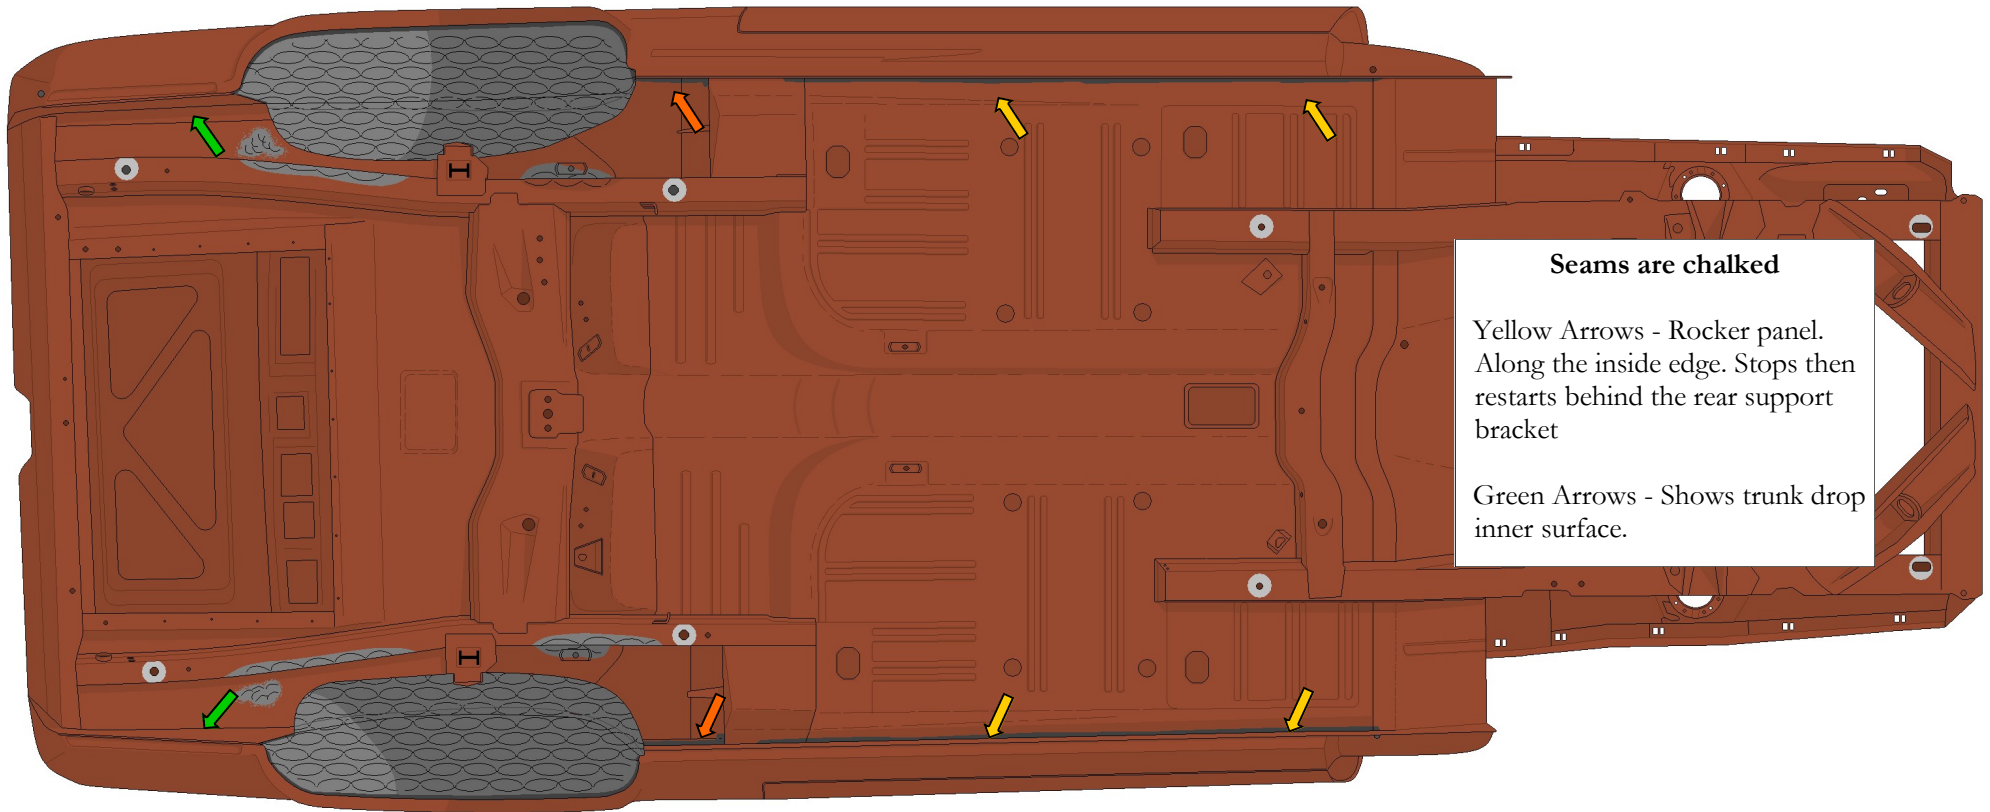
**Seams are chalked**

Yellow Arrows - Rocker panel. Along the inside edge. Stops then restarts behind the rear support bracket

Green Arrows - Shows trunk drop inner surface.

- Rocker to floor seam sealed with a wipe of black smooth sealant normally from the firewall panel to floor overlap joint to the rear spring front torque box to floor seam. Likely at about the same time the short outer wheel house to trunk drop seam was sealed with a thick wipe of the same black smooth sealant. (Pg 11) The sealant was applied between/on the seam between the floor and rocker panel. Typically 90% of the sealant was applied to the floor panel section of the joint.

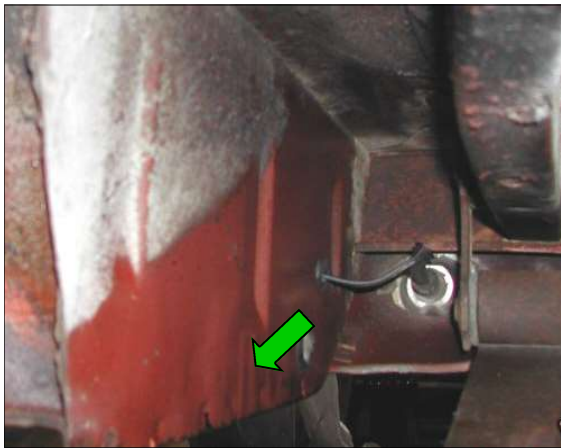
Trunk drop surface. No sealer at bottom edge

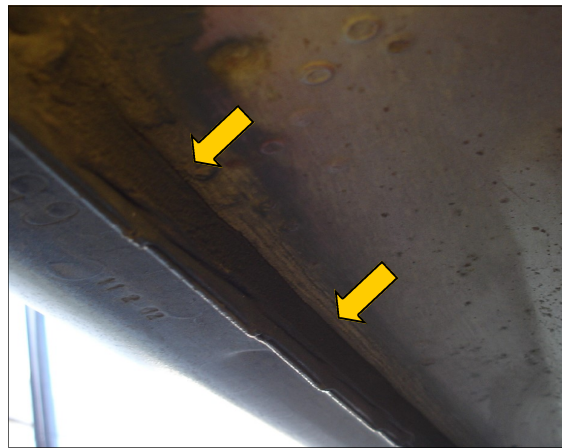
Rocker panel to floor seam chalking

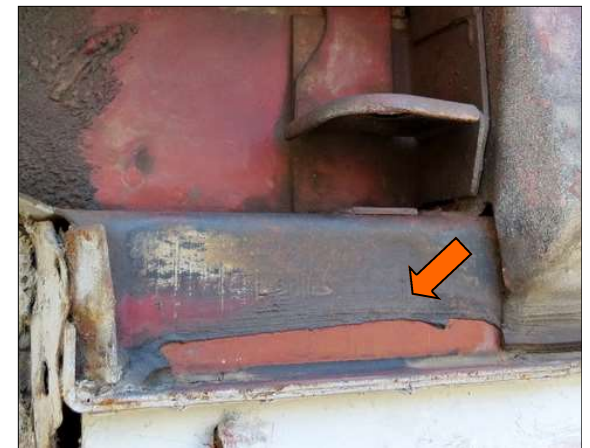
Convertible rocker panel to floor seam chalking

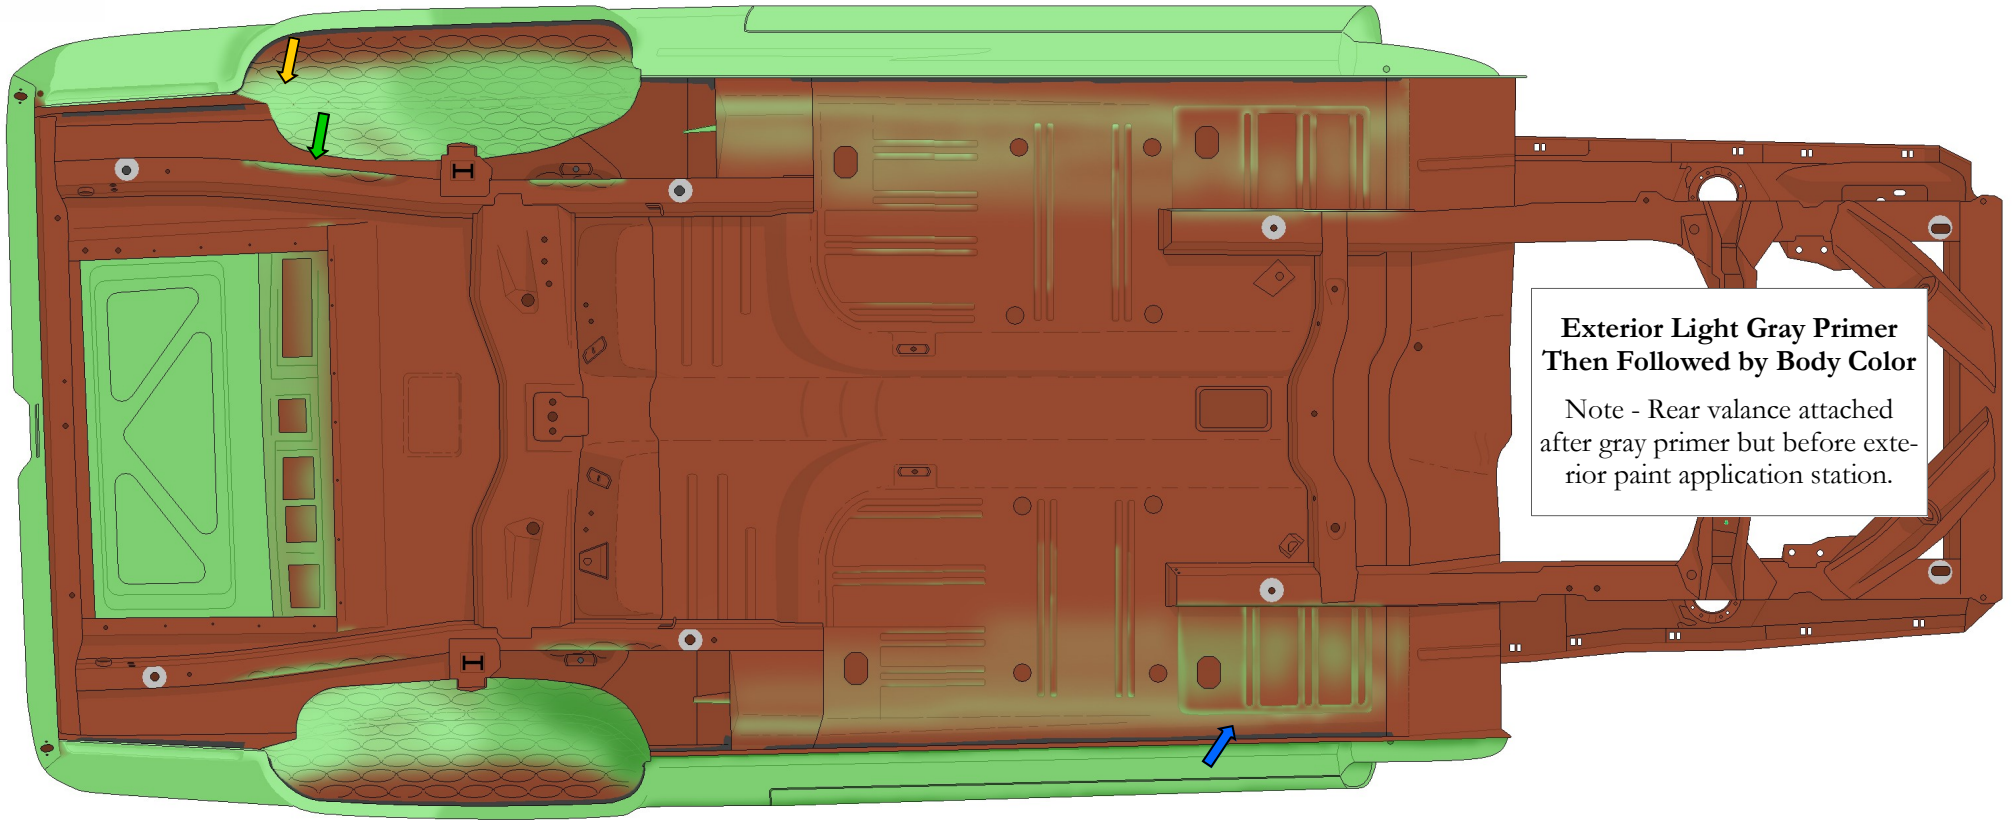
**Exterior Light Gray Primer  
Then Followed by Body Color**

Note - Rear valance attached  
after gray primer but before exterior  
paint application station.

- 5- Exterior body was next primed with a light gray surface primer. The painters focused mostly on the sides and upper body since that was the most visible surfaces. Little effort was made to coat the lower areas such as rocker panels and other panels so overspray is not typically found on the undercarriage or much in the rear wheel well, door jambs or trunk. (Pg 12)

- 8- Door jambs and exterior of the car were painted. (Pg 12) During this process, using the spray guns of the period, a fair amount of over spray and direct application ended up on areas other than the exterior body such as the interior of the car, the rear wheel wells, the bottom of the floors and undercarriage and any panels or details that hung down more than the surrounding ones. Front frame rails would be one example. This process pushed a lot of body color overspray onto the bottom surface of the floor pans and the panels over the rearend housing area.

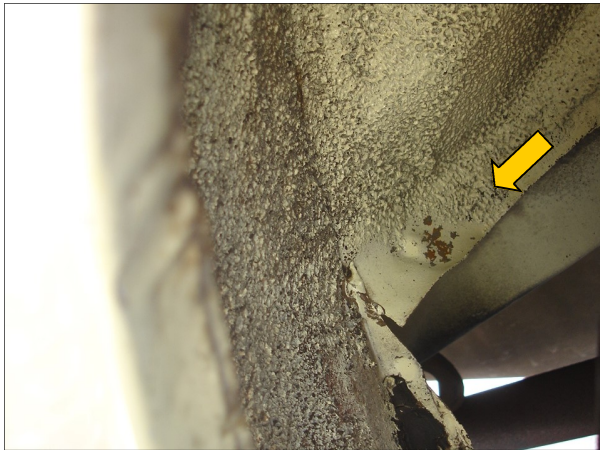
Example of amount of direct exterior color on the visible surface over sound deadener. In right picture

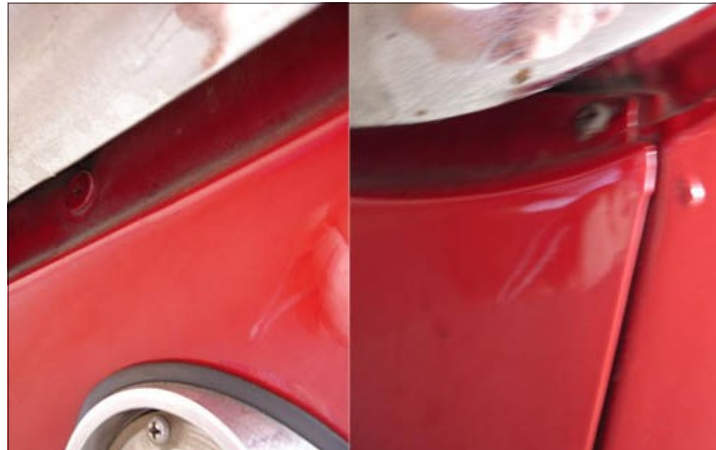
Example of the painted and unpainted screws holding the rear valance to the taillight panel on a later car.

- Rear bumper guard lower brackets were attached to the rear cross member and the rear valance was attached with two screws only at this point and allowed to hang from those points. Normally the screw holes used were typically the second or third one (most often the third) in from the ends of the rear valance. Type/style of mounting screw often differed between the two painted and the remaining screws as well as production period. Before this was done the rear bumper guard brackets were installed to the rear cross member and trunk surface.

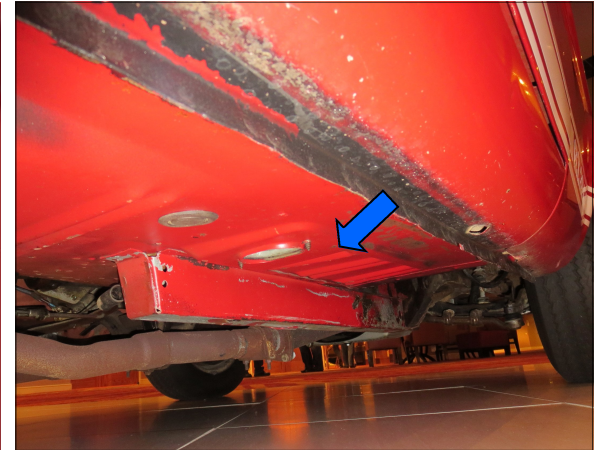
Example of a lot of body color

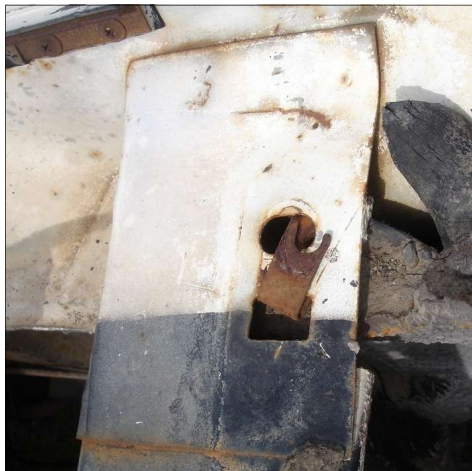
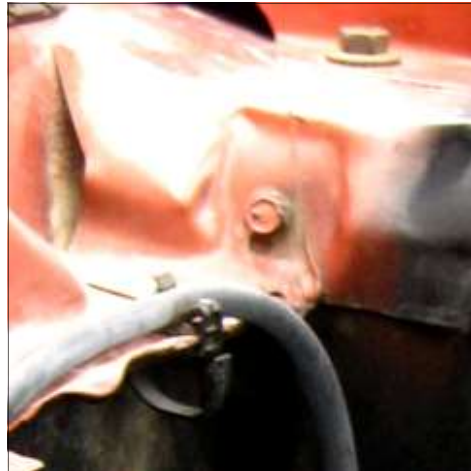
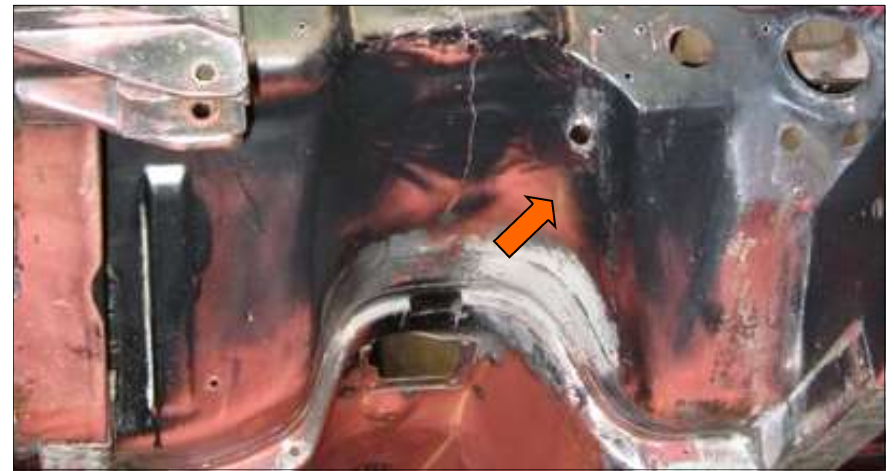
Typical location of black paint to cowl body color. Soft line/edge = not taped.  
Picture, above right, shows the post mid March painted splash shield screw.

Transition from floor pan area still shows the red oxide color with black over it.  
Amount of over and direct space could produce sharp shadows or smooth fading.

- Sometime during March of 1966 San Jose production, workers started installing the rear splash shields located in the front wheel prior to applying the exterior paint. This resulted in the inside upper mounting screw, visible from the engine compartment, being painted exterior color as it is often at or rearward the transition point between the exterior color and the engine compartment black. On earlier cars the visible screw head would not be painted except for possibly ( if the black was applied that far rearward) with black overspray. (Pg. 13 Lower left center picture)

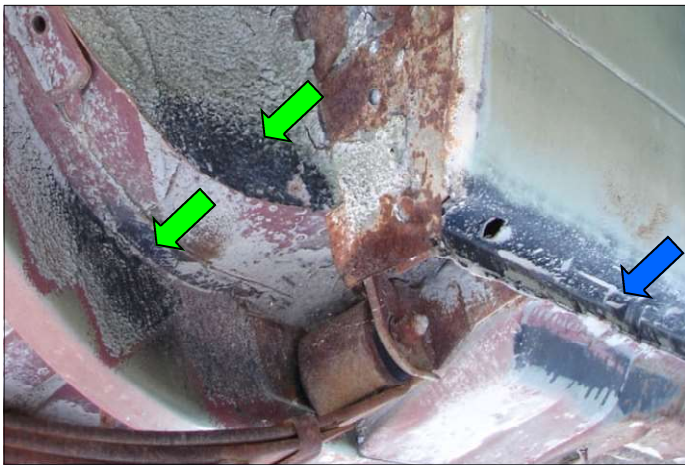
What is left of the pinch and rear wheel well black out

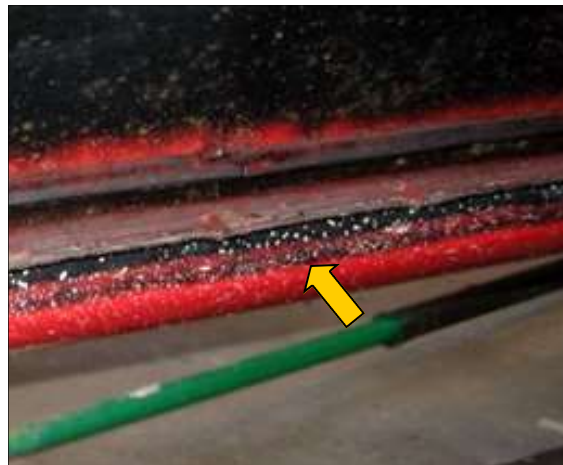
Rocker panel pinch weld blackout—often it is not as wide

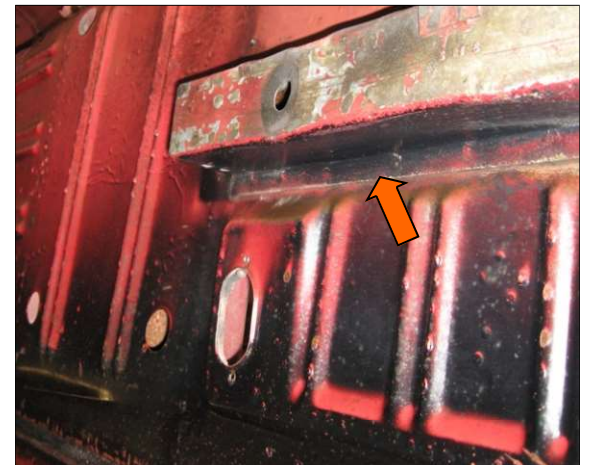
This car received a heavy (more overspray) coat close to the pinch weld likely due to paint gun angle

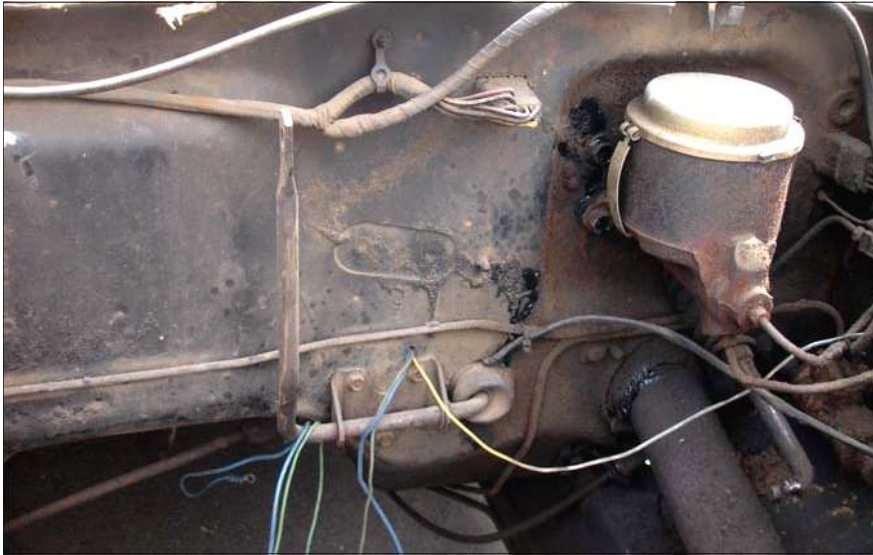
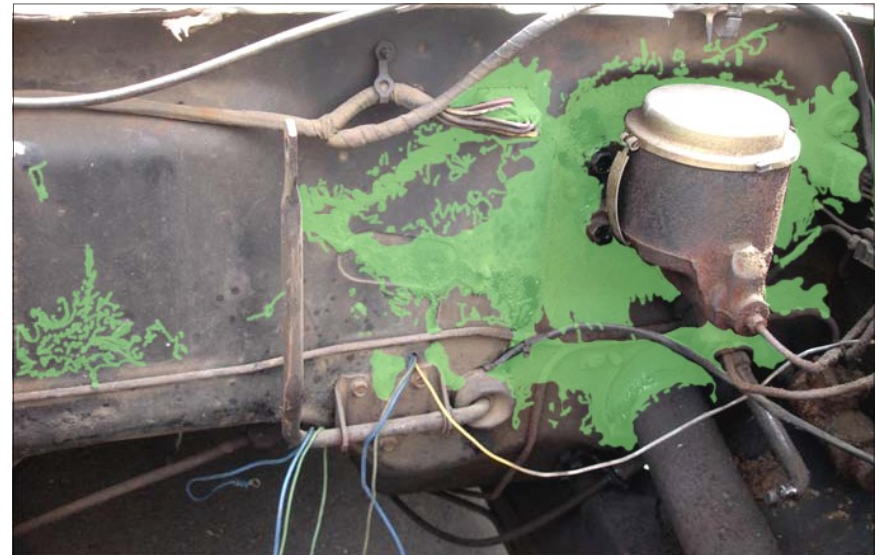
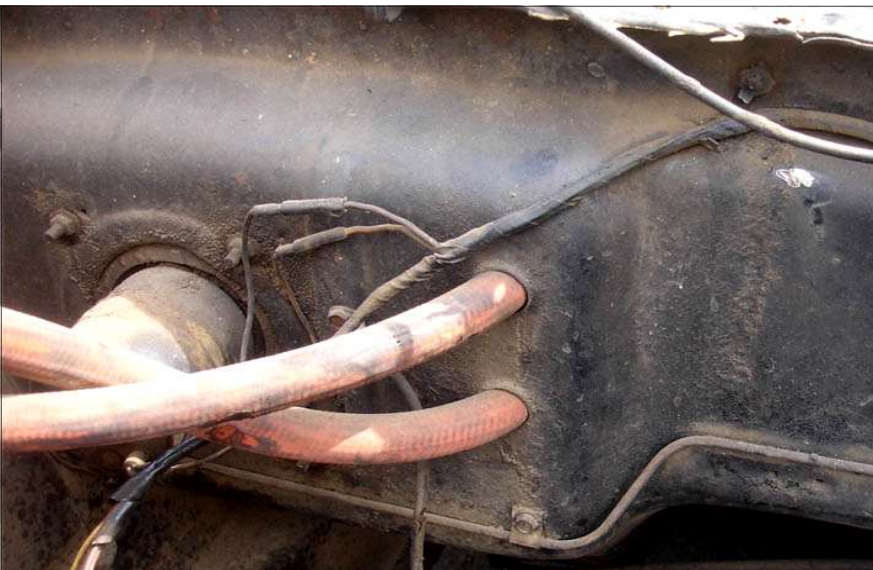
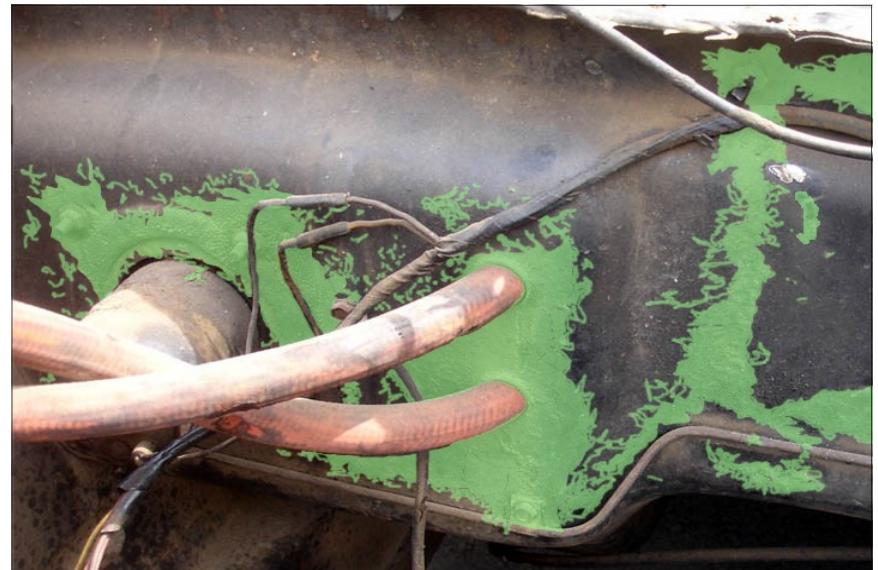
Example of typical sealant applied at or around all firewall attachments and pass-through locations (not engine ground). On the right I've highlighted the spray pattern. As you can see the product is a very fine spray similar to what is produced with spray adhesive (adhesive was the term for Ford used for the product) to a somewhat runny and thin undercoating later in the year.

Sealant normally applied in a continuous spray carried from point to point though the pattern between the target spots can vary from worker to worker..

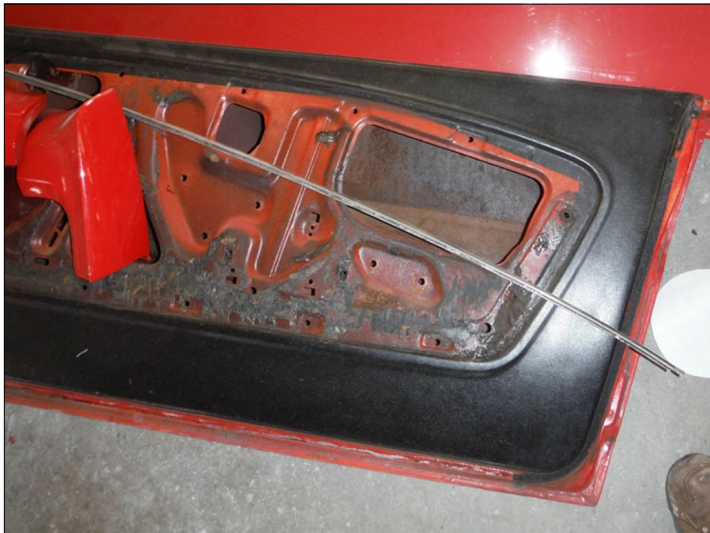
Inner door mask off pattern

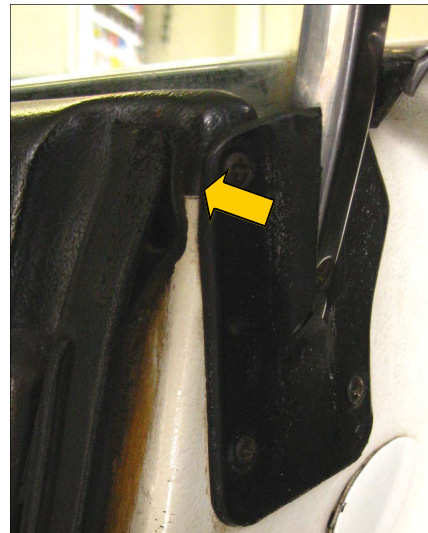
Upper door/interior paint detail

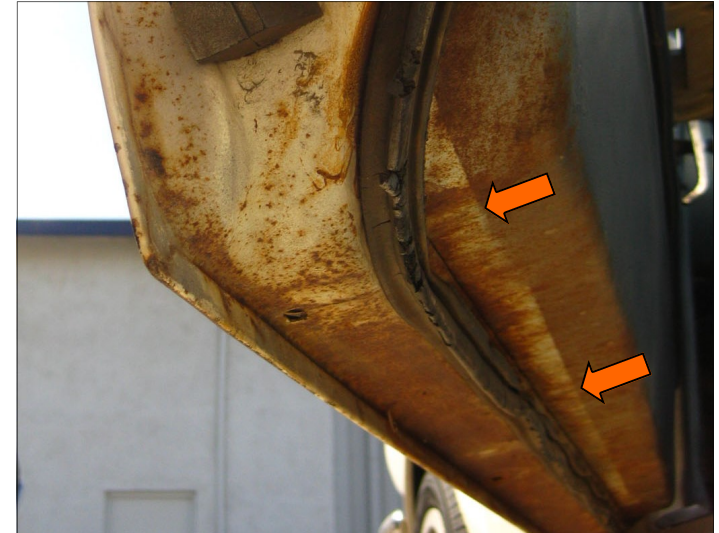
Bottom door edge paint break

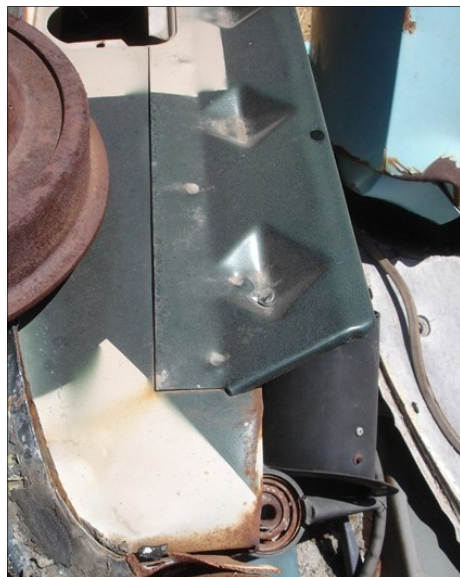
Dash paint details. Top coat green exterior over tan interior paint

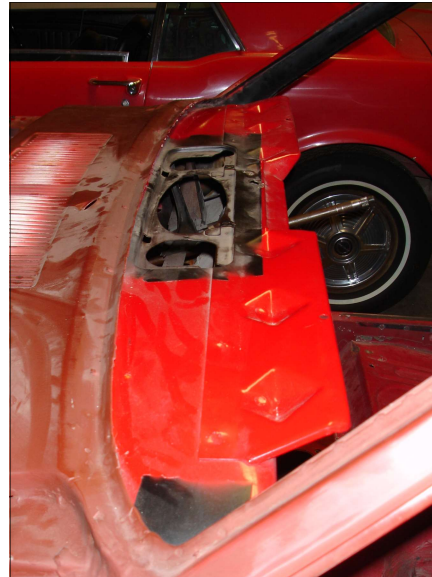
Dash paint details. Top coat red exterior over black interior paint

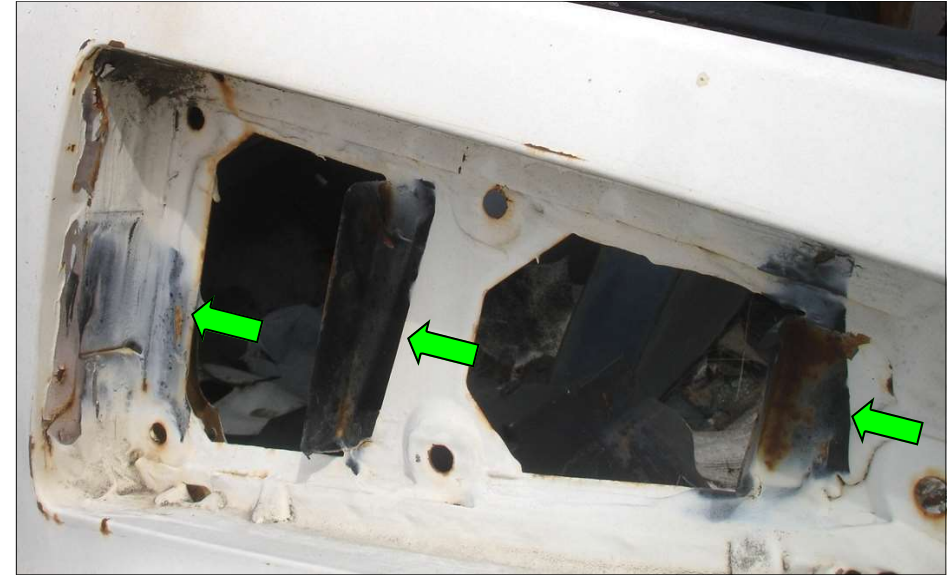
Fastback rear black out detail. What appears to be shadow is a blacked out area. The second and third surfaces (from left) are painted on front and rear surface.

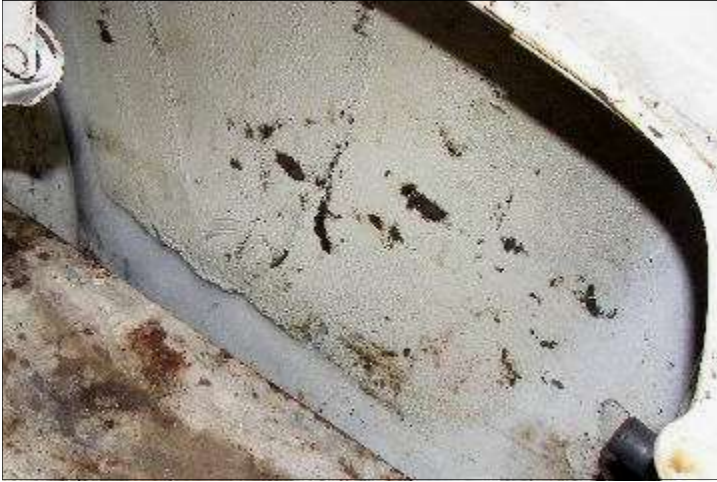
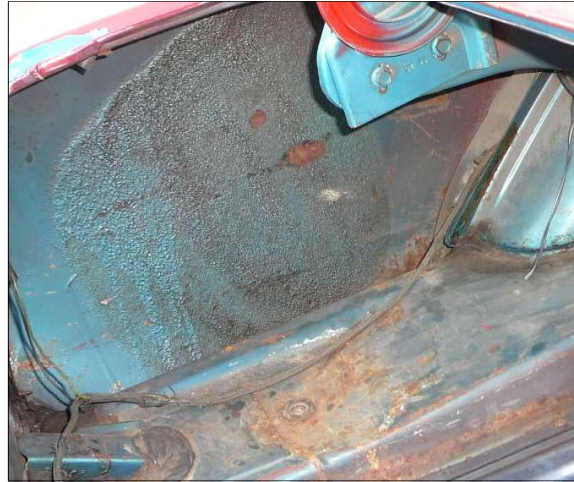
## Trunk Sound Deadener and Seam Sealer Application

Typical sound deadener application onto the inner surface of the quarter panels. Applied, typically, away from any of the edges . Application wand produced a fairly strong edge to the application without much or any overspray.

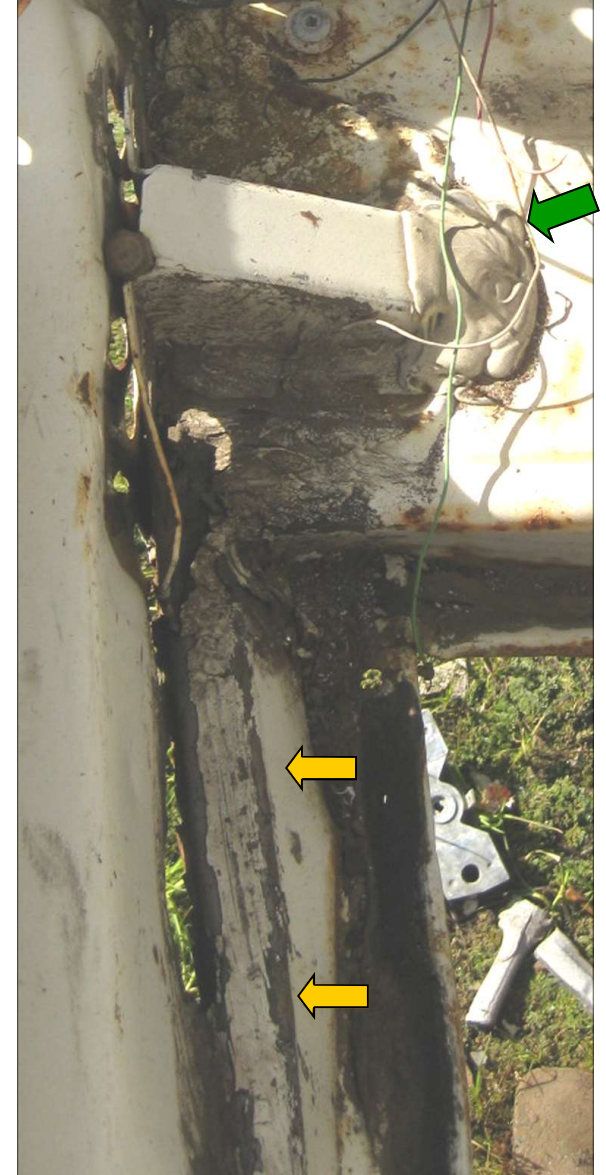
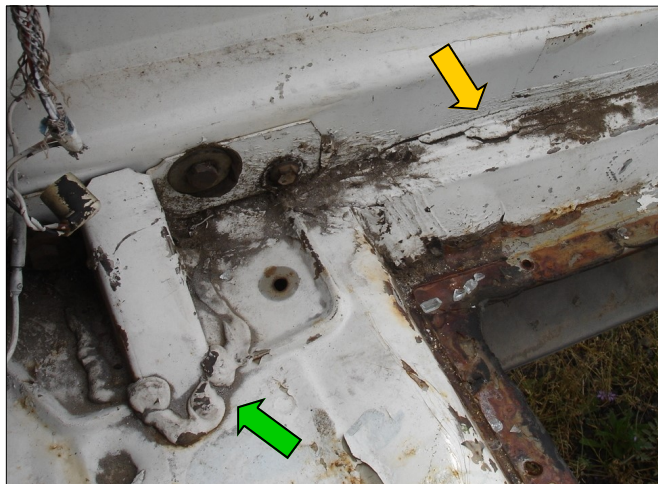
Green-Chalking applied but not spread or wiped

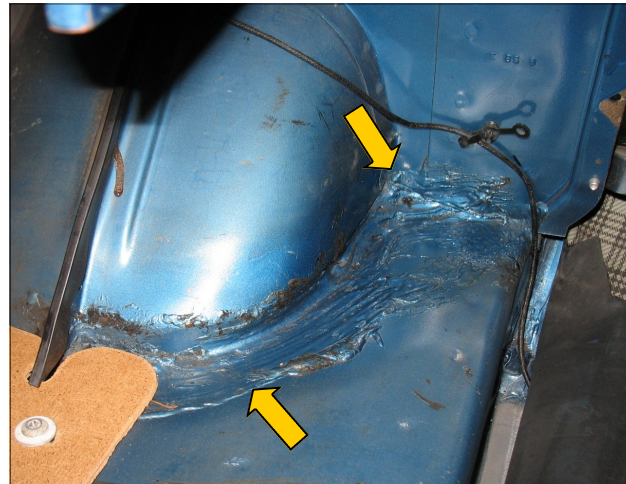
Yellow-Sealant applied then wiped with solvent rag
