# Restoration Support 67 San Jose Unibody (Undercarriage)

*This is an ongoing project of mine I expect to be continually updating as new information is documented, studied and discovered.*

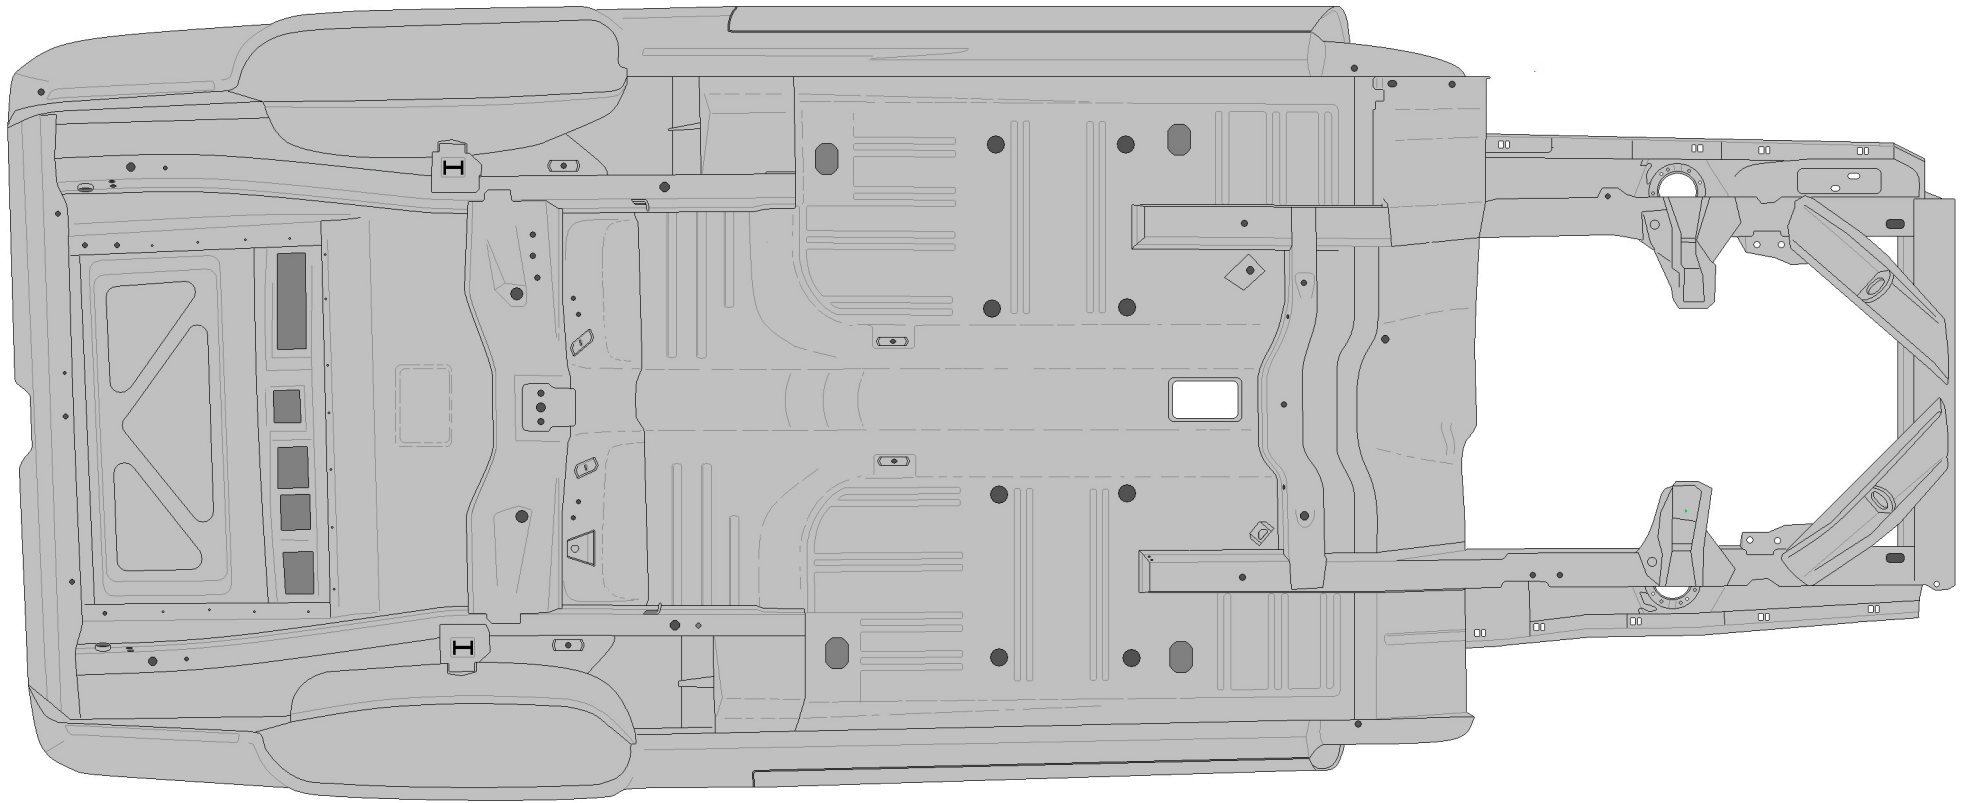
Panels and subassemblies were assembled together to make up the unibody. The unibody was installed on a dolly that would carry it through the rest of the assembly process. To the unibody the trunk lid, doors were installed. Many but not all exterior and seam sealers in other locations were applied next. Following that step exterior and interior were painted with a coat of red oxide primer sealer.

- The unibody was assembled from subassemblies and single panels on a pair of moving skids that were each attached, at eight different location, to the body. Four of these attachments passed through the body and were tightened from above to hold the body tightly to the skids, in the interior and trunk areas, which produce round bare areas visible on the finished vehicle at these points. Visible, on a completed car from below, this process resulted in eight round sections (showing the galvanized metal of those panels) on the finished product. (Page 6)

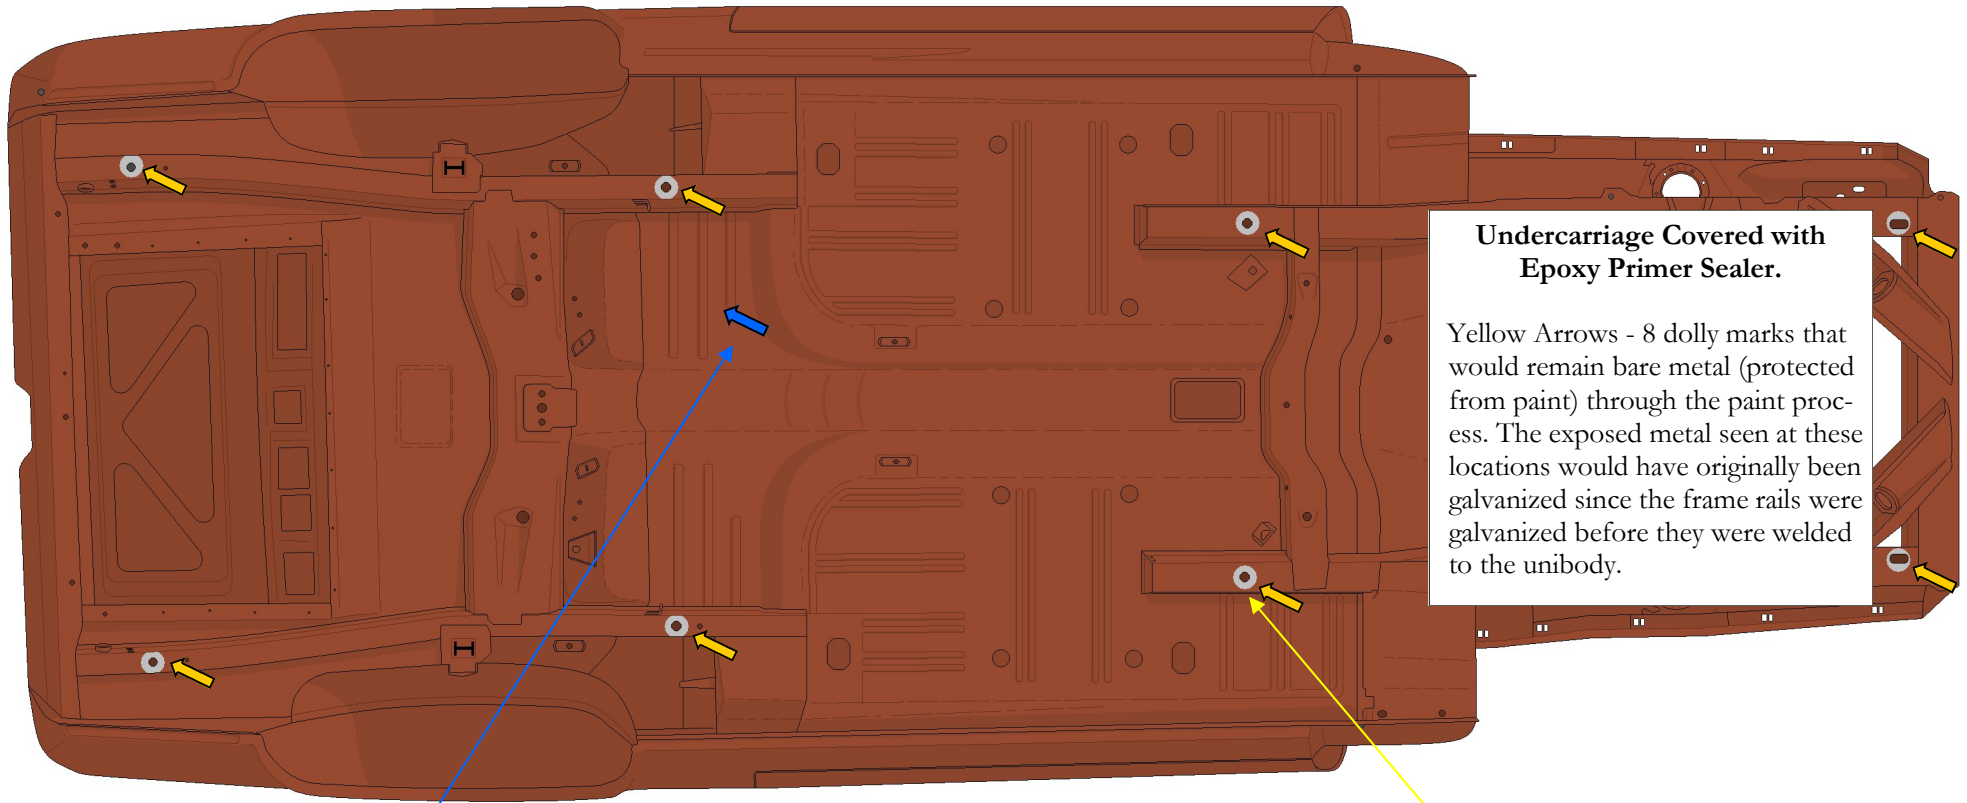
**Undercarriage Covered with Epoxy Primer Sealer.**

Yellow Arrows - 8 dolly marks that would remain bare metal (protected from paint) through the paint process. The exposed metal seen at these locations would have originally been galvanized since the frame rails were galvanized before they were welded to the unibody.

- Undercarriage, from approximately the firewall rearward, was sprayed with a brownish red epoxy primer sealer in a slightly shinny (nothing like red oxide primer) final look. During identified periods of production the red oxide color became lighter, more pale or salmon in tone and tint. During another production period a very dark, almost black tone of epoxy sealer

was applied to this same area. The primer sealer, no matter the color, was applied to the undersides of the car from firewall rearward, stopping approximately four-six inches short of the rear cross member. This was accomplished with the body sitting fairly level as it passed over a series of spray jets arranged below the track system the body traveled over. This process produced multiple runs that collected on the lowest surfaces and edges of the lower body panels. (Pg. 6)

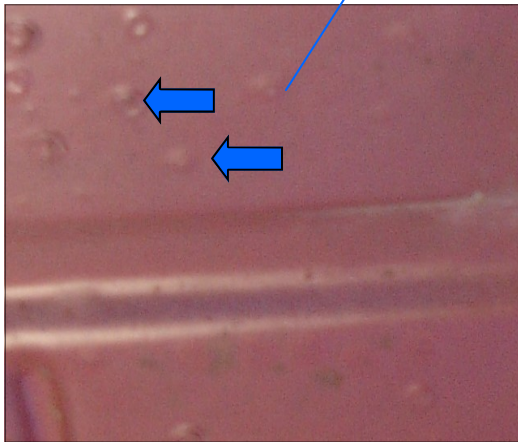
Heavy application produced drips in many areas

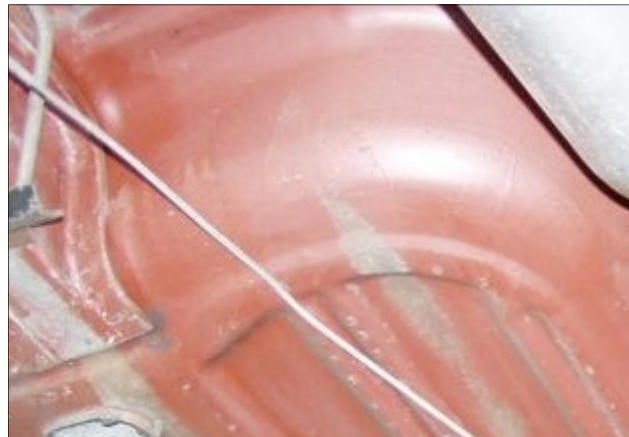
Example of overall finish

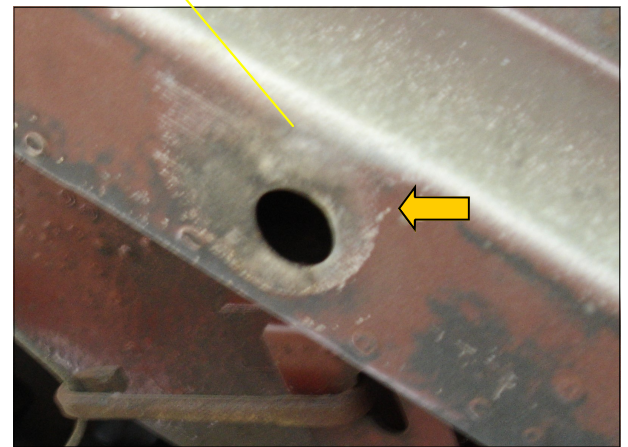
Example of dolly mark

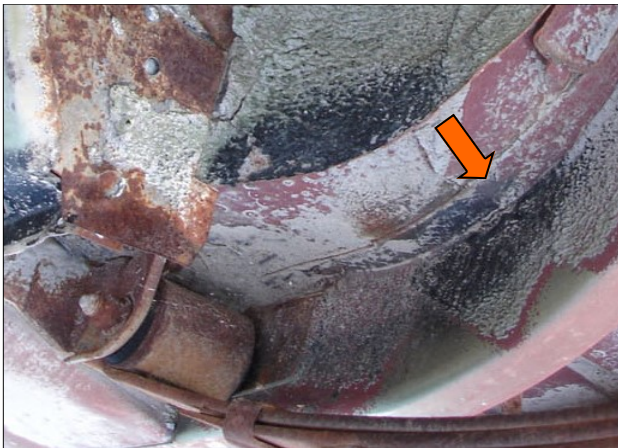
Visible sound deadener overspray on the frame rail though exterior paint has worn off.

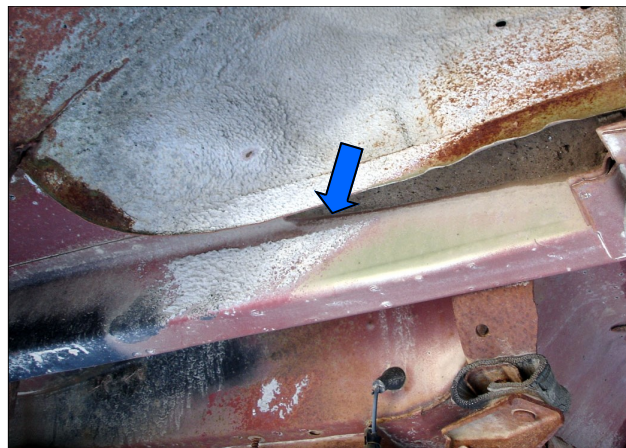
Another example of sound deadener and exterior color on frame and wheel well.

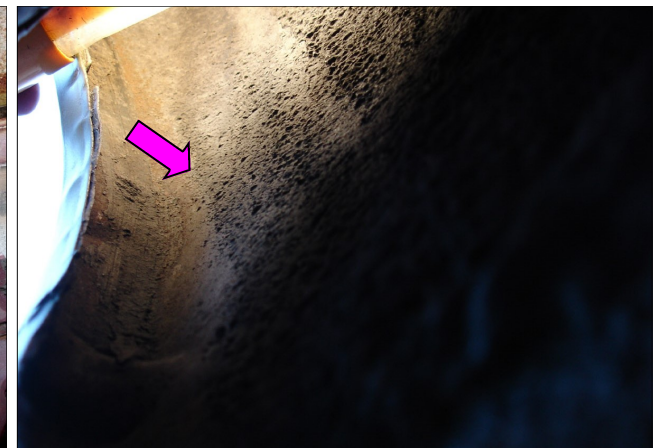
Sound deadener not applied all the way to fender lip.

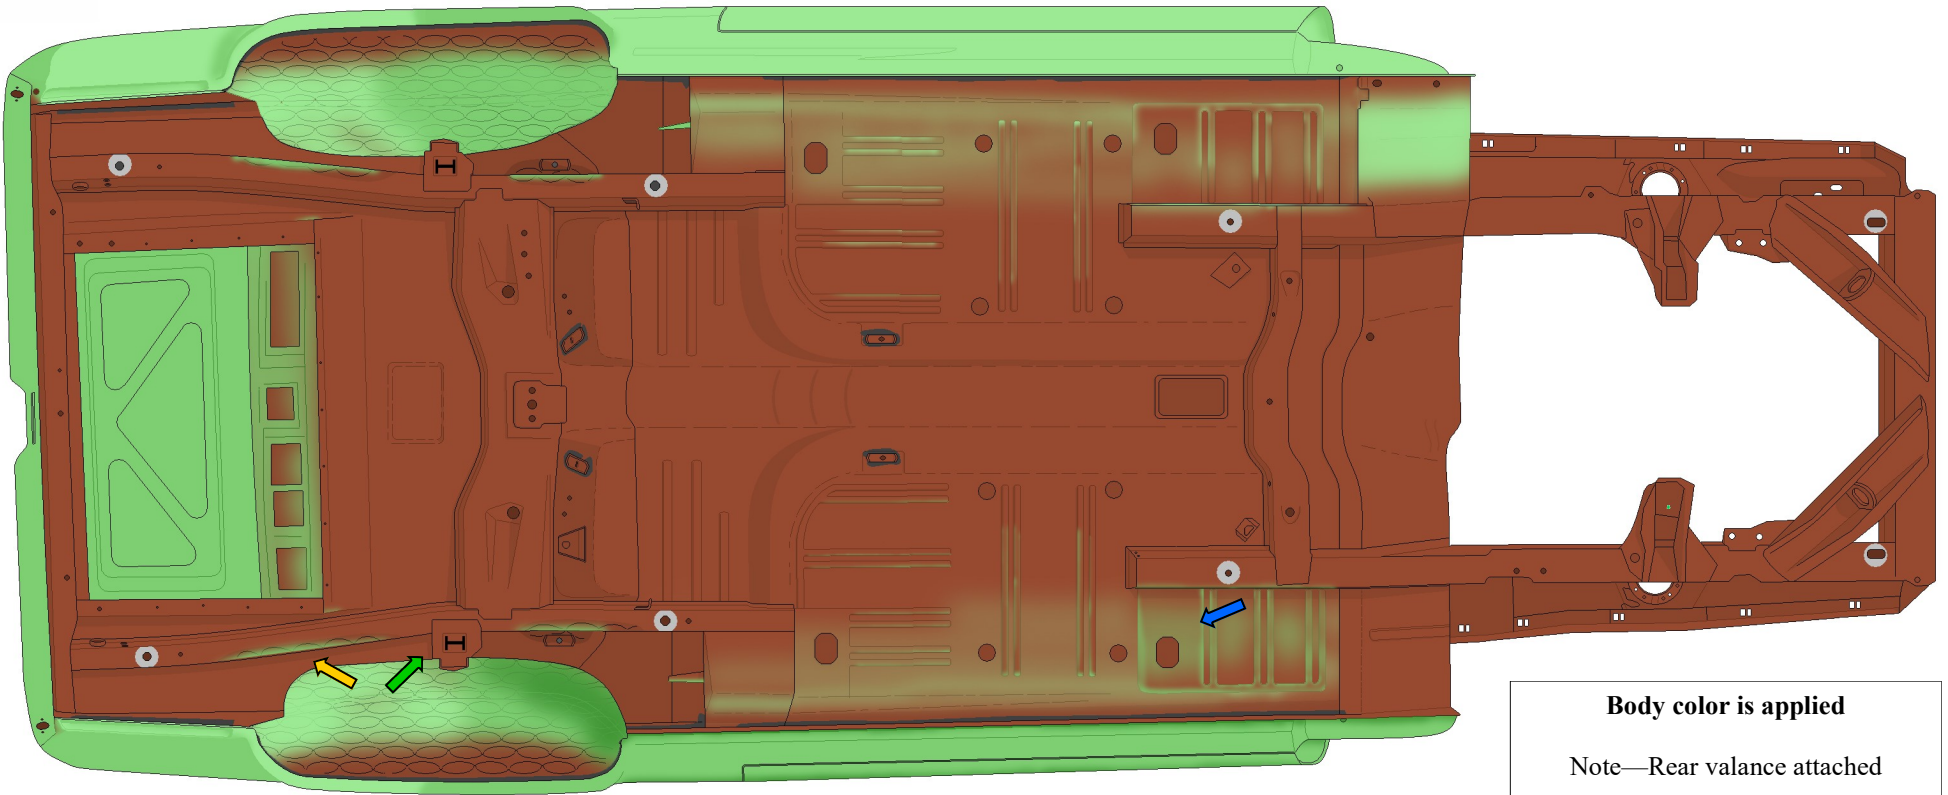
**Body color is applied**  
Note—Rear valance attached

- 8- Door jambs and exterior of the car were painted. (Pg. 9) During this process, using the spray guns of the period, a fair amount of over spray and direct application ended up on areas other than the exterior body such as the interior of the car, the rear wheel wells, the bottom of the floors and undercarriage and any panels or details that hung down more than the surrounding ones. Front frame rails would be one example. This process pushed a lot of body color overspray onto the bottom surface of the floor pans and the panels over the rearend area.

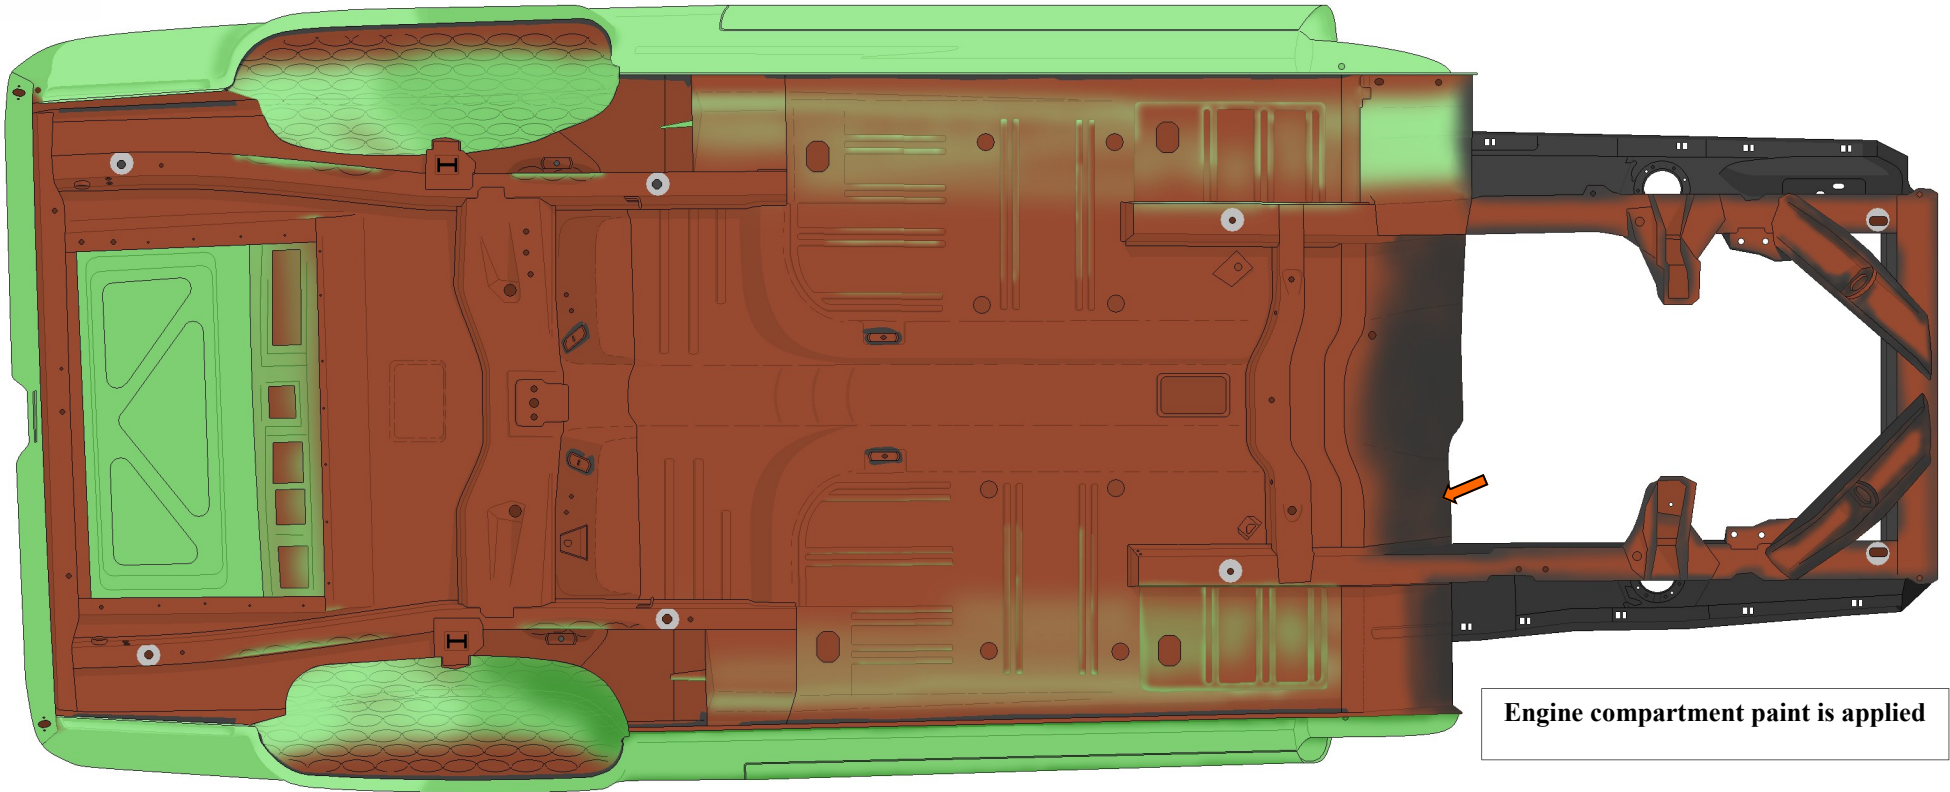
Engine compartment paint is applied

- 9- Engine compartment and inner fender areas were next painted semi-gloss to satin black. (Pg. 10) On the inside of the engine compartment from the cowl to firewall pinch weld downward the black faded away as the panel bends back toward the junction with the floor pan at the bottom. How far varies depending on the worker, how much they bent over, their height and the effort they put forward on the particular car. Black paint was applied to all of the inner fender panels in the engine compartment as well as from the top all brackets and mounts along the bottom of the engine compartment. Examples being the strut rod brackets.

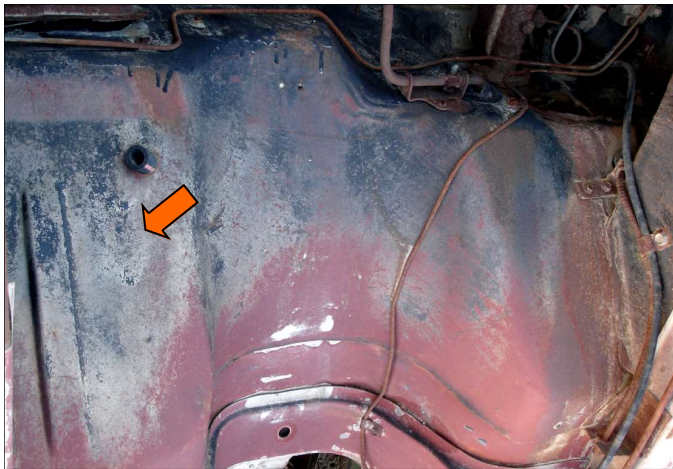
Transition from floor pan area to firewall.

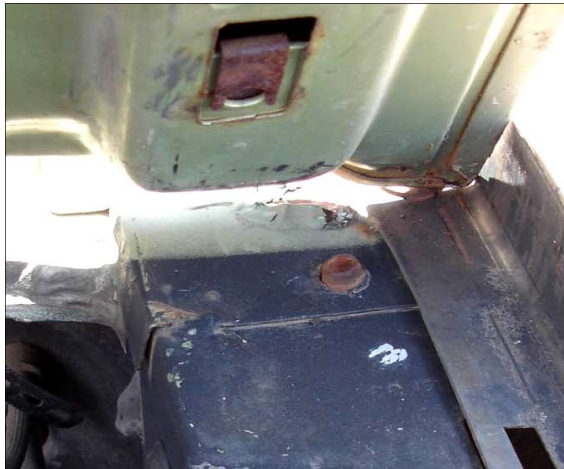
Correct location of black paint to cowl body color

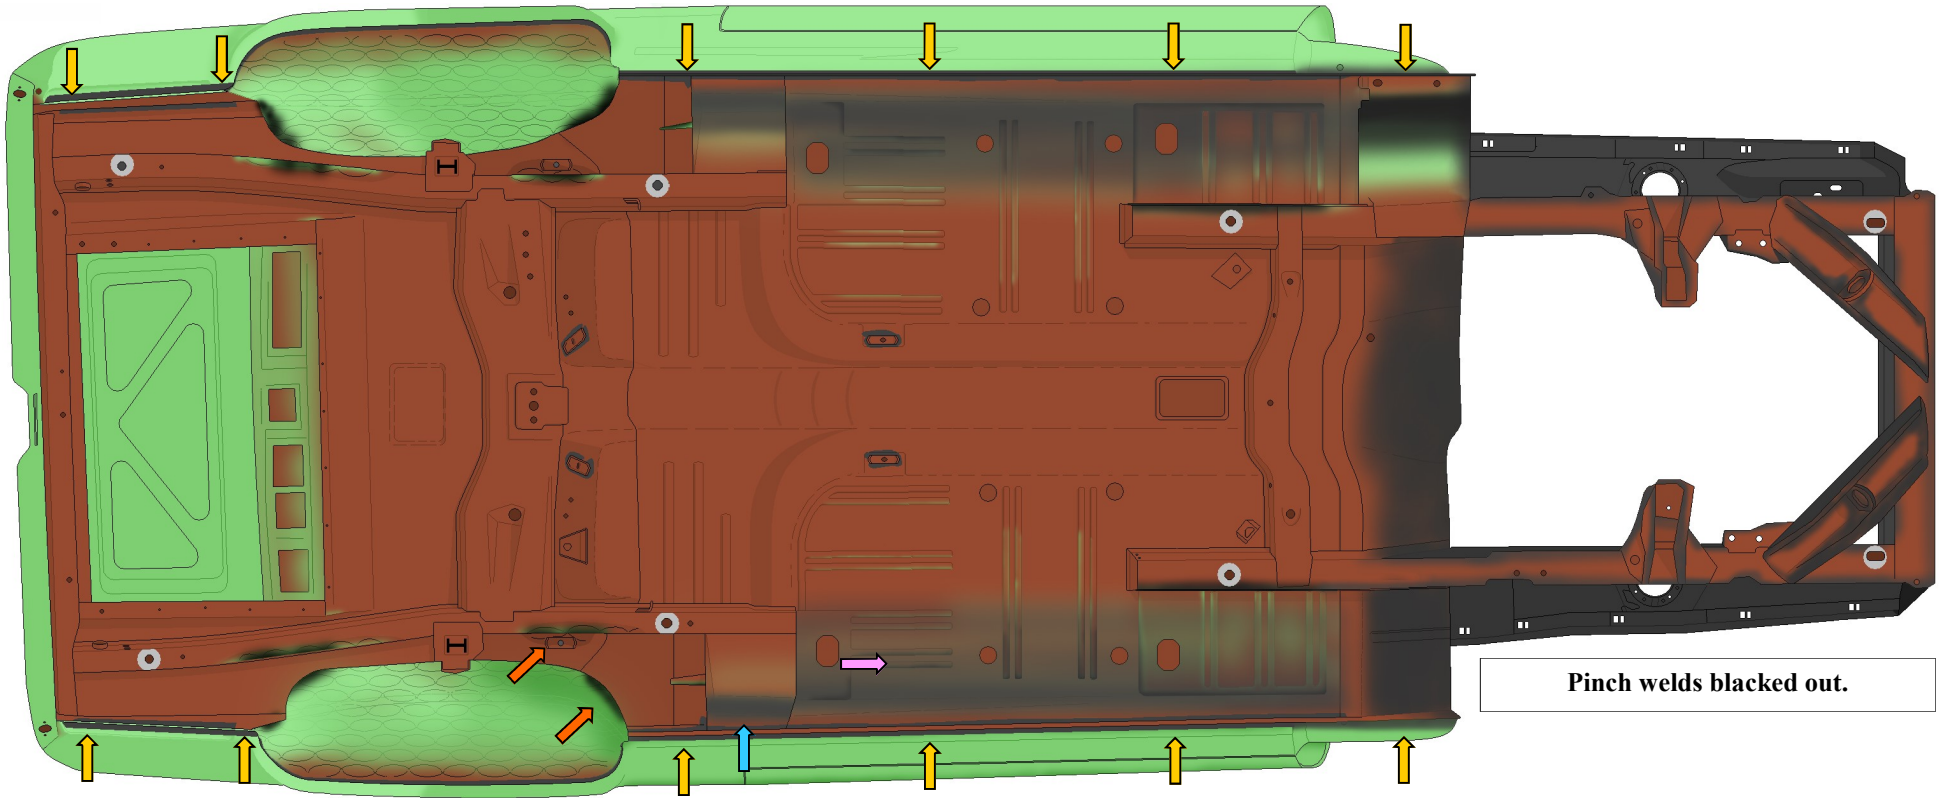
Pinch welds blacked out.

- 10- Next the pinch welds were blacked out from the front edge at the front wheel well, to the rear valance, surface stopping and restarting at the front and rear edge of the rear wheel well. This stopping and starting produced black paint being applied to the rear wheel well, frame and floor sections in that immediate area. (Pg. 10) Because of the angle of the gun the overspray from the pinch weld black out travels across and onto the undercarriage/floor and any bracket, panel or detail that hung down as well as floor surface closer to the rocker panel. Because of the pinch weld and the angle of the gun a shadow from the spray of black paint was produced immediately behind and inward for a very short distance. Many today use a backwards masking technique or foam tape to produce a straight but soft paint edge to the black out.

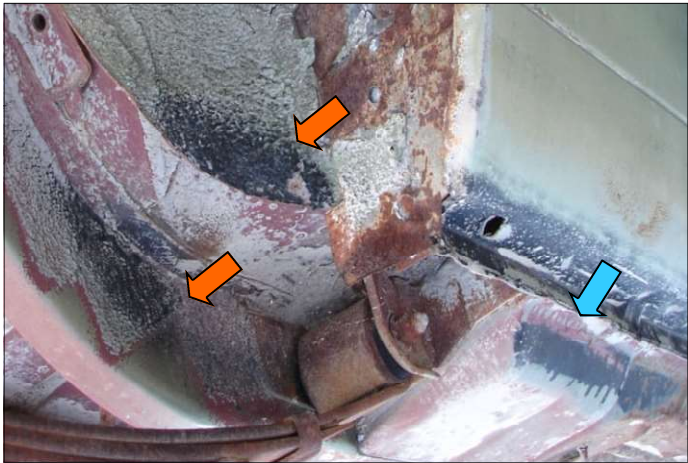
What is left of the pinch and rear wheel well black out

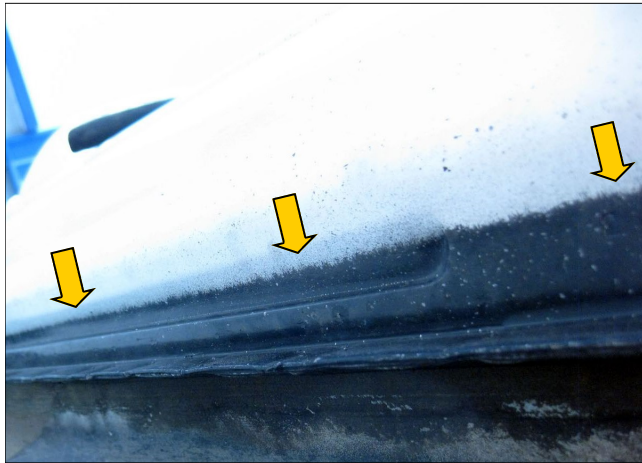
Rocker panel pinch weld blackout

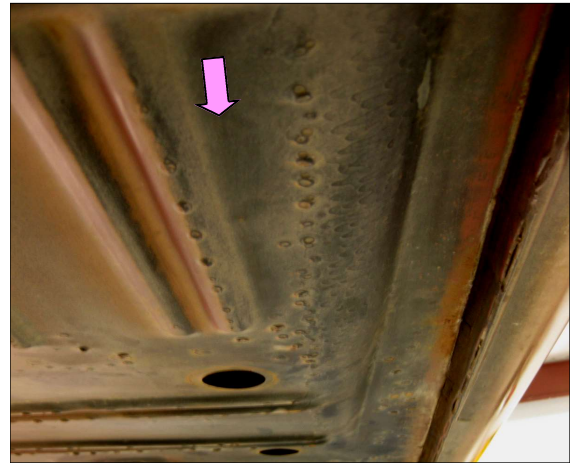
Floor behind rocker lip showing paint shadow.

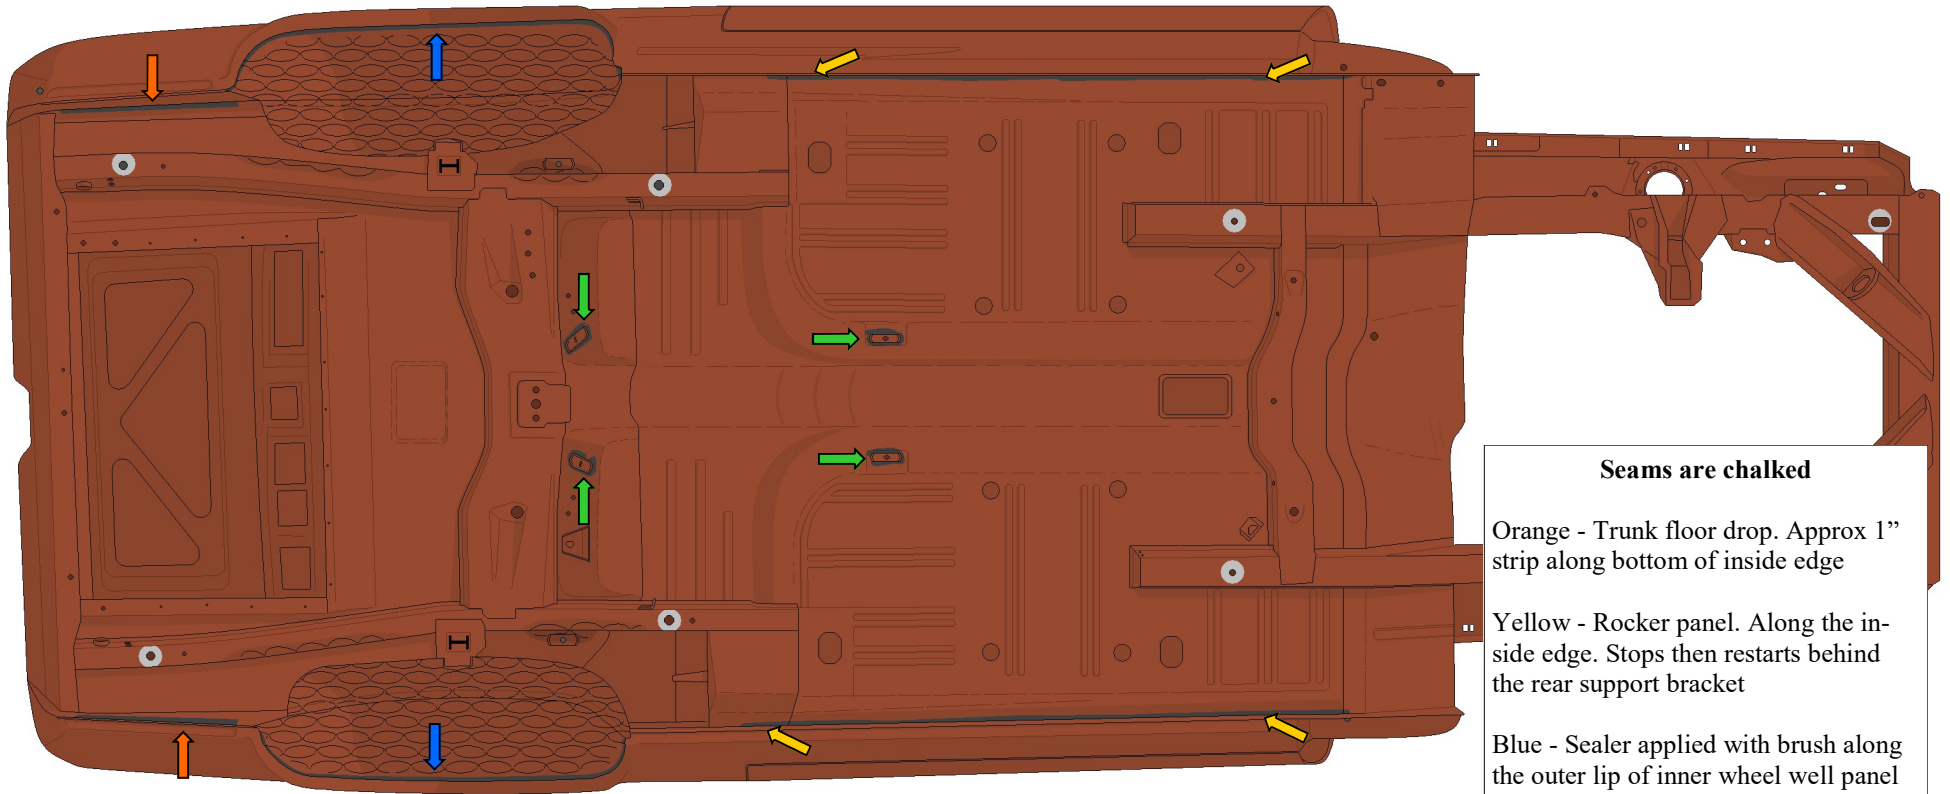
**Seams are chalked**

Orange - Trunk floor drop. Approx 1" strip along bottom of inside edge

Blue - Sealer applied with brush along the outer lip of inner wheel well panel

Green - Seat belt mounting points

- 11- Next sealants were applied to specific locations on the undercarriage. (Pg. 12) The material used was a smooth (no grit) black elastomeric chalk, applied from a gun then spread with a rag soaked in a thinner. Many restorers today use a 1" brush with all the bristles cut off except for the last quarter of an inch to spread the material in a single pass. The sealant was applied between/on the seam between the floor and rocker panel. Typically 90% of the sealant was applied to the floor part of the joint with approximately 10% of the product on the rocker section.

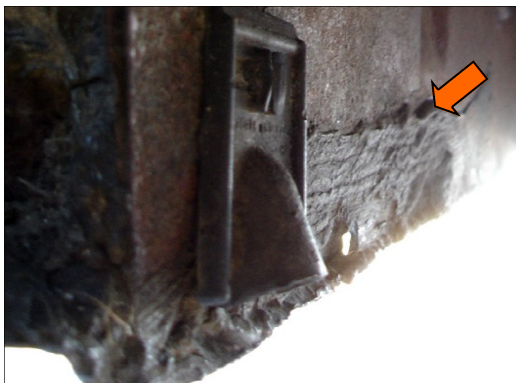
Trunk drop sealant Drain added later

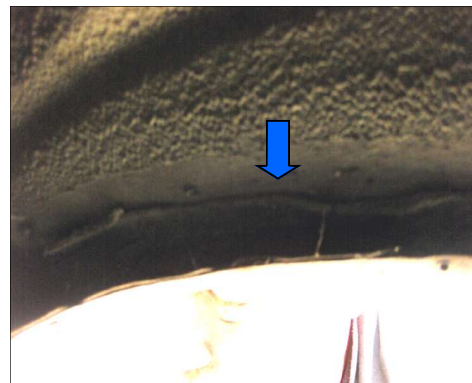
Wheel well lip sealant

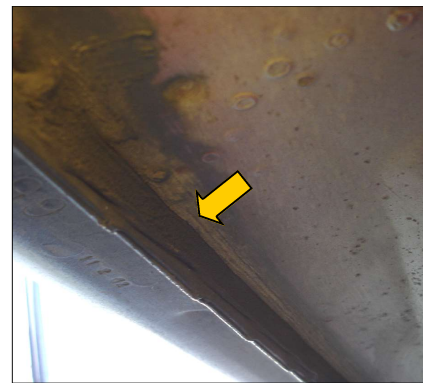
Rocker panel chalking

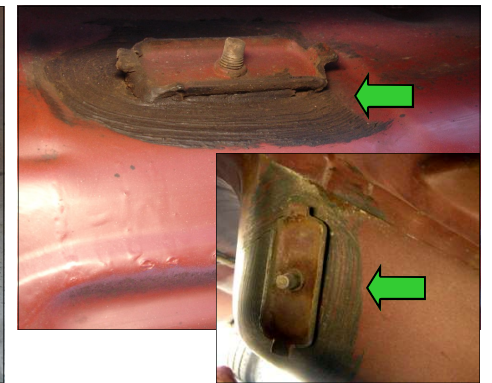
Seat belt anchor sealant example

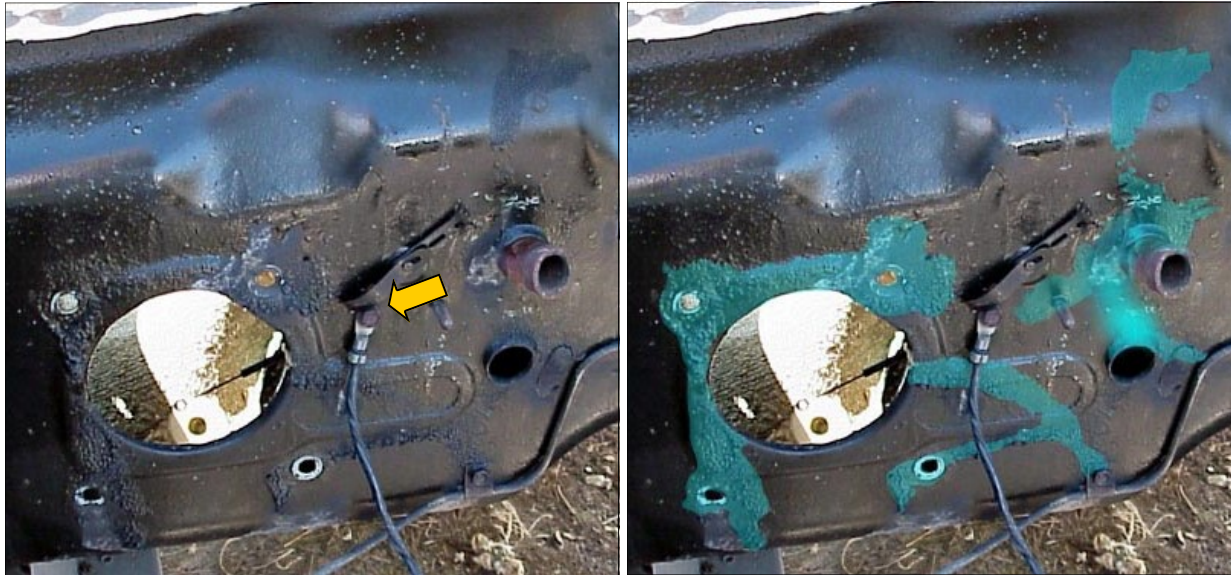
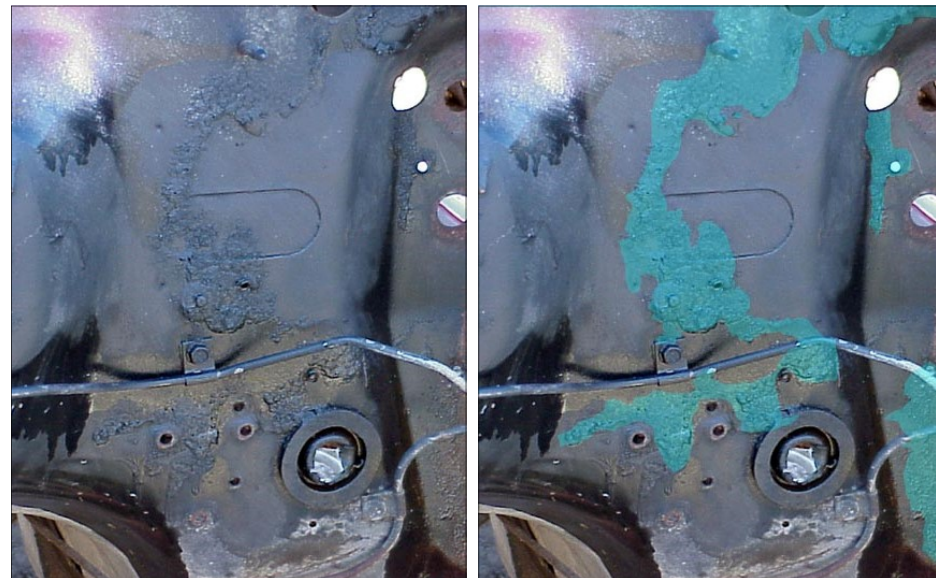
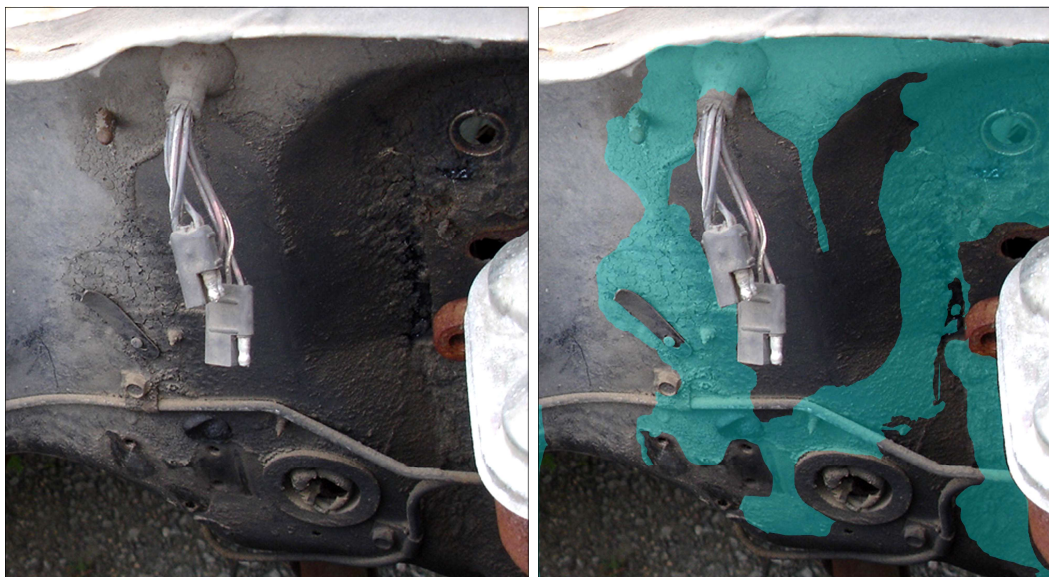
Example of typical sealant applied at or around all firewall attachments and pass-through locations except for the grounding wiring and attaching screw. They were attached to the firewall later in the assembly process. For each of the picture I've highlighted the spray pattern to make it visible on each. As you can see the product is a very fine spray, in areas, similar to what is produced with spray adhesive (adhesive was the term for Ford used for the product) while in other areas where the product was applied heavily it was thicker. Often you will find it was thin enough to produce runs even where not much sealant was applied.

Patterns vary from car to car. The example above is one worker's efforts to cover all required points as instructed.

Sealant normally applied in a continuous spray carried from point to point though the pattern between the target spots can vary from worker to worker.

13- Once all of the items were installed to the firewall and before the engine was installed the firewall openings, pass-throughs and attachment points were sealed using what Ford referred to as an adhesive. (Pg. 12-13) This includes the master cylinder, brake lines and retaining clips, electrical connections, emergency brake and throttle brackets. Only the engine ground strap would not be attached to the firewall at that point and because of that not have sealer at firewall attachment point. Typically, with a wand, the worker would apply the sealant while moving the wand from spot to spot sealing and spraying as he went. This practice often produced a connect-a-dot pattern or look of the finished product.

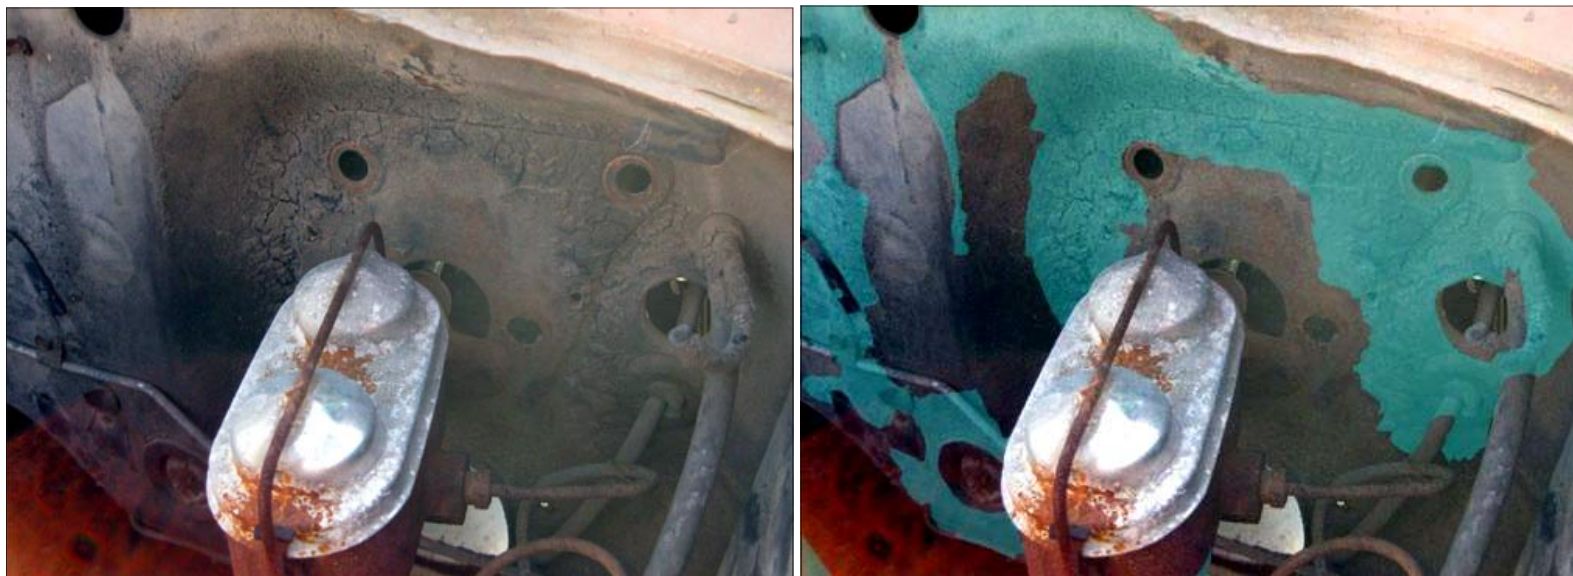
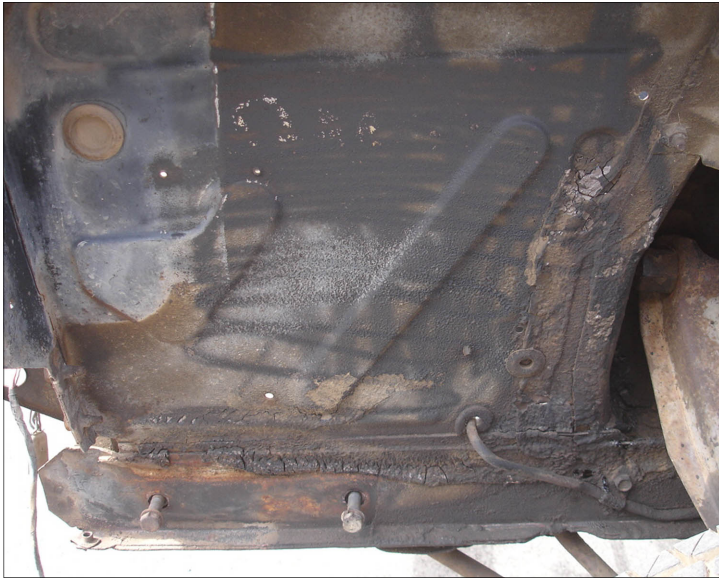
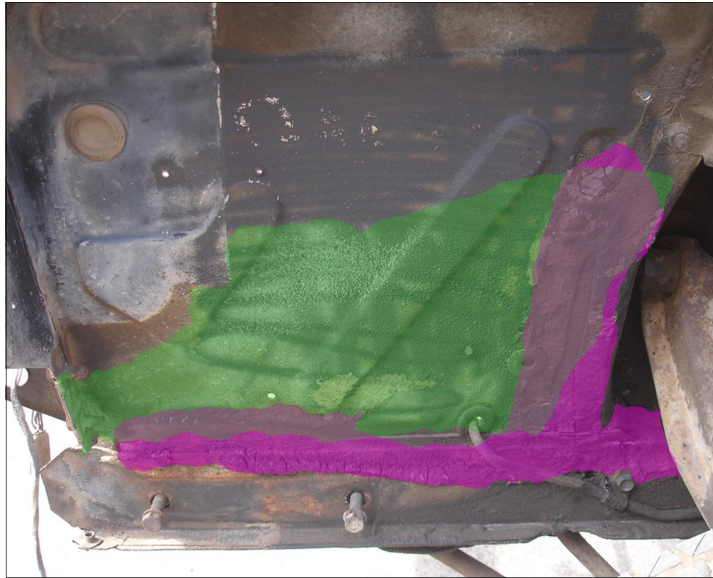
## Front Wheel Well Sound Deadener Applied - Inner Fender Aprons

Highlighted areas show two applications of a spray sealer. One (highlighted in purple) a narrow, heavier, closer application designed to fill and seal and a wider, lighter application designed to deaden sound and vibrations. Ignore the thin back and forth pattern you see on the panel to the left. It's a results of someone attempting to clean the surface using a method that removed some sound deadener.

Once the car was completely assembled (minus front wheels and tires) sound deadener was applied to the front wheel well. The amount and area covered depended completely on the specific worker that applied it and what they did that day. Application falls between a little and a lot with no real identifiable pattern. But all original examples show some on the rear splash shield, firewall section exposed in the wheel well, inner fender panels forward and rearward of the shock tower (normally at a minimum from the lower rear to the top rear edge of the shock/spring cover then from the forward top edge of the shock/spring cover forward and downward.) and finally on the front splash shield.

We often see examples where the bottom side of the fender received a single pass, upper right picture, with the application wand but not all cars received this.

14- Once the car was completely assembled, minus the front wheels and tires, sound deadener was applied to the front wheel wells to seal out water and reduce road noise. Typically the minimum application of sound deadener to the inner fender panels was a single diagonal pass of the application wand (all of this applied from below the car in the pit) from around the front bumper bracket attachment point to the top just in front of the spring cover on the front inner fender panels. Product on the spring cover

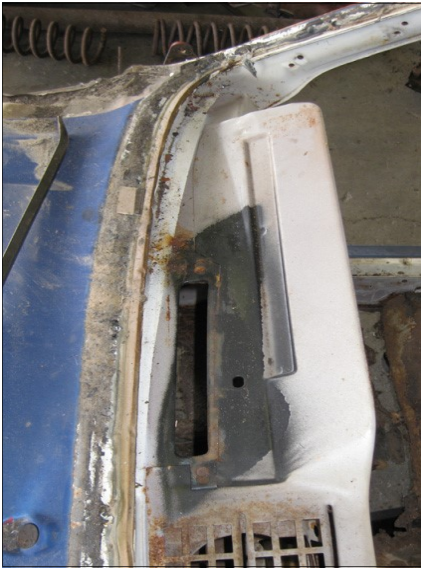
Defroster vent black out

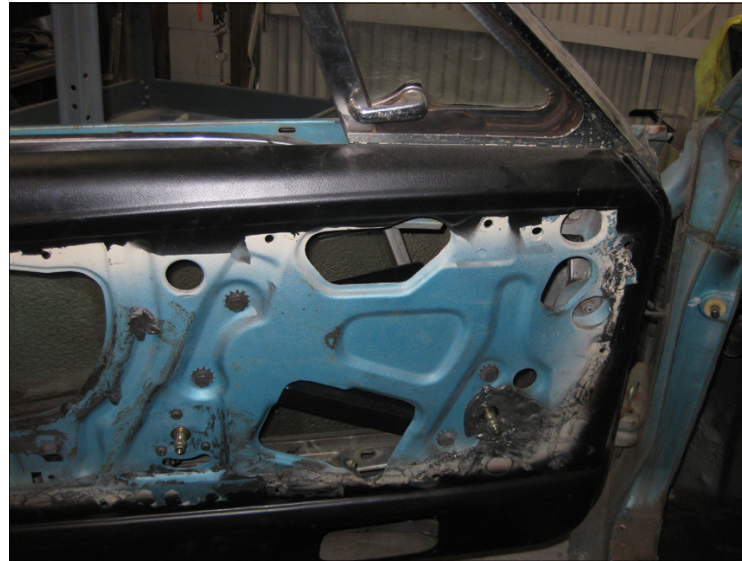
Once the interior of the door was painted a mask was taped over the inner surface of the door leaving the pattern above.

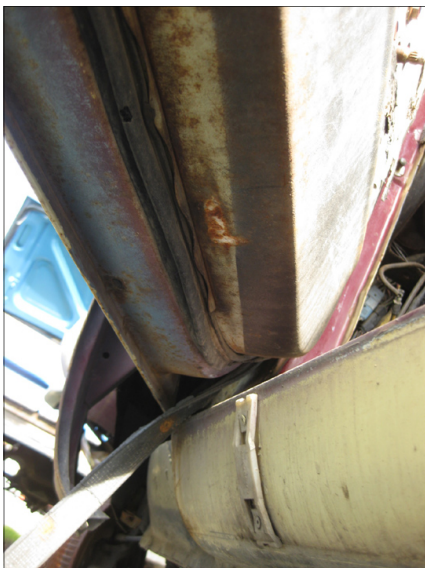
Interior panel paint was the first paint coat applied to the unibody. Once painted and dry, these surfaces were masked off to protect them from the other paints that were applied later during the process. As can be seen in the bottom of the door examples not every painter bent down enough to apply a good coat of exterior paint to the bottom of the doors.

Inner door surface mask left a gap between the lower edge of the mask and the lower door weather-strip channel.

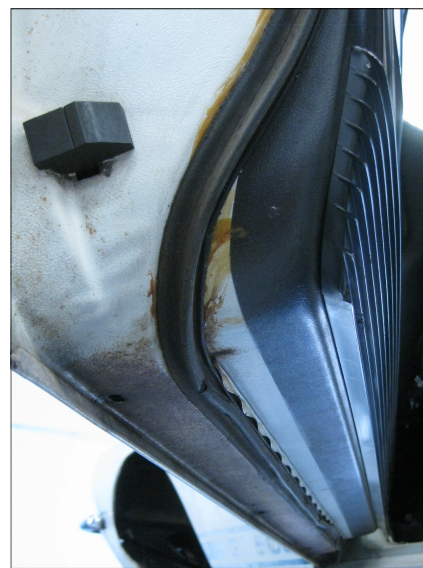
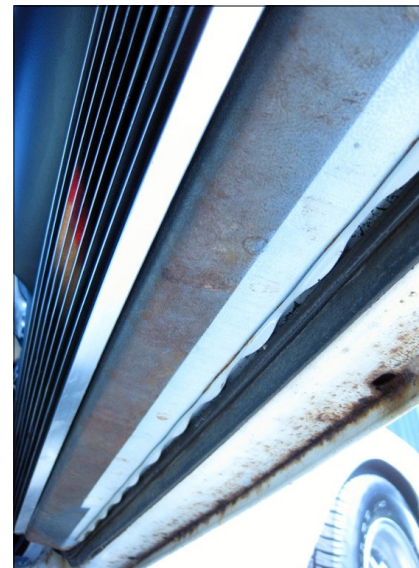
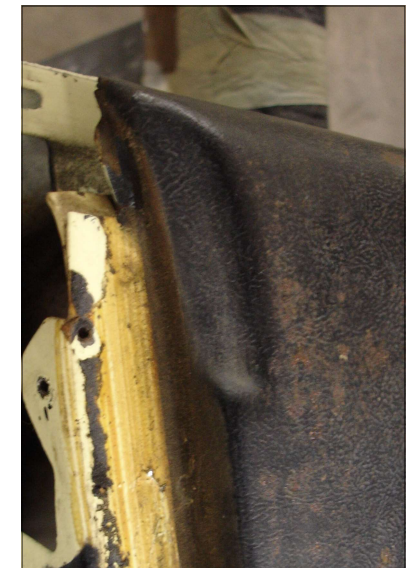
Paint detail at top rear edge of door

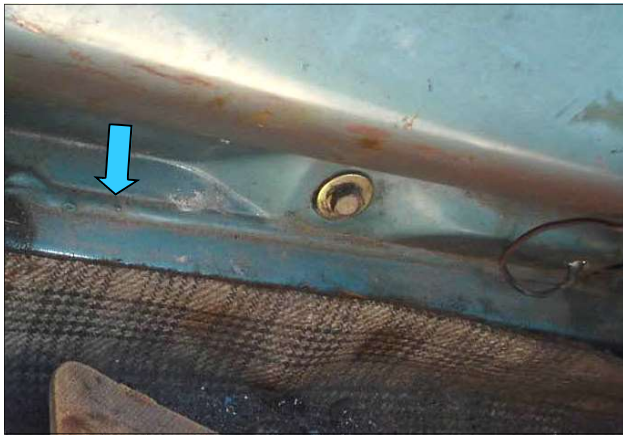
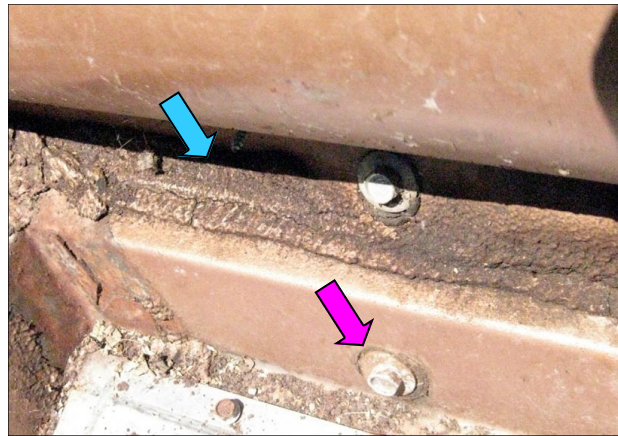
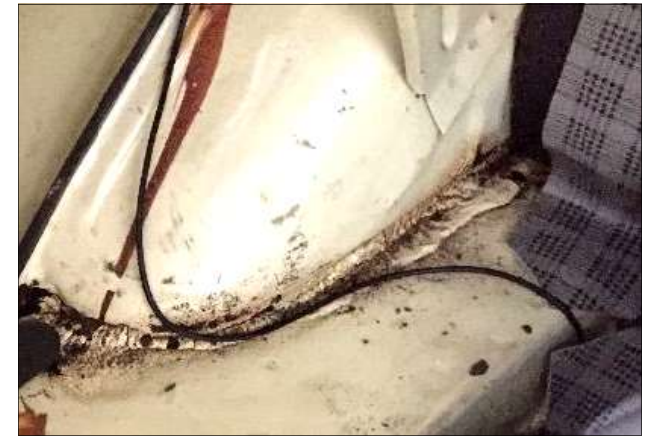
Above and below (blue arrow) shows the taillight to rear trunk floor seam and sealant. During one period chalking applied in a thin neat bead while during another production period it was sprayed with the same product and technique as the other floor seams around the trunk. Product appears to match the version of sealant used around the rear bumper brackets shown in the pictures below. Change appears to have taken place in December 1966. Purple arrow indicates the upper mounting bolt for the rear bumper guard bracket which was installed prior to paint application so this would have been painted, along with the sealant, body color.

Seam sealant at wheel wells to trunk floors was a spray on process that resulted in very little splatter or overspray and a narrower spread than the application of the trunk floor panels to other floor panels. Material was a heavy body sealant that flowed outward often leaving a very well defined edge especially on the edges.
