# Restoration Support 67 San Jose Unibody (Undercarriage)

*This is an ongoing project of mine I expect to be continually updating as new information is documented, studied and discovered.*

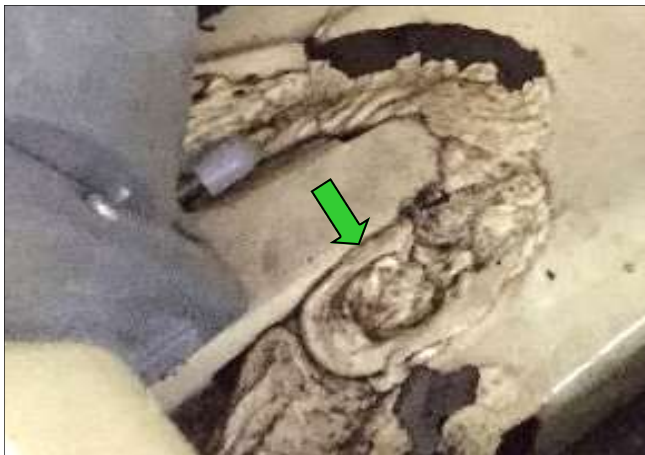
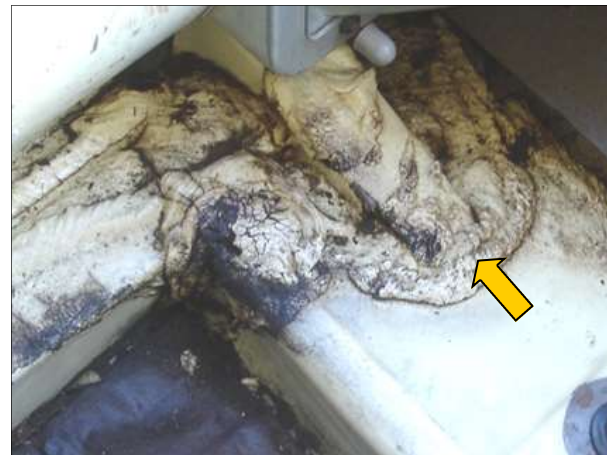
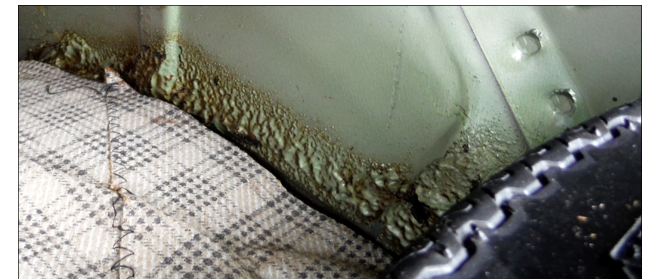
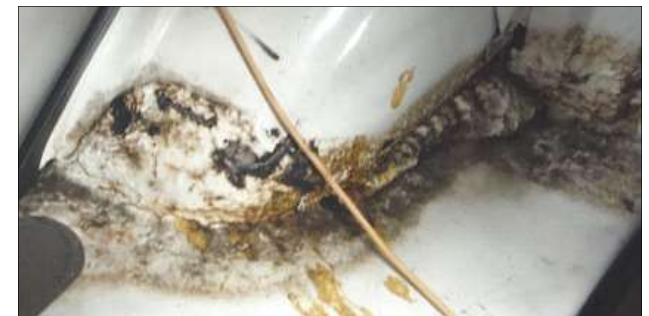
Sealant applied straight out of the chalking applicator and left untouched. This product tends to match the product used during this period, the product used above for the taillight panel seam.

This style of sealant application, sprayed, was applied from one quarter panel to the other side producing a finish similar to the other sprayed seams in the trunk area.

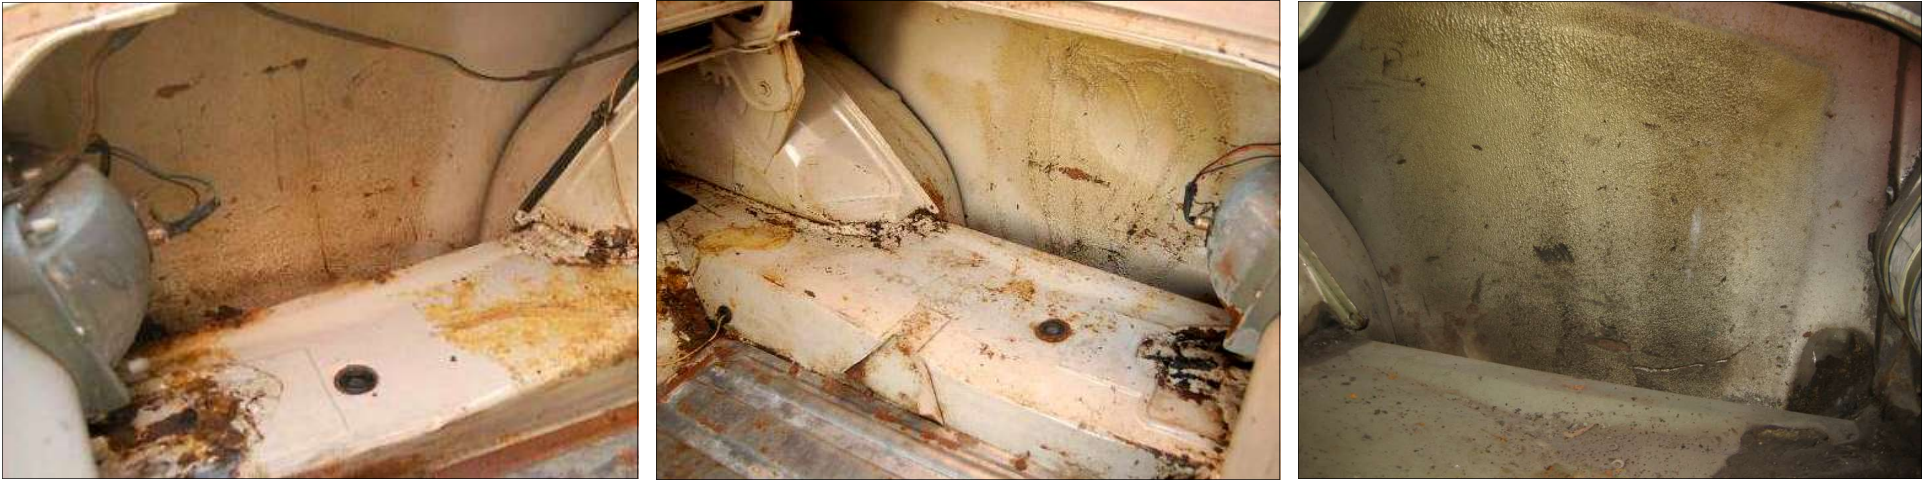
Typical sound deadener application onto the inner surface of the quarter panels. Applied to the center of the panel surface, away from any of the edges . Application wand produced a fairly strong edge to the application without much or any overspray. Example in the center, above, appears to be an example where the applicator wand end was plugged or partially blocked producing less than equally balanced application when compared to the example to the left and the far right.

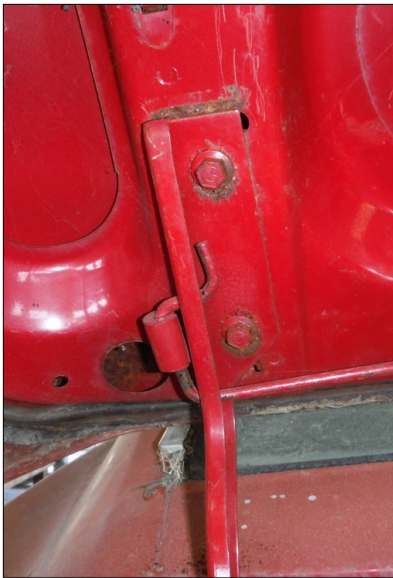
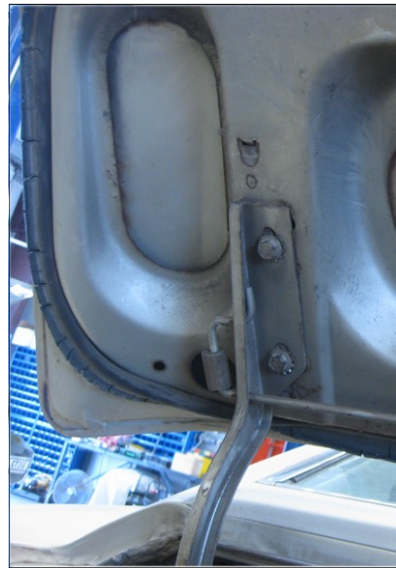
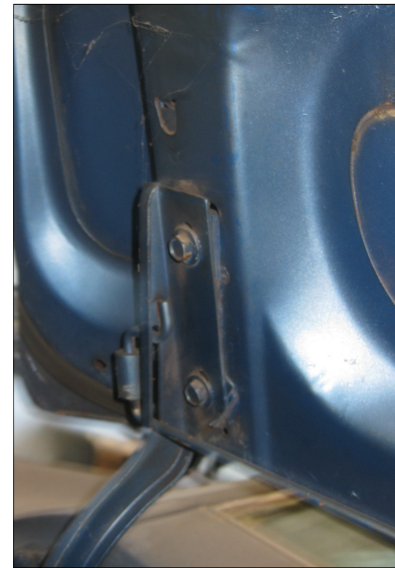
At San Jose on fastback models, workers placed on the trunk lid spring an extra trunk spring insulator, like the one attached to the trunk lid in the middle with the bracket, to the driver's end of the spring. As shown in the pictures to the left.
