69 Dearborn Unibody (Undercarriage) Restoration Guide

This is an ongoing project of mine and just one section of a much larger project. It is a work in progress so it will hopefully be continually updated as we discover additional or new information and it is researched and accepted.

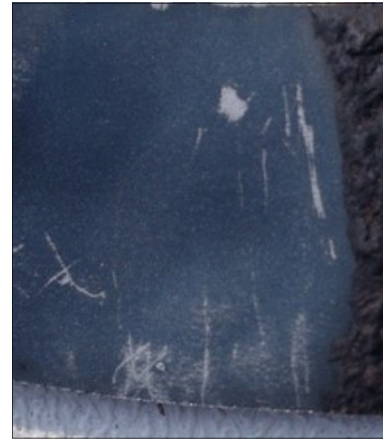
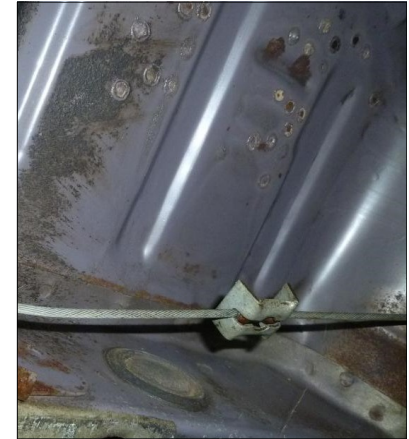
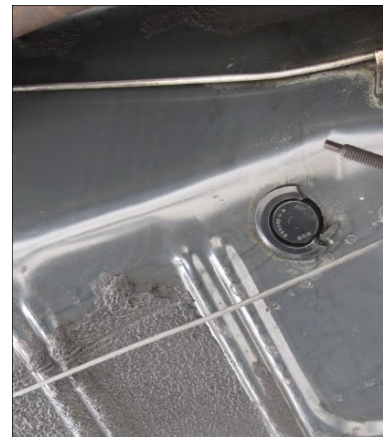
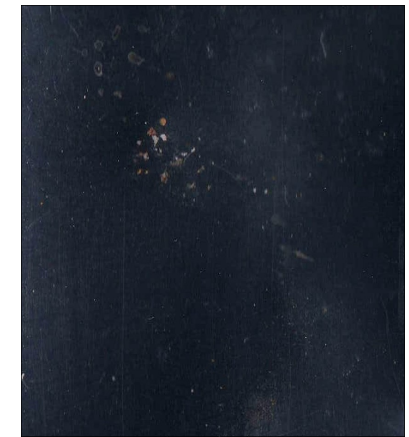
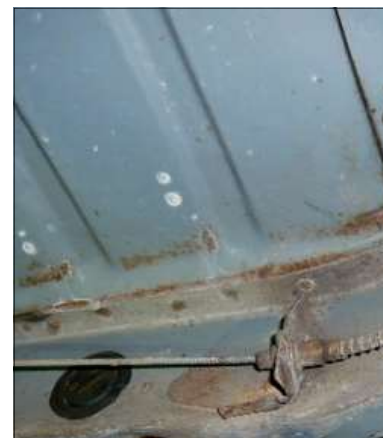
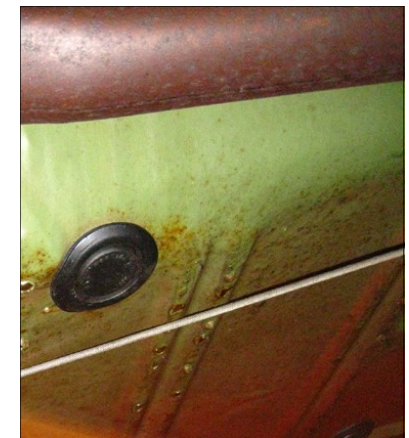
To the right are just a few examples to illustrate the wide variety of colors found of batch paint from 1969 Dearborn built Mustangs & Cougars.

In the later months of production the color of the batch paint applied to the floor panes (firewall rearward) varied greater than in earlier production. The bottom two examples reflect the ongoing change that continued into 1970 production.

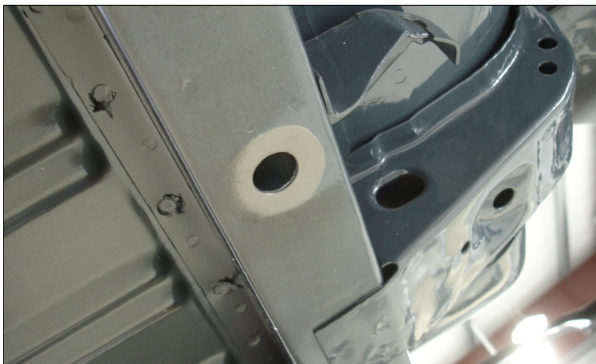
On this restored example it shows the round dolly make with soft edges and the much fainter design left from the pinch weld black out that produces more of a U shaped pattern since it was only applied from one direction.

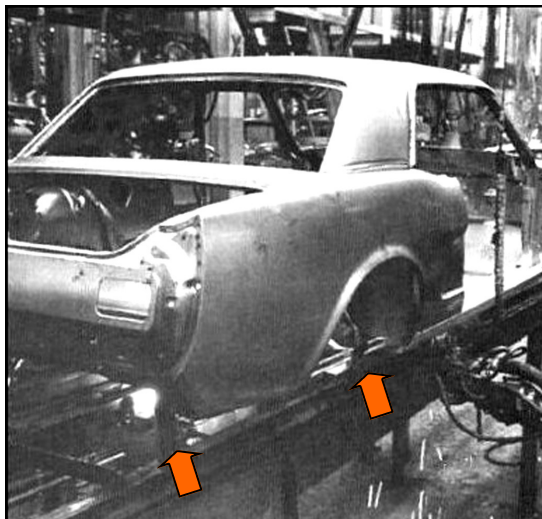
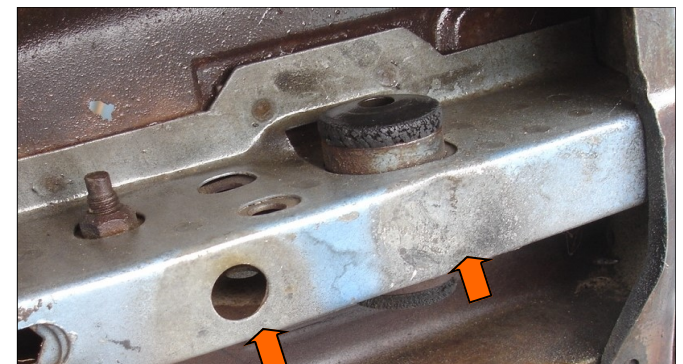
The rear most dolly stand had two attachment points to accommodate both Mustang and Cougar bodies. This left an additional shadow on both models. Above a Mustang

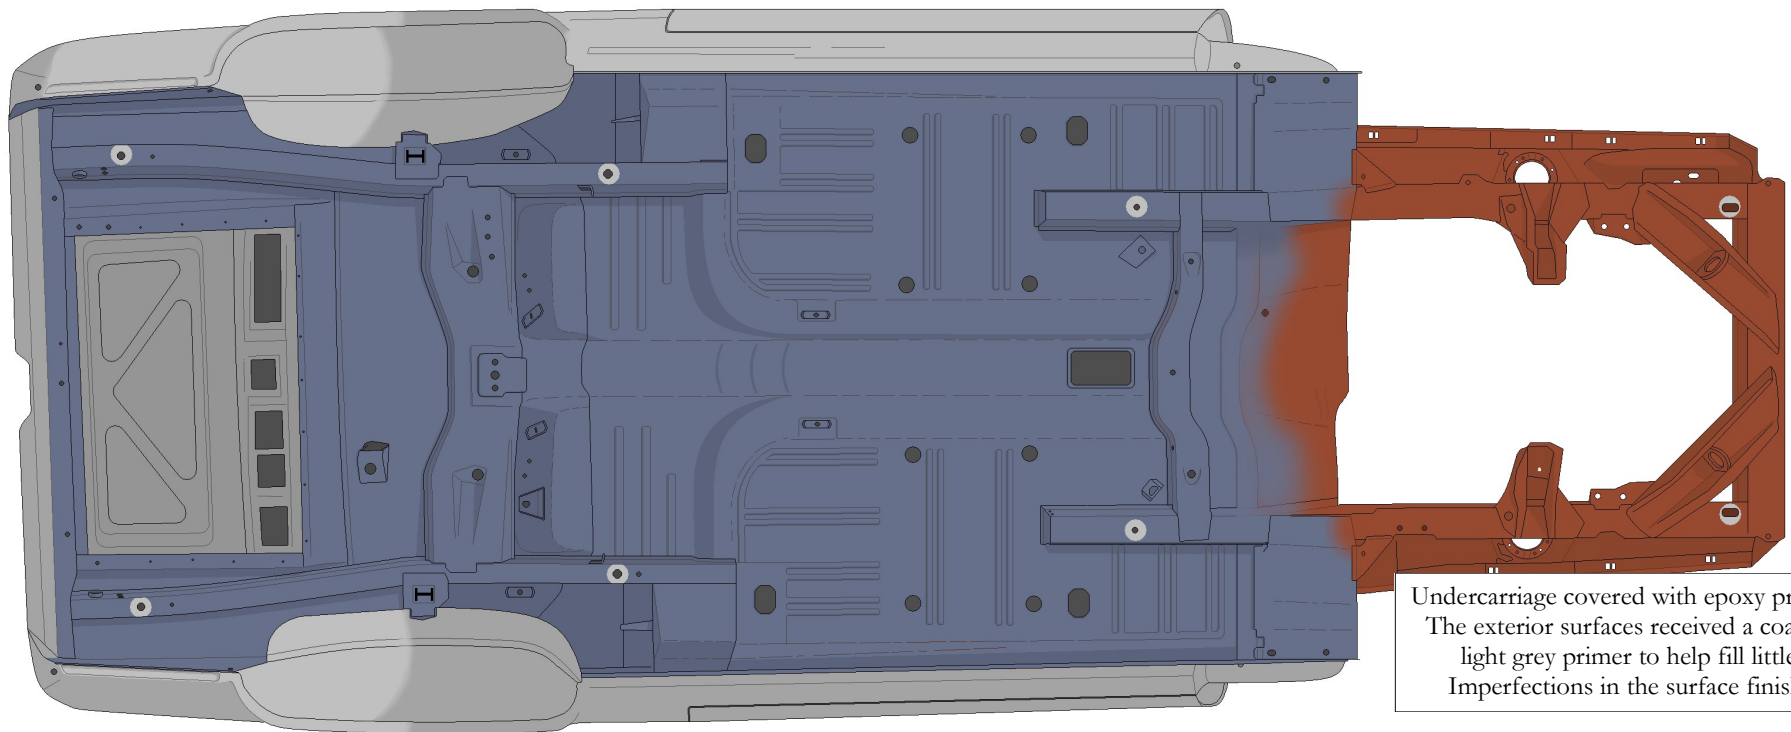
Undercarriage covered with epoxy primer.
The exterior surfaces received a coat of
light grey primer to help fill little
Imperfections in the surface finish.

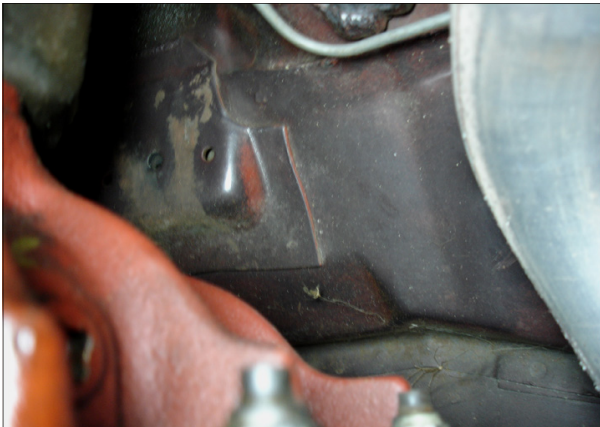
Blackish/Purple-blue found on 9F188388

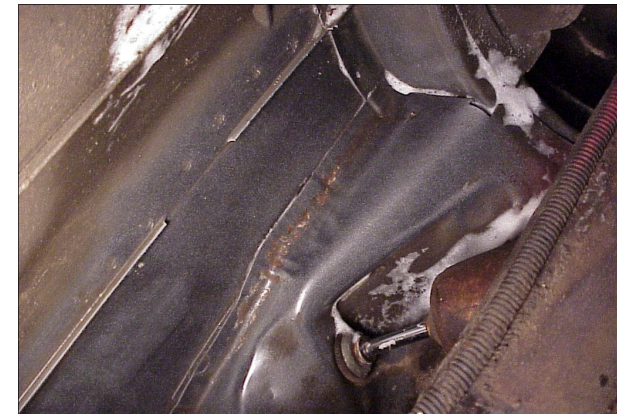
Blackish from another 69 Dearborn car in the 180000's

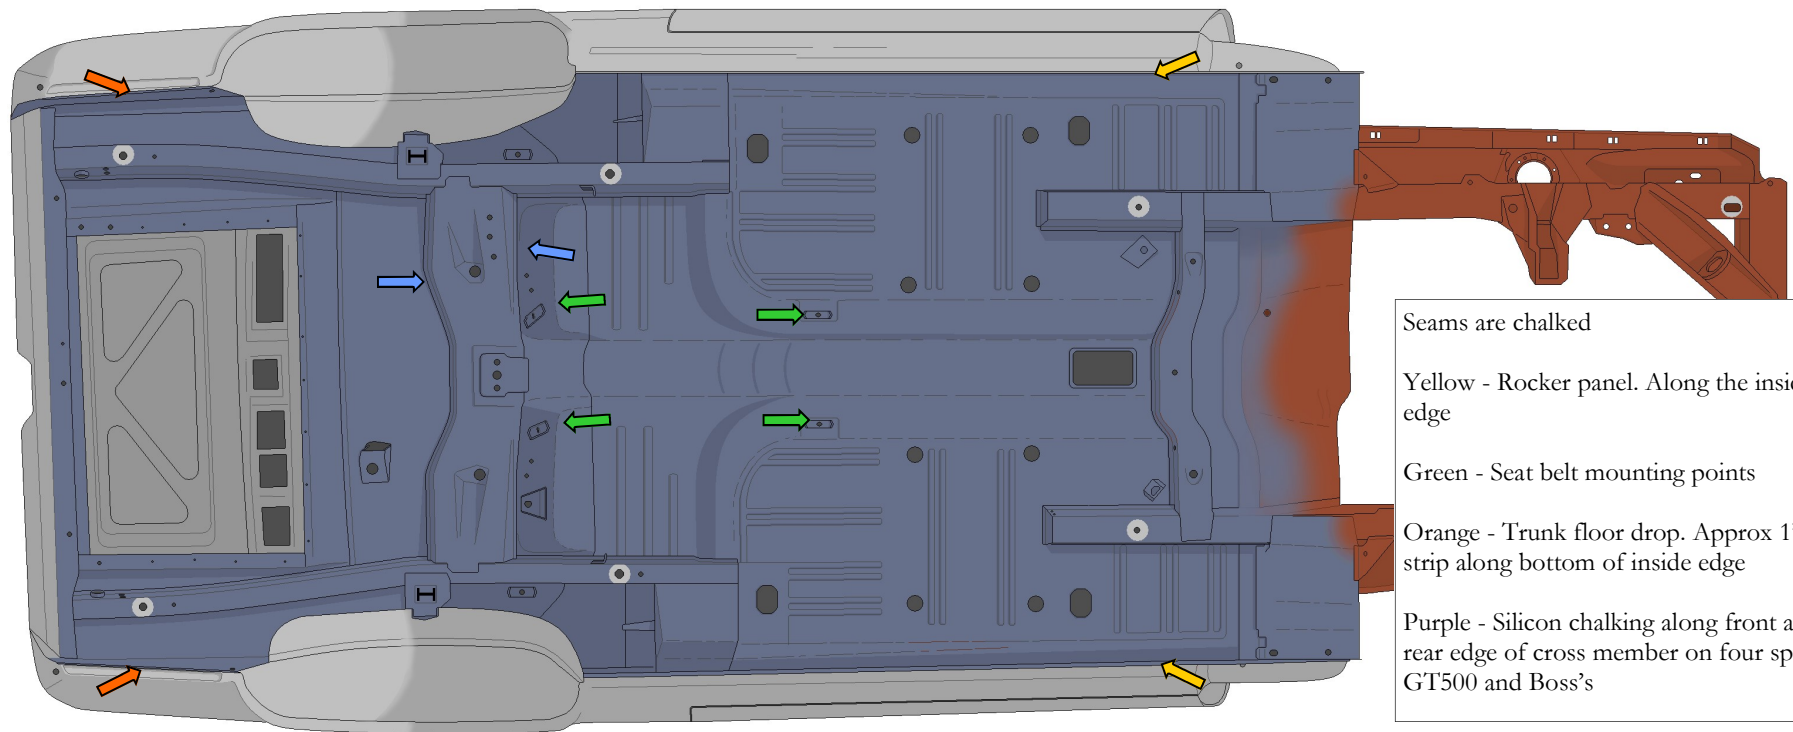
Seams are chalked

Yellow - Rocker panel. Along the inside edge

Green - Seat belt mounting points

Orange - Trunk floor drop. Approx 1" strip along bottom of inside edge

Purple - Silicon chalking along front and rear edge of cross member on four speed GT500 and Boss's

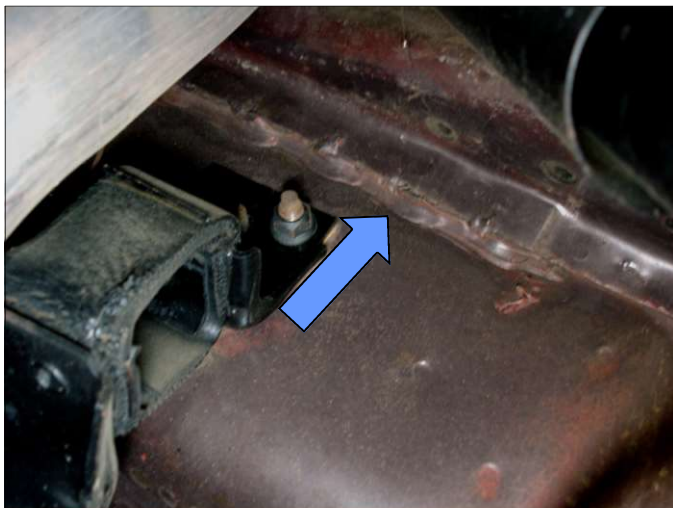
Silicon looking chalking (different product than the others on this page) from a Boss 302 so not for non- Boss cars.

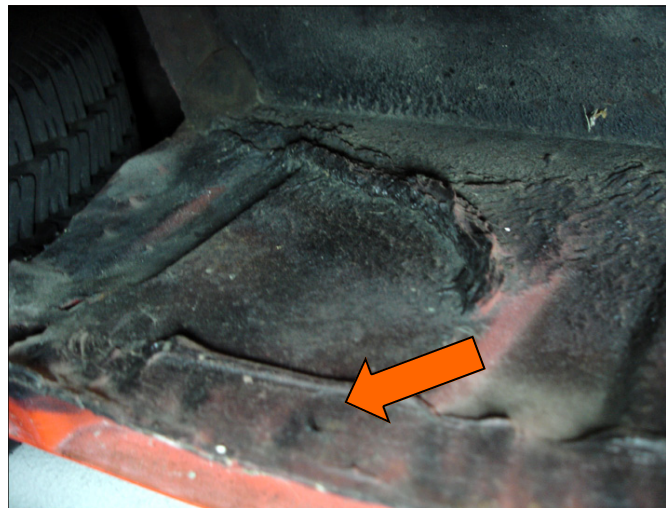
Trunk drop sealant. Goop above the arrow is some wild over spray from the sound deader overspray

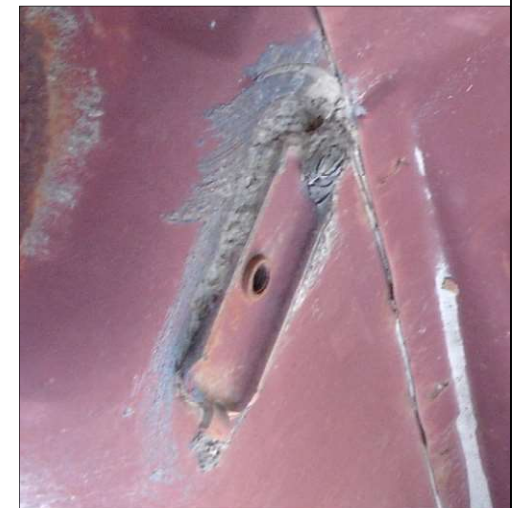
Not from this year but a good example of the seat belt sealant

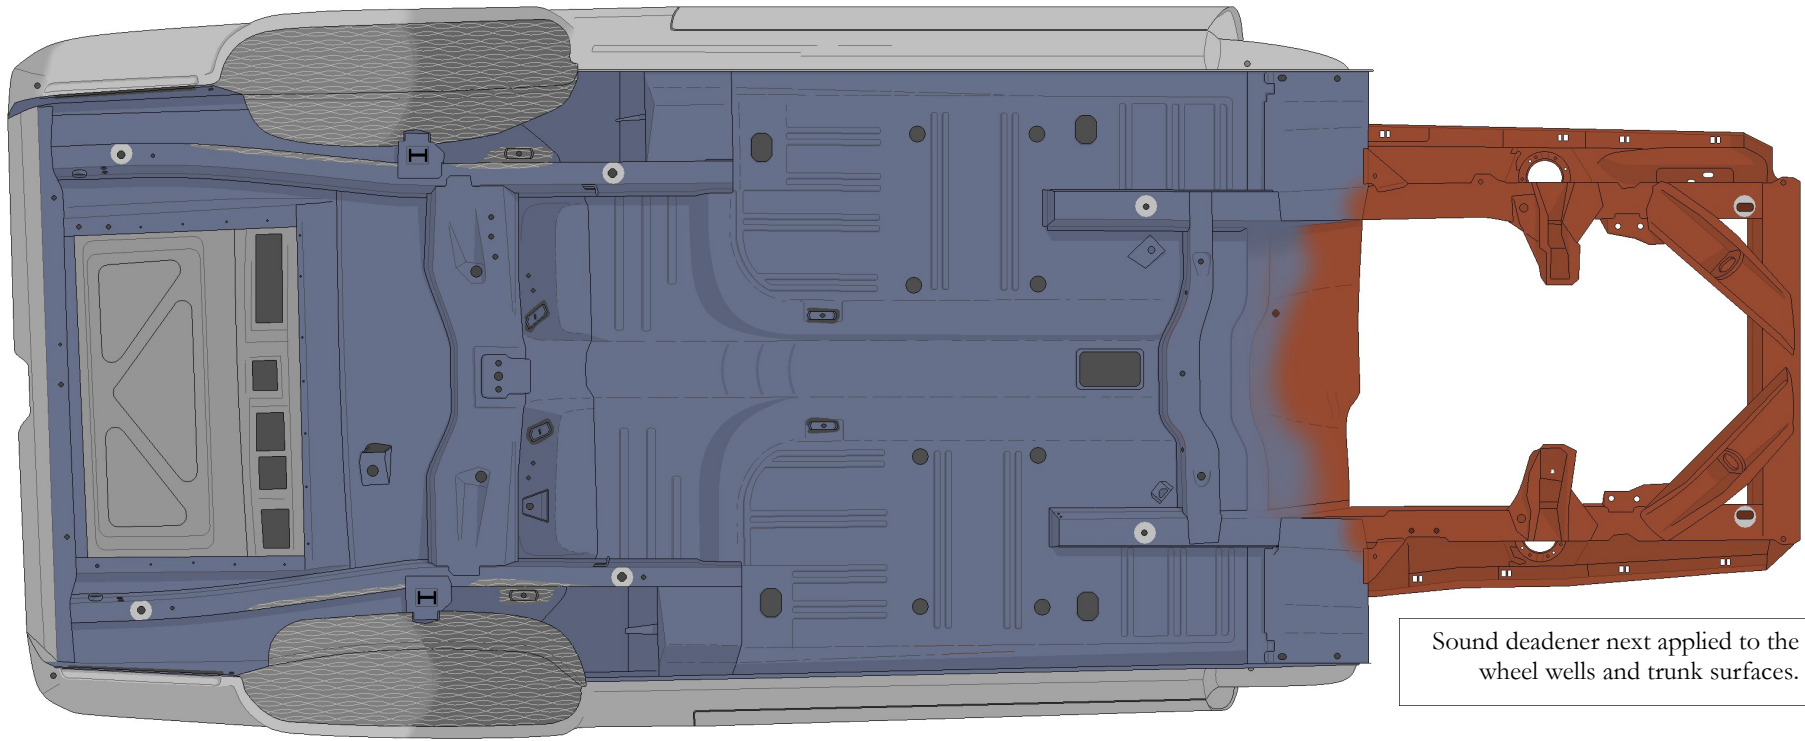
Sound deadener next applied to the rear wheel wells and trunk surfaces.

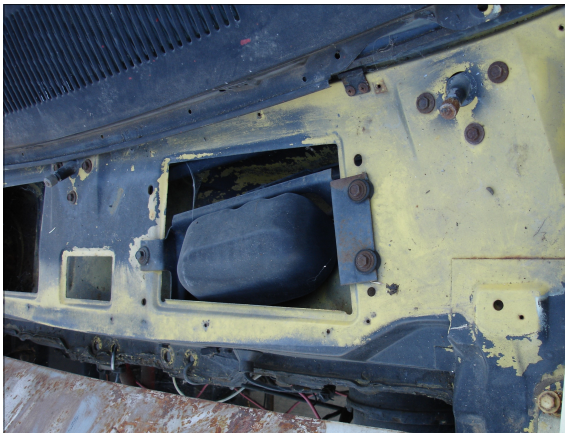
Cowl under cowl cover was body color or blacked out with engine compartment black depending on the car's build date. Black paint is worn on example

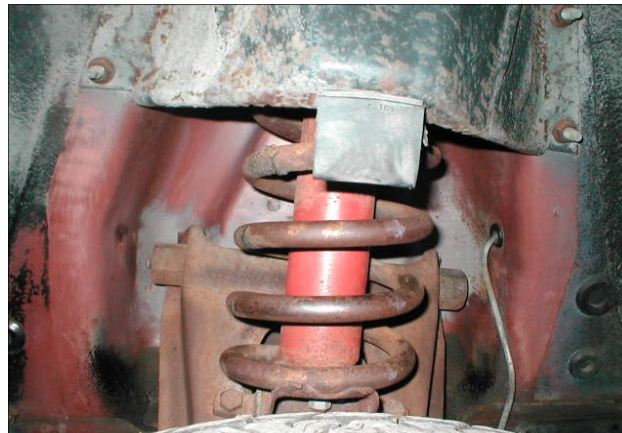
Front wheel well finish (before sound deadener was applied) is a combination of base color (in this example red oxide) body color at the rear and black towards the front .

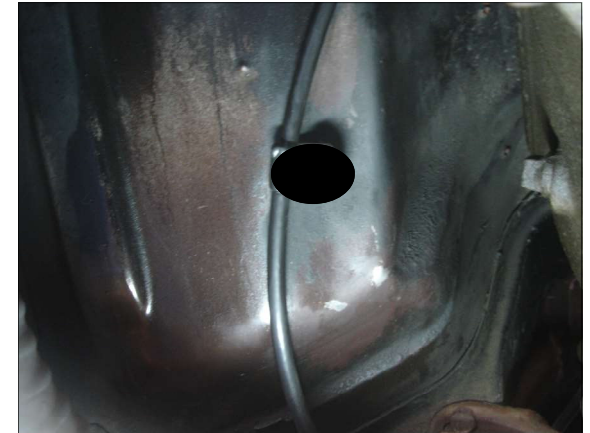
Transition from batch color of the floor/undercarriage to red oxide/firewall to engine compartment black over both.

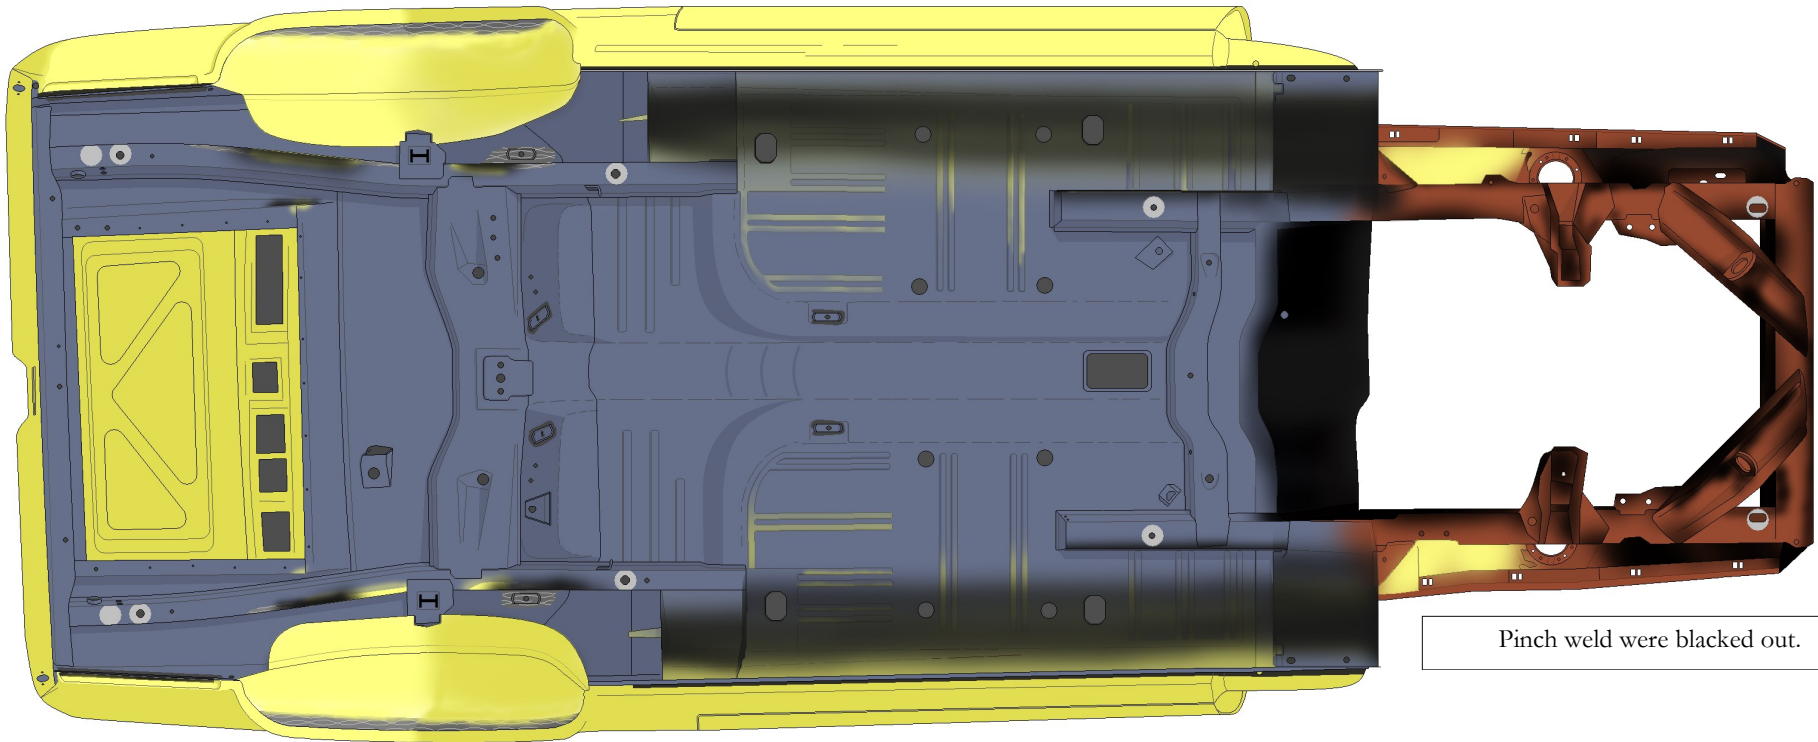
Pinch weld were blacked out.

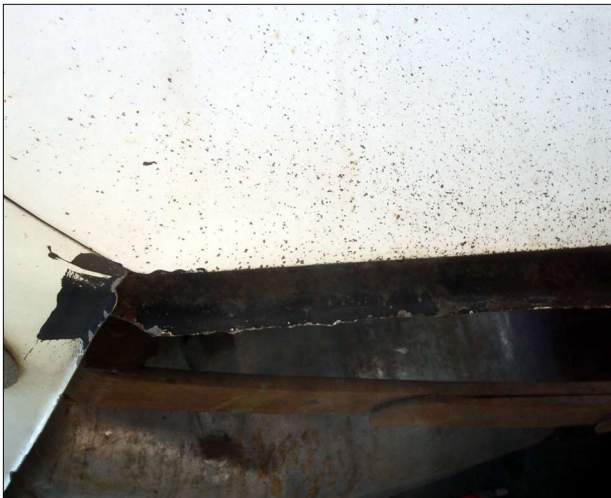
Rear quarter panel pinch weld black out applied after rear valance was pulled into the body at the bottom edge.

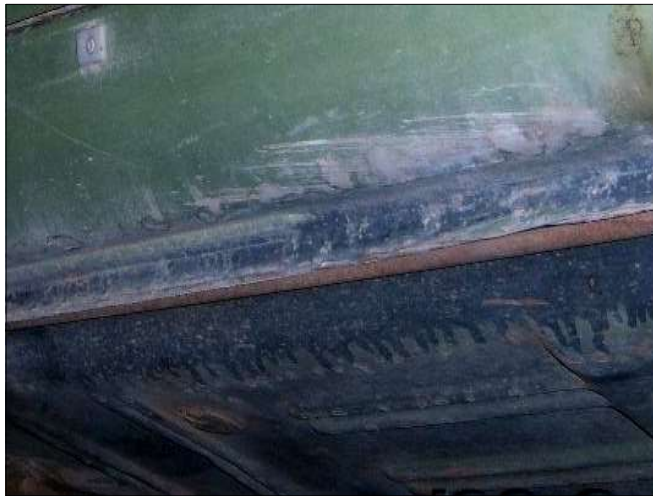
Closely applied example of pinch weld blackout on this example produced runs of black paint on floor near gun and less overspray inward on the floor

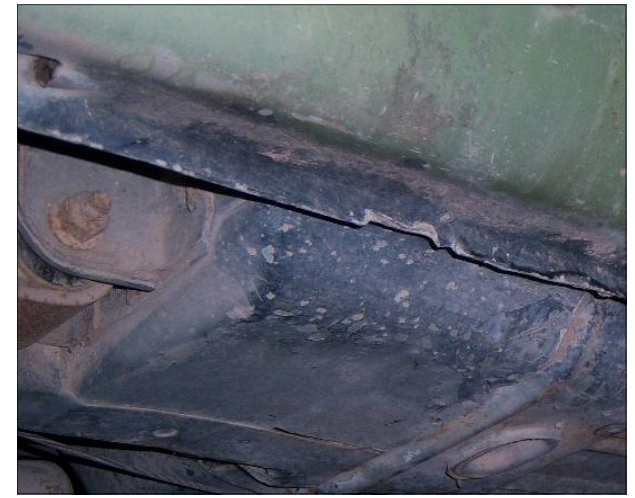
In this example paint was applied at a slightly different angle and distance which produced a wider black paint application and less runs on the floor pan close by.

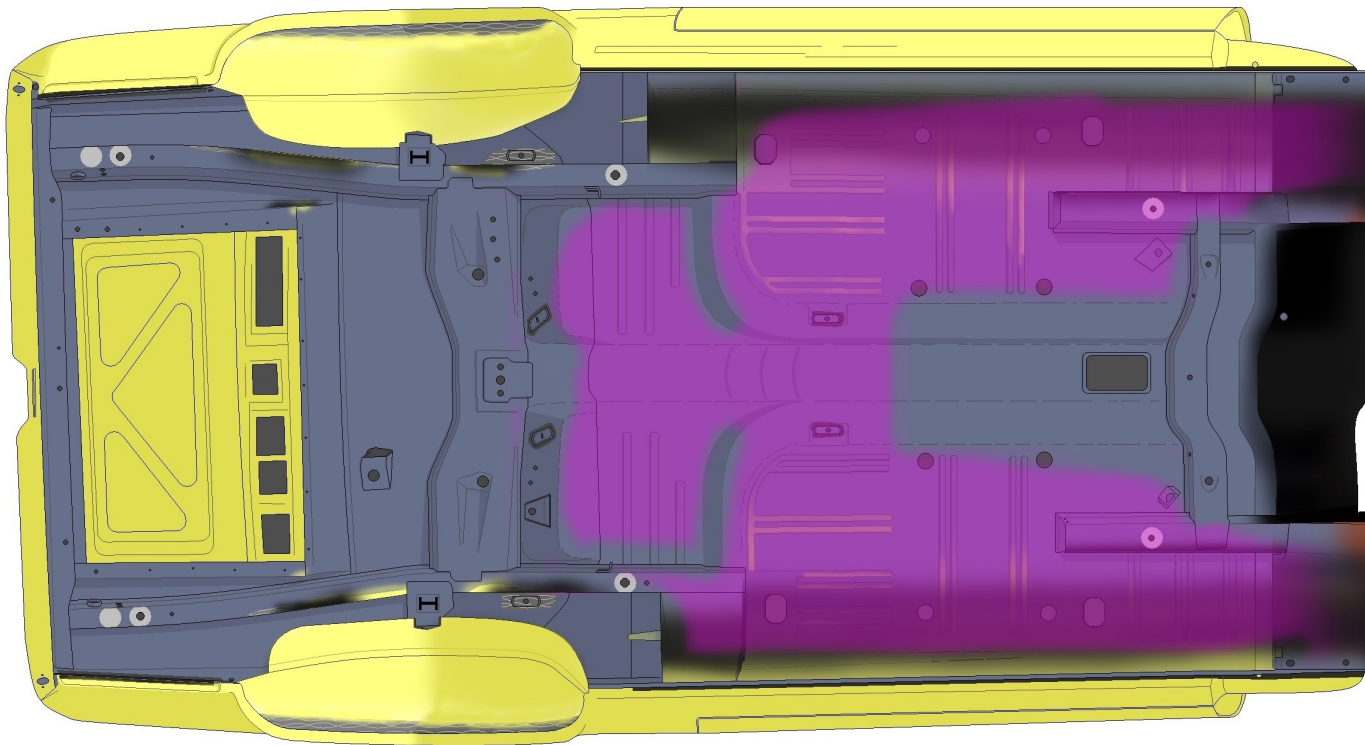
Grande, Mach I , Shelby and some others Note:

Once fuel line brake lines, rear suspension, engine and trans (basically everything under the car except the exhaust and driveline) the floor sound deadener was applied. (shown in Purple)

Since these items were installed shadows were created as sound deadener was applied over some (example would be brake & fuel lines and emergency brake cables).

Typically this was applied in three passes with the wand, front to back or back to front. Like many applications the area of coverage varies and amount could be a little or allot depending on the worker.

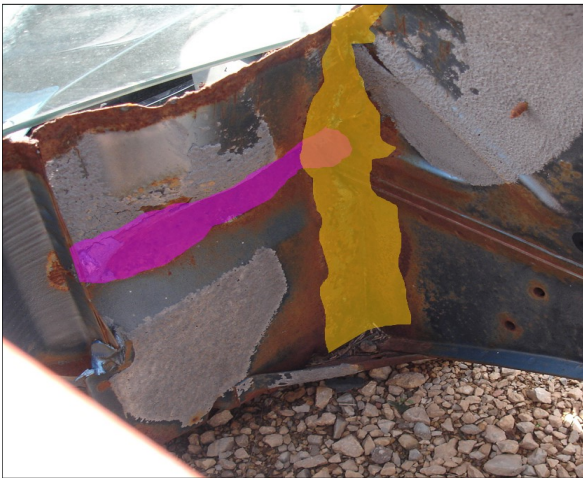
In the picture above the area covered with the spray on sealant is highlighted.

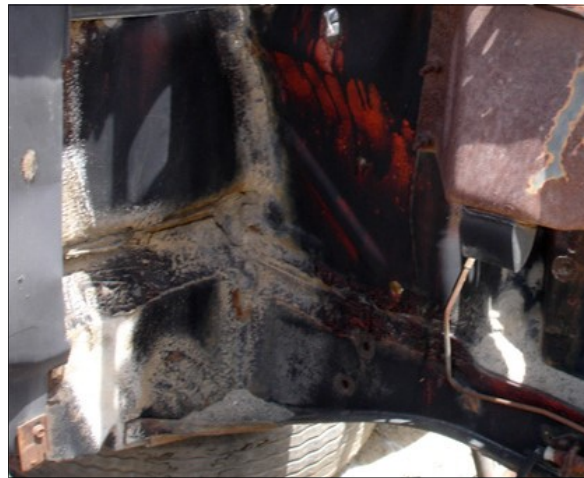
In the example above the worker applied the sealer to a larger area and number of seams in the area.

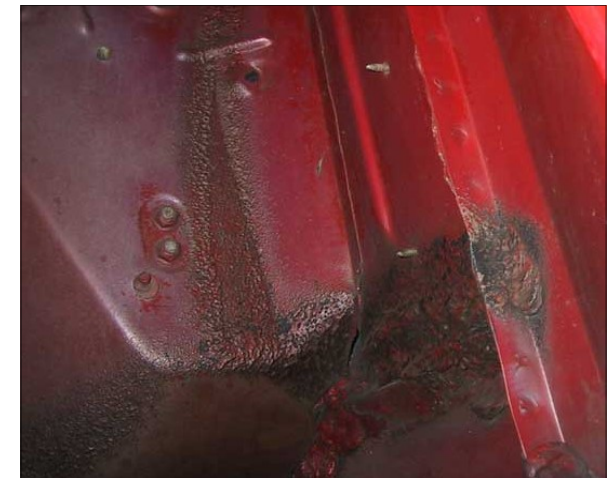
This examples show the seam sealer under the exterior paint coat on both vertical and horizontal seams.

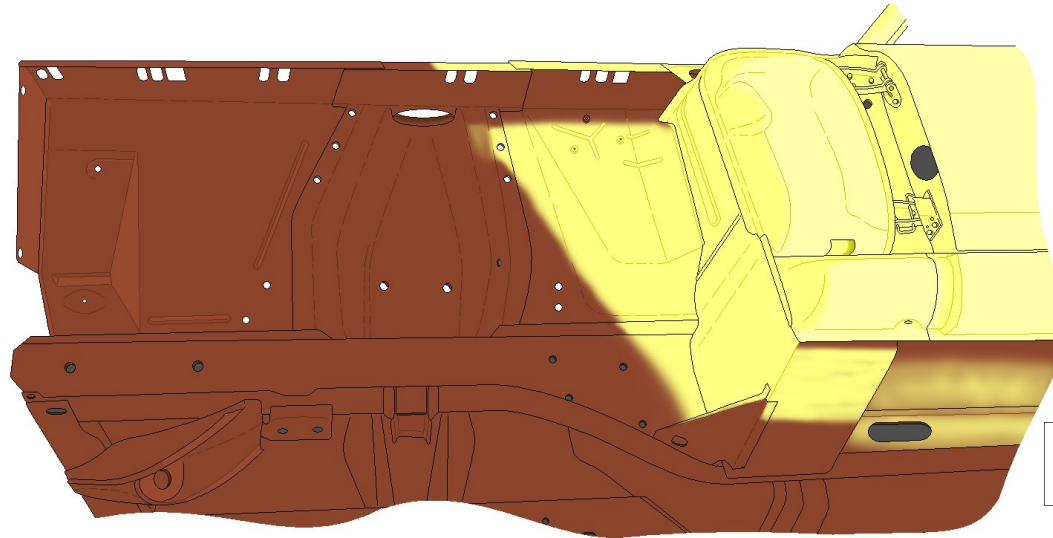
Example of the typical body color forward application.

Front Wheel Well Painting: The paint/primer that was used on the bottom of the frame rails, firewall forward, is typically found applied on the wheel side of the inner fender panels as well as the firewall section visible in the front wheel well. During the body color application it was normal that the painter applied body color to at least the rear edge of the shock tower area, angling down and rearward with his passes with the spray gun. In many cases the paint was applied further forward into the shock tower area or even further forward. The amount of coverage and where each stopped and started depended on what the painter wanted to do that moment it appears. Patterns appear to be unrelated so far to body type or month of production.

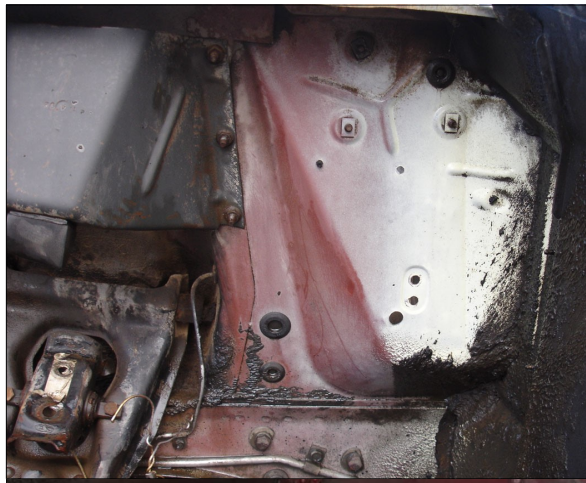
An example showing the amount of white body color over the base red oxide to a lesser amount.

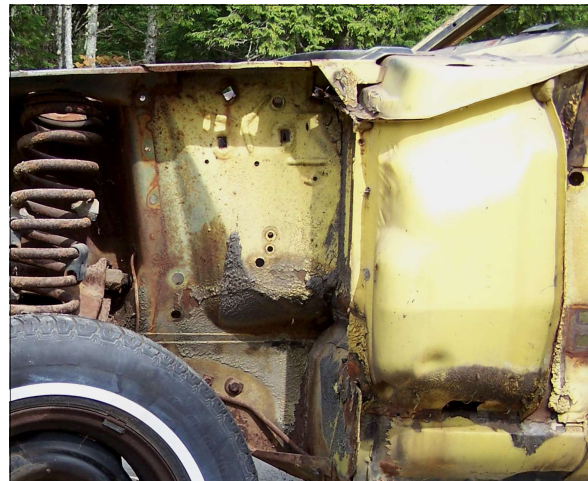
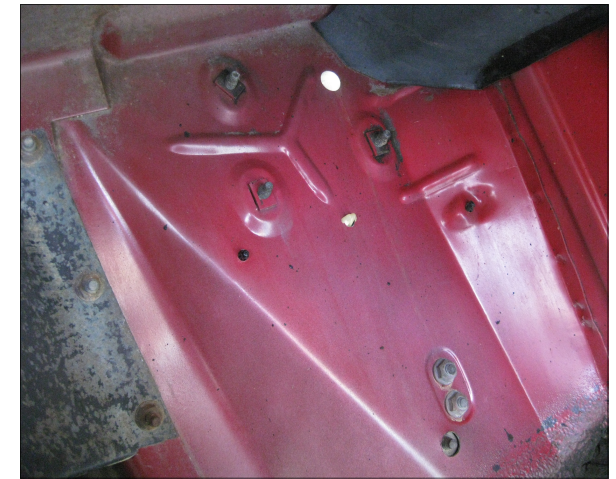
This picture shows the extent of body color forward in this drivers side front wheel well.

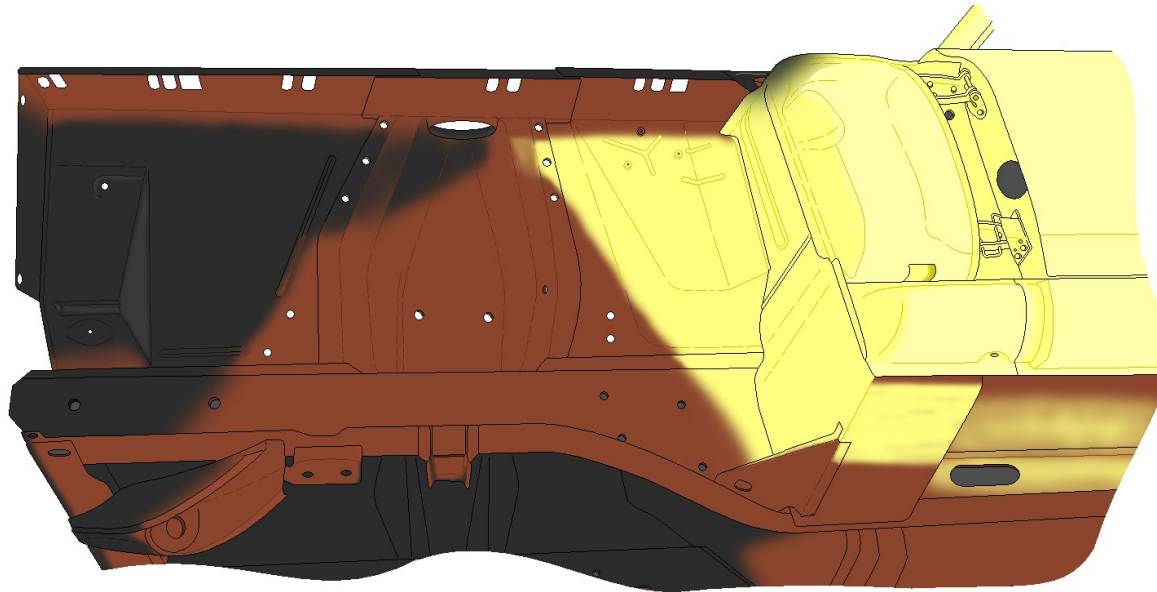
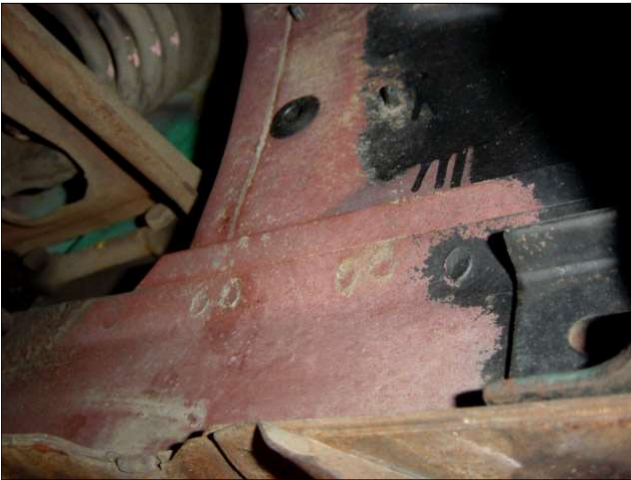
Wide range of how much engine compartment black wrapped around from painting the face of the radiator support has been found on original unrestored cars during this study. To the right (passenger side inner fender in front of the shock tower pocket) and a minimal amount applied (to the right) to the drivers side inner fender panel while, in this example, more black paint lower on the panel and frame rail.

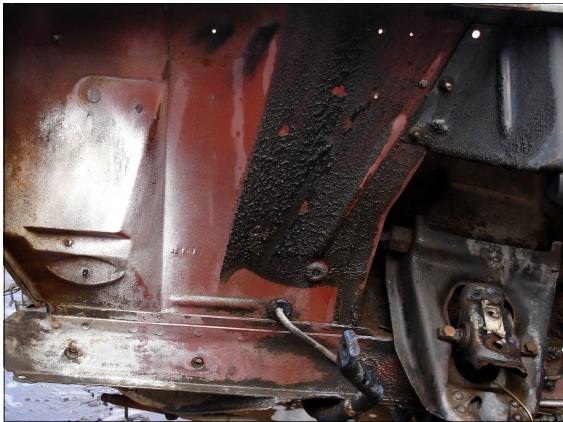
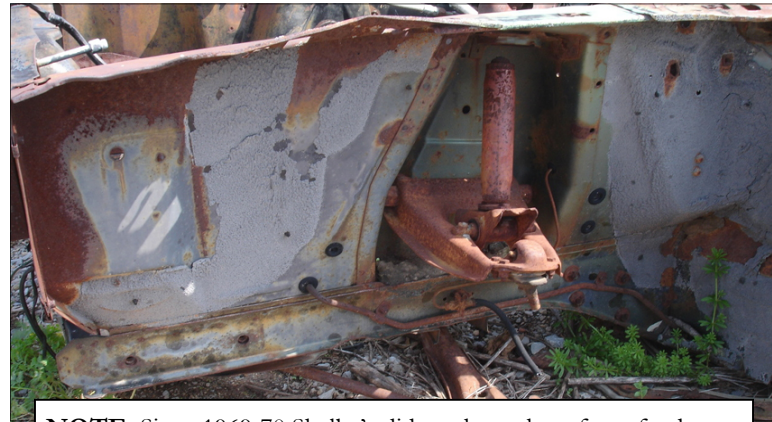
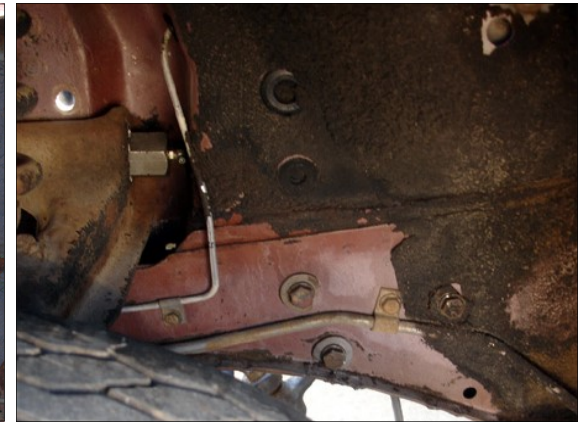
Front Wheel Well: When the engine compartment black was applied to the inner fender panels (engine side and upper lip), firewall (extending up over the cowl to the windshield opening and the radiator support (front and rear surface) it was normal that the black paint, either from a heavy overspray or direct application, would get applied to the wheel side surface of the inner fender panels in front of the shock tower or either side as well as a dusting below the fender lip of the inner fender panel. This fine overspray is often washed/scrubbed away during cleaning of the original surfaces. The extent and how far reward the black extended varied allot as did the exterior paint application forward in this area of the body.

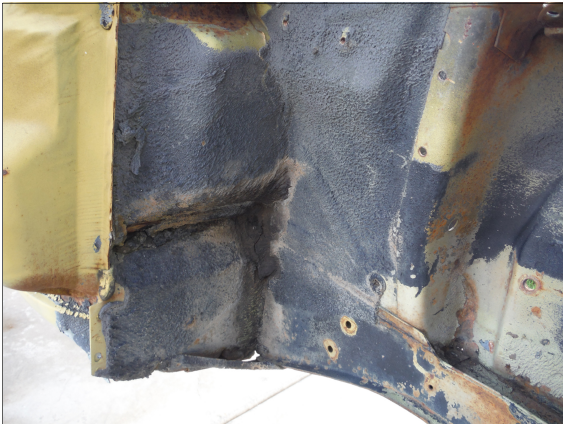
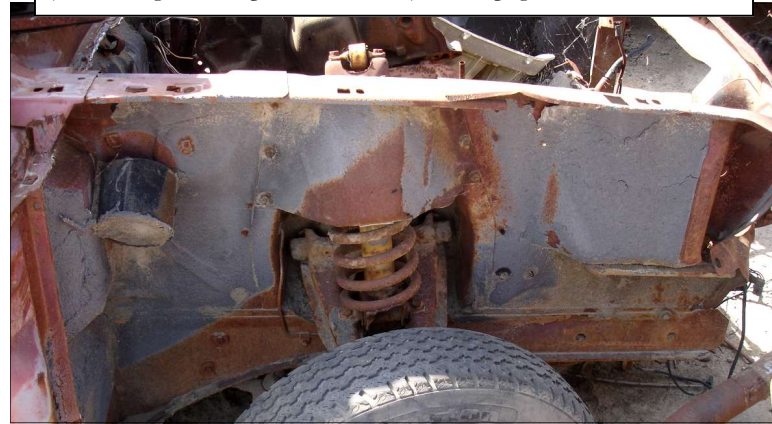
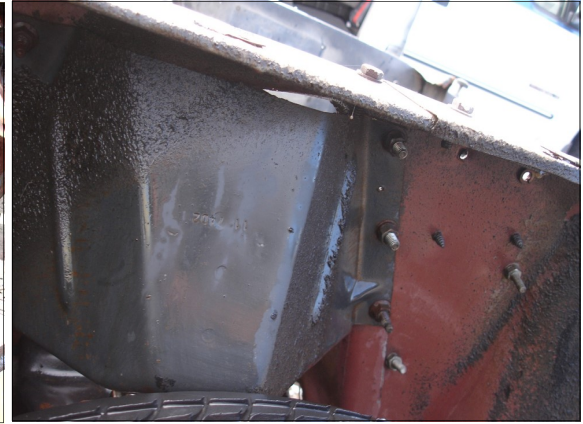
Front Wheel Well Sound Deadener: Once the car was assembled, but prior to the installation of the front wheels and tires sound deadener was applied, from below the vehicle, on the inner fender panels (in front and behind the shock towers), the firewall section in the wheel well, over the front and rear splash panels/shields as well as the bottom surface of the front fenders. Typically the amount of area covered could be anywhere between a little/minimal (left set of pictures) or allot (right hand set of pictures). Sound deadener was applied by a worker in a pit below the body as it passed over head. The spray pattern will reflect this location and angles it produced. Shape edges in the pictures above in most cases reflect the shadows produced by the fender splash shields that would have been attached at the time of sound deadener application, but removed for these pictures.

NOTE: Since 1969-70 Shelby's did not have their front fenders installed at Dearborn assemble plant this step was not done on those cars and should lack any top coat sound deadener in the final restoration. Examples of these cars can be found in the examples (bottom right most picture on both) of the page 12 & 13

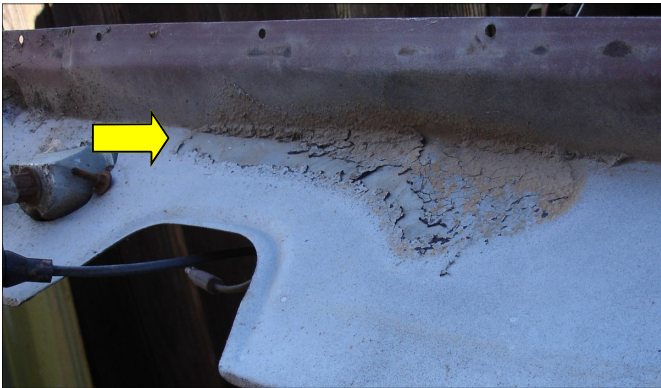
Backside of Rear Valance: In an attempt to soften the drone or hum that can sometimes be produced by sheet metal vibrating, a small amount of sealer was applied by spray onto the forward surface (facing the rear cross member) of the rear valance approximately over each location where the exhaust pipes would exit below on a dual exhaust car. The location was approximately center between the lower edge and the upper mounting lip and applied prior to being installed on the vehicle. Diameter of the product was approximately four to six inches as illustrated in the picture to the right. Passenger side shown in picture.
